# Access Compliance Report Public Rights-of-Way (Pedestrian Signals)

Main Street: MOUNTAIN\_VIEW\_AVE Cross Street: KELLOGG\_DR Location: W

ADA ID: SGAT210922124846 Signal Type: One Push Button-Non APS Overall Compliance: No Severity Scores: BTN 1: 35 BTN 2: N/A No BTN: N/A

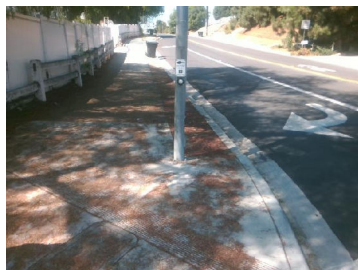
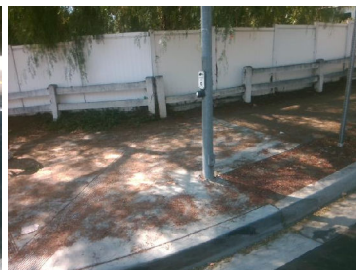
| No B 1 Pilot Light? | No | N/A B 2 Pilot Light? | N/A |

| Compliance | Description | Data | Compliance | Description | Data |
|---|---|---|---|---|---|
| No B 1 Clear Floor Space XSlope (%) | | 4 | N/A | B 2 Clear Floor Space XSlope (%) | N/A |
| No B 1 DistanceTo XWalk (in) | | 72 | N/A | B 2 DistanceTo XWalk (in) | N/A |

Possible Solutions: Replace Signal Push Button With APS Button. Remove & Relocate Sign.

Total Cost: \$ 650
