# Access Compliance Report Public Rights-of-Way (Pedestrian Signals)

Main Street: LINCOLN\_AVE Cross Street: BATAVIA\_ST Location: SE

ADA ID: SGAT210924092043 Signal Type: One Push Button-Non APS Overall Compliance: No Severity Scores: BTN 1: 35 BTN 2: N/A No BTN: N/A

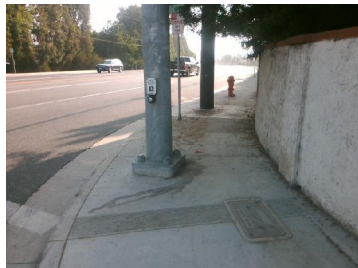
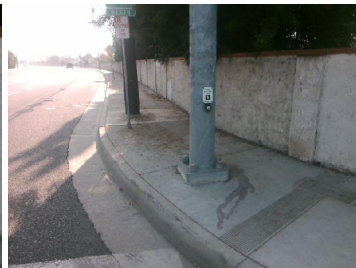
| Compliance | Description | Data | Compliance | Description | Data |
|---|---|---|---|---|---|
| No | B 1 Clear Floor Space XSlope (%) | 2.8 | N/A | B 2 Clear Floor Space XSlope (%) | N/A |

| No | B 1 Pilot Light? | No | N/A | B 2 Pilot Light? | N/A |

Possible Solutions: Replace Signal Push Button With APS Button. Remove and Replace Clear Space.

OC Std/PROW: R404.2, MUTCD 4e.08
