# Access Compliance Report Public Rights-of-Way (Pedestrian Signals)

Main Street: LINCOLN\_AVE Cross Street: N\_ORANGE\_OLIVE\_RD Location: NE

ADA ID: SGAT210924140937 Signal Type: One Push Button-Non APS Overall Compliance: No Severity Scores: BTN 1: 35 BTN 2: N/A No BTN: N/A

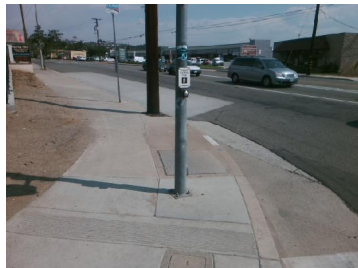
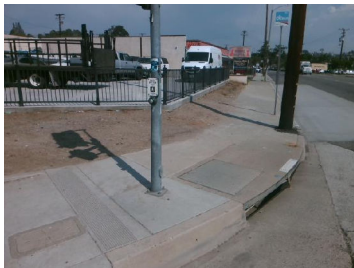
| Compliance | Description | Data | Compliance | Description | Data |
|---|---|---|---|---|---|
| No | B 1 Clear Floor Space Slope (%) | 2.5 | N/A | B 2 Clear Floor Space Slope (%) | N/A |

| No | B 1 Pilot Light? | No | N/A | B 2 Pilot Light? | N/A |

Possible Solutions: Replace Signal Push Button With APS Button. Remove and Replace Clear Space.

OC Std/PROW: R404.2, R404.3, MUTCD 4e.08

Total Cost: \$ 1278
