# Access Compliance Report Public Rights-of-Way (Pedestrian Signals)

Main Street: CHAPMAN\_AVE Cross Street: HEWES\_ST Location: NW

ADA ID: SGAT210929133107 Signal Type: One Push Button-Non APS Overall Compliance: No Severity Scores: BTN 1: 35 BTN 2: N/A No BTN: N/A

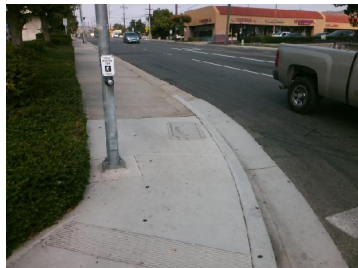
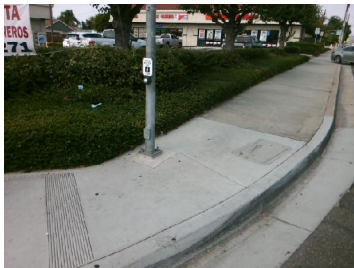
| Compliance | Description | Data | Compliance | Description | Data |
|---|---|---|---|---|---|
| No | B 1 Clear Floor Space XSlope (%) | 2.8 | N/A | B 2 Clear Floor Space XSlope (%) | N/A |

| No | B 1 Pilot Light? | No | N/A | B 2 Pilot Light? | N/A |

Possible Solutions: Replace Signal Push Button With APS Button. Remove and Replace Clear Space.

OC Std/PROW: R404.2, MUTCD 4e.08

Total Cost: \$ 1278
