# Access Compliance Report Public Rights-of-Way (Pedestrian Signals)

Main Street: DODGE\_AVE Cross Street: DODGE\_AVE Location: NE

ADA ID: SGAT211018114258 Signal Type: One Push Button-Non APS Overall Compliance: No Severity Scores: BTN 1: 25 BTN 2: N/A No BTN: N/A

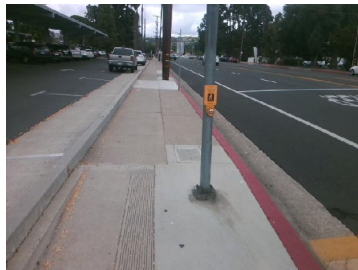
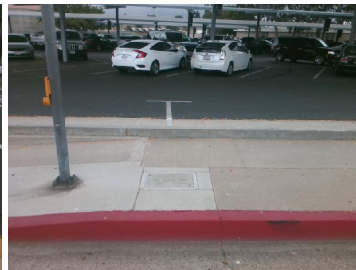
| Compliance | Description | Data | Compliance | Description | Data |
|---|---|---|---|---|---|
| No | B 1 Clear Floor Space Slope (%) | 9.2 | N/A | B 2 Clear Floor Space Slope (%) | N/A |
| No | B 1 Clear Floor Space XSlope (%) | 3.4 | N/A | B 2 Clear Floor Space XSlope (%) | N/A |

Possible Solutions: Remove and Replace Clear Space.

OC Std/PROW: R404.2, R404.3
