# Access Compliance Report Public Rights-of-Way (Pedestrian Signals)

Main Street: PROSPECT\_AVE Cross Street: FAIRHAVEN\_AVE Location: SW

ADA ID: SGAT211021103322 Signal Type: One Push Button-Non APS Overall Compliance: No Severity Scores: BTN 1: 35 BTN 2: N/A No BTN: N/A

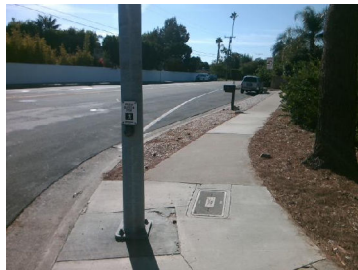
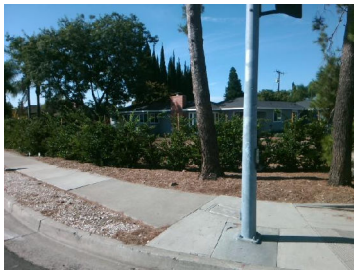
| Compliance | Description | Data | Compliance | Description | Data |
|---|---|---|---|---|---|
| No | B 1 Clear Floor Space Slope (%) | 5.3 | N/A | B 2 Clear Floor Space Slope (%) | N/A |
| No | B 1 DistanceTo XWalk (in) | 104 | N/A | B 2 DistanceTo XWalk (in) | N/A |

| No | B 1 Pilot Light? | No | N/A | B 2 Pilot Light? | N/A |

Possible Solutions: Replace Signal Push Button With APS Button. Remove & Relocate Sign.
