# Access Compliance Report Public Rights-of-Way (Pedestrian Signals)

Main Street: PROSPECT\_ST Cross Street: NONE Location: W

ADA ID: SGAT211028083304 Signal Type: One Push Button-Non APS Overall Compliance: No Severity Scores: BTN 1: 35 BTN 2: N/A No BTN: N/A

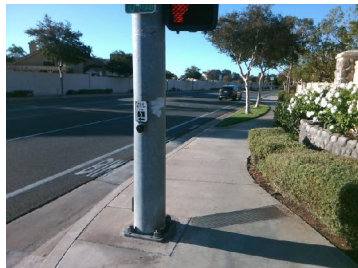
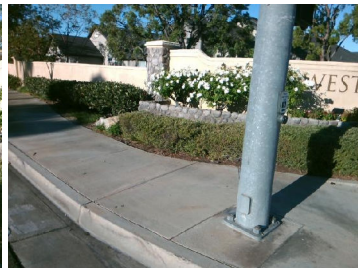
| Compliance | Description | Data | Compliance | Description | Data |
|---|---|---|---|---|---|
| No | B 1 Clear Floor Space Slope (%) | 3.3 | N/A | B 2 Clear Floor Space Slope (%) | N/A |
| No | B 1 Clear Floor Space XSlope (%) | 2.1 | N/A | B 2 Clear Floor Space XSlope (%) | N/A |

| No | B 1 Pilot Light? | No | N/A | B 2 Pilot Light? | N/A |

Possible Solutions: Replace Signal Push Button With APS Button. Remove and Replace Clear Space.

OC Std/PROW: R404.2, R404.3, MUTCD 4e.08

Total Cost: \$ 1278
