# Access Compliance Report Public Rights-of-Way (Pedestrian Signals)

Main Street: PROSPECT\_ST Cross Street: NONE Location: W

ADA ID: SGAT211028083441 Signal Type: One Push Button-Non APS Overall Compliance: No Severity Scores: BTN 1: 35 BTN 2: N/A No BTN: N/A

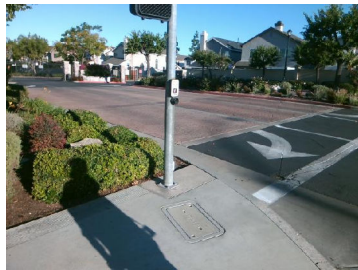
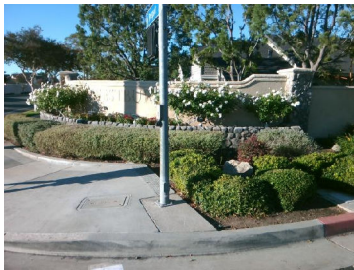
| Compliance | Description | Data | Compliance | Description | Data |
|---|---|---|---|---|---|
| No | B 1 Clear Floor Space? | No | N/A | B 2 Clear Floor Space? | N/A |

| No | B 1 Pilot Light? | No | N/A | B 2 Pilot Light? | N/A |

Possible Solutions: Replace Signal Push Button With APS Button. Provide Clear Space.

OC Std/PROW: R404.1, MUTCD 4e.08

Total Cost: \$ 1278
