# Access Compliance Report Public Rights-of-Way (Pedestrian Signals)

Main Street: NONE Cross Street: PROSPECT\_ST Location: N

ADA ID: SGAT211028084226 Signal Type: One Push Button-Non APS Overall Compliance: No Severity Scores: BTN 1: 10 BTN 2: N/A No BTN: N/A

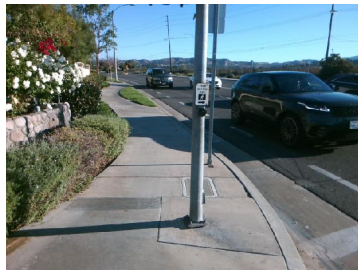
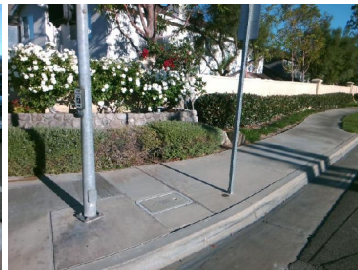
| N/A | Is Button 1 APS or Non-APS? | NonAPS | N/A | Is Button 2 APS or Non-APS? | N/A |
| No | B 1 Pilot Light? | No | N/A | B 2 Pilot Light? | N/A |

Possible Solutions: Replace Signal Push Button With APS Button.

OC Std/PROW: MUTCD 4e.08

Total Cost: \$ 900
