# Access Compliance Report Public Rights-of-Way (Pedestrian Signals)

Main Street: PROSPECT\_ST Cross Street: BOND\_AVE Location: E

ADA ID: SGAT211028084816 Signal Type: One Push Button-Non APS Overall Compliance: No Severity Scores: BTN 1: 35 BTN 2: N/A No BTN: N/A

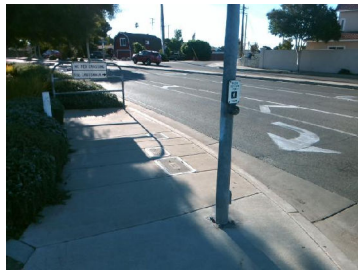
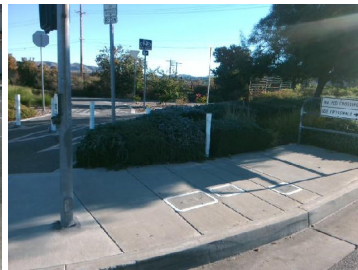
| Compliance | Description | Data | Compliance | Description | Data |
|---|---|---|---|---|---|
| No | B 1 Clear Floor Space Slope (%) | 2.5 | N/A | B 2 Clear Floor Space Slope (%) | N/A |

| No | B 1 Pilot Light? | No | N/A | B 2 Pilot Light? | N/A |

Possible Solutions: Replace Signal Push Button With APS Button. Remove and Replace Clear Space.

OC Std/PROW: R404.2, R404.3, MUTCD 4e.08
