# Access Compliance Report Public Rights-of-Way (Pedestrian Signals)

Main Street: FRONTERA\_ST Cross Street: N\_GLASSELL\_ST Location: SE

ADA ID: SGAT220127091624 Signal Type: One Push Button-Non APS Overall Compliance: No Severity Scores: BTN 1: 35 BTN 2: N/A No BTN: N/A

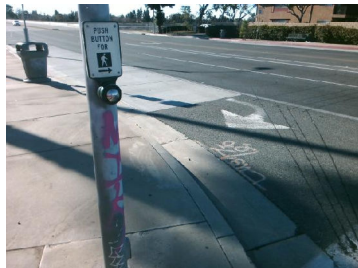
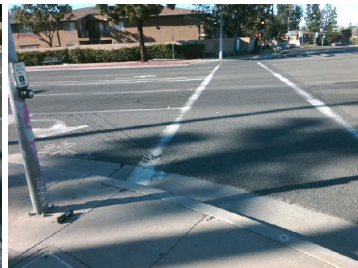
| Compliance | Description | Data | Compliance | Description | Data |
|---|---|---|---|---|---|
| No | B 1 Clear Floor Space Slope (%) | 5.7 | N/A | B 2 Clear Floor Space Slope (%) | N/A |
| No | B 1 Pressure (#) | 10 | N/A | B 2 Pressure (#) | N/A |

| No | B 1 Pilot Light? | No | N/A | B 2 Pilot Light? | N/A |

Possible Solutions: Replace Signal Push Button With APS Button. Remove and Replace Clear Space.

OC Std/PROW: R404.2, R404.3, R403.4, MUTCD 4e.08
