# Access Compliance Report Public Rights-of-Way (Pedestrian Signals)

Main Street: YORBA\_LINDA\_BLV Cross Street: YORBA\_LINDA\_BLV Location: NW

ADA ID: SGAT220221103115 Signal Type: One Push Button-Non APS Overall Compliance: No Severity Scores: BTN 1: 35 BTN 2: N/A No BTN: N/A

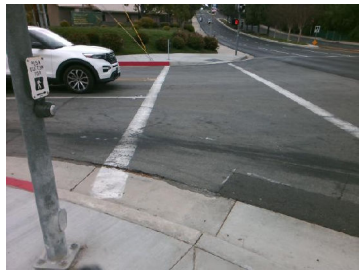
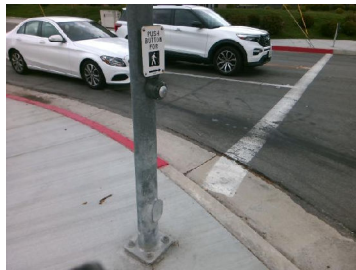
| Compliance | Description | Data | Compliance | Description | Data |
|---|---|---|---|---|---|
| No | B 1 Clear Floor Space Slope (%) | 5 | N/A | B 2 Clear Floor Space Slope (%) | N/A |
| No | B 1 Pressure (#) | 10 | N/A | B 2 Pressure (#) | N/A |

| No | B 1 Pilot Light? | No | N/A | B 2 Pilot Light? | N/A |

Possible Solutions: Replace Signal Push Button With APS Button. Remove and Replace Clear Space.
