# Access Compliance Report Public Rights-of-Way (Pedestrian Signals)

Main Street: KATELLA\_AVE Cross Street: GILBERT\_ST Location: SE

ADA ID: SGRK210916140447 Signal Type: One Push Button-Non APS Overall Compliance: No Severity Scores: BTN 1: 25 BTN 2: N/A No BTN: N/A

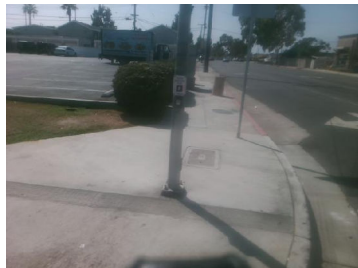
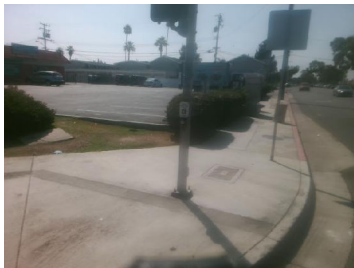
| Compliance | Description | Data | Compliance | Description | Data |
|---|---|---|---|---|---|
| No | B 1 Clear Floor Space Slope (%) | 3.3 | N/A | B 2 Clear Floor Space Slope (%) | N/A |
| No | B 1 Clear Floor Space XSlope (%) | 10.2 | N/A | B 2 Clear Floor Space XSlope (%) | N/A |

Possible Solutions: Remove and Replace Clear Space.

OC Std/PROW: R404.2, R404.3
