# Access Compliance Report Public Rights-of-Way (Pedestrian Signals)

Main Street: CERRITOS\_AVE Cross Street: GILBERT\_ST Location: NW

ADA ID: SGRK210923133204 Signal Type: One Push Button-Non APS Overall Compliance: No Severity Scores: BTN 1: 25 BTN 2: N/A No BTN: N/A

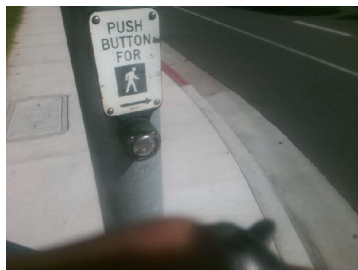
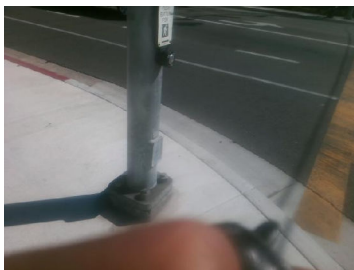
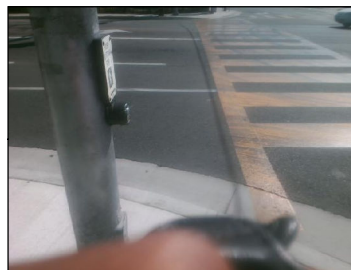
| Compliance | Description | Data | Compliance | Description | Data |
|---|---|---|---|---|---|
| No B 1 Clear Floor Space Slope (%) | 3.2 | N/A | N/A | B 2 Clear Floor Space XSlope (%) | N/A |
| No B 1 Clear Floor Space XSlope (%) | 8.8 | N/A | N/A | B 2 PAR Slope (%) | N/A |

Possible Solutions: Remove and Replace Clear Space.

OC Std/PROW: R404.2, R404.3
