# Access Compliance Report Public Rights-of-Way (Pedestrian Signals)

Main Street: GILBERT\_ST Cross Street: GUINIDA\_LN Location: NE

ADA ID: SGRK210924121827 Signal Type: One Push Button-APS Overall Compliance: No Severity Scores: BTN 1: 35 BTN 2: N/A No BTN: N/A

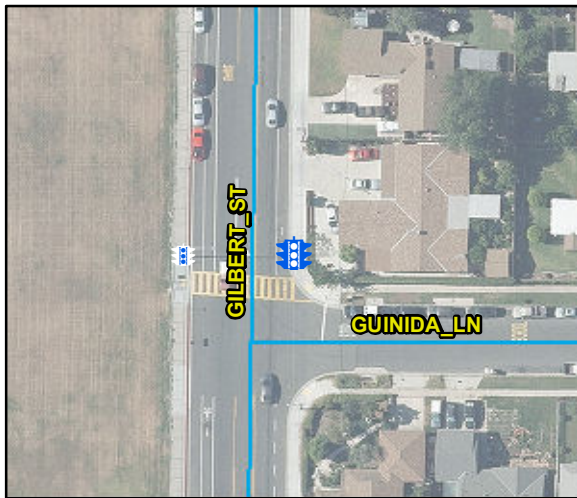
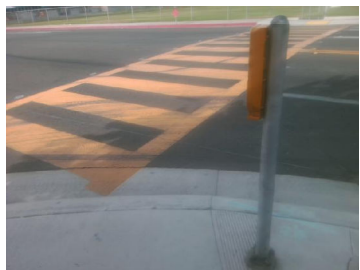
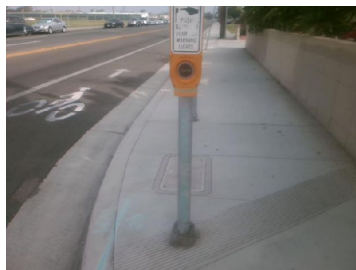
| No B 1 Pilot Light? | No | N/A B 2 Pilot Light? | N/A |
| N/A B 1 Locator Tone? | No | N/A B 2 Locator Tone? | N/A |

| Compliance | Description | Data | Compliance | Description | Data |
|---|---|---|---|---|---|
| No | B 1 Clear Floor Space XSlope (%) | 6.8 | N/A | B 2 Clear Floor Space XSlope (%) | N/A |

Possible Solutions: Replace Signal Push Button With APS Button. Remove and Replace Clear Space.
