# Access Compliance Report Public Rights-of-Way (Pedestrian Signals)

Main Street: COW\_CAMP\_RD Cross Street: CHIQUITA\_CANYON\_DR Location: NW

ADA ID: SGRK211124121853 Signal Type: One Push Button-Non APS Overall Compliance: No Severity Scores: BTN 1: 25 BTN 2: N/A No BTN: N/A

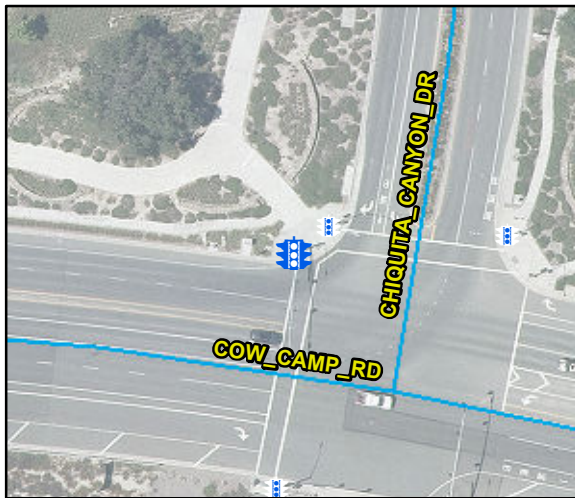
Surveyor Notes: N/A

Possible Solutions: Remove and Replace Clear Space.

OC Std/PROW: R404.2, R404.3

Total Cost: \$ 378

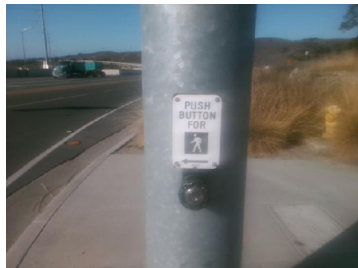
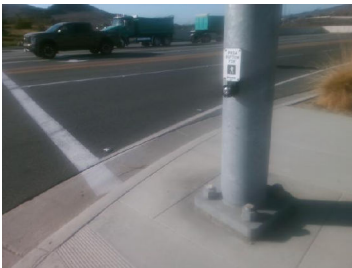
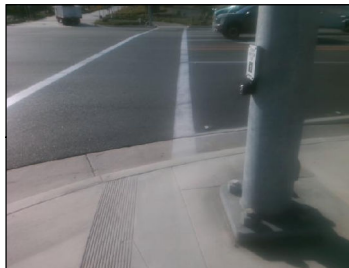
| Compliance | Description | Data | Compliance | Description | Data |
|---|---|---|---|---|---|
| No B 1 Clear Floor Space Slope (%) | 7.2 | N/A | N/A | B 2 Clear Floor Space XSlope (%) | N/A |
