# Access Compliance Report Public Rights-of-Way (Pedestrian Signals)

Main Street: **ESENCIA\_DR** Cross Street: **CHIQUITA\_CANYON\_DR** Location: **NE**

ADA ID: **SGRK211124134058** Signal Type: **One Push Button-Non APS** Overall Compliance: **No** Severity Scores: **BTN 1: 35** **BTN 2: N/A** **No BTN: N/A**

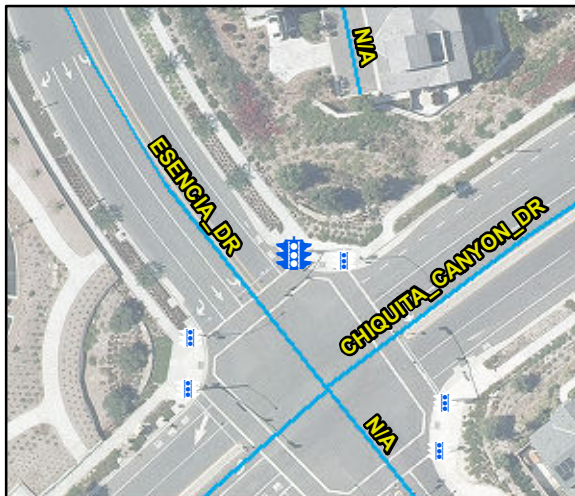
| <b>No</b> B 1 Pilot Light? | <b>No</b> | <b>N/A</b> B 2 Pilot Light? | <b>N/A</b> |

| Compliance | Description | Data | Compliance | Description | Data |
|---|---|---|---|---|---|
| <b>No</b> | B 1 Clear Floor Space Slope (%) | <b>3.1</b> | <b>N/A</b> | B 2 Clear Floor Space Slope (%) | <b>N/A</b> |

Possible Solutions: Replace Signal Push Button With APS Button. Remove and Replace Clear Space.
