| Main Street: CHIQUITA_CANYON_DR | | Cross Street: AIROSO_ST | | Location: | | SE | |
| ADA ID: SGRK211130124642 | | Signal Type:One Push Button-Non APS | | Overall Compliance: No | | Severity Scores: BTN 1: 35 BTN 2: N/A No BTN: N/A | |

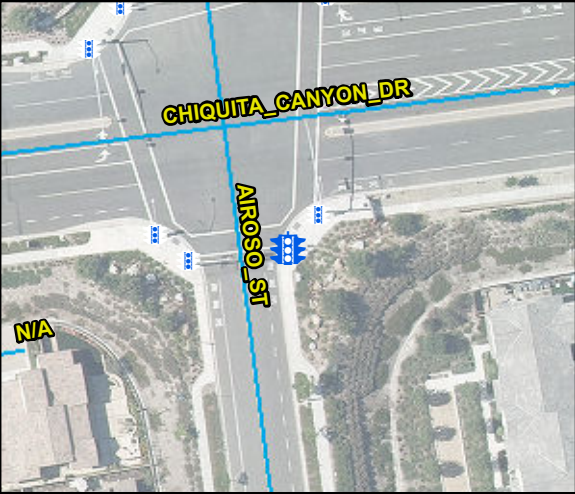
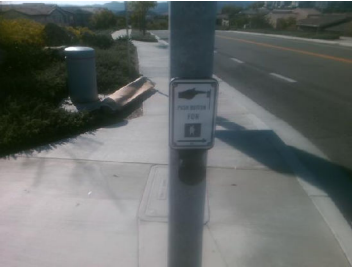
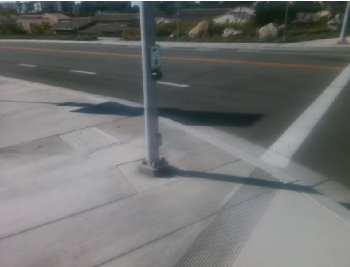
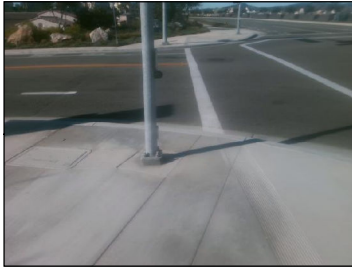
| No B 1 Pilot Light? | No | N/A B 2 Pilot Light? | N/A | | | | |
| | | | | No B 1 Clear Floor Space XSlope (%) 4.6 N/A B 2 Clear Floor Space XSlope (%) N/A | | | |

| | | <p>Possible Solutions: Replace Signal Push Button With APS Button. Remove and Replace Clear Space.</p> <p>Surveyor Notes: N/A</p> <p>OC Std/PROW: R404.2, MUTCD 4e.08</p> <p>Total Cost: \$ 1278</p> | | | | | |
