# Access Compliance Report Public Rights-of-Way (Pedestrian Signals)

Main Street: N/A Cross Street: ANTONIO\_PKWY Location: NW

ADA ID: SGRK211202130804 Signal Type: One Push Button-Non APS Overall Compliance: No Severity Scores: BTN 1: 35 BTN 2: N/A No BTN: N/A

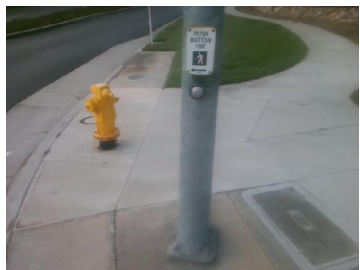
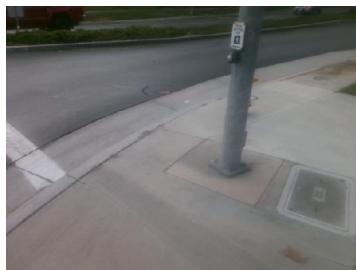
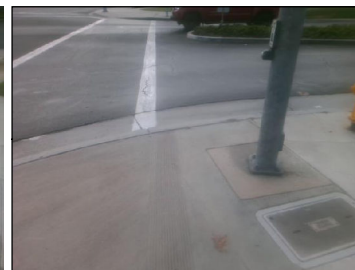
| Compliance | Description | Data | Compliance | Description | Data |
|---|---|---|---|---|---|
| No B 1 Clear Floor Space Slope (%) | | 7.3 | N/A | B 2 Clear Floor Space Slope (%) | N/A |

Possible Solutions: Replace Signal Push Button With APS Button. Remove and Replace Clear Space.

OC Std/PROW: R404.2, R404.3, MUTCD 4e.08
