| Main Street: IRVINE BLVD | | Cross Street: TUSTIN RANCH RD | | Location: S | |
| ADA ID: SGRK220103131507 Signal Type:One Push Button-APS | | Overall Compliance: No | | Severity Scores: BTN 1: 25 BTN 2: N/A No BTN: N/A | |

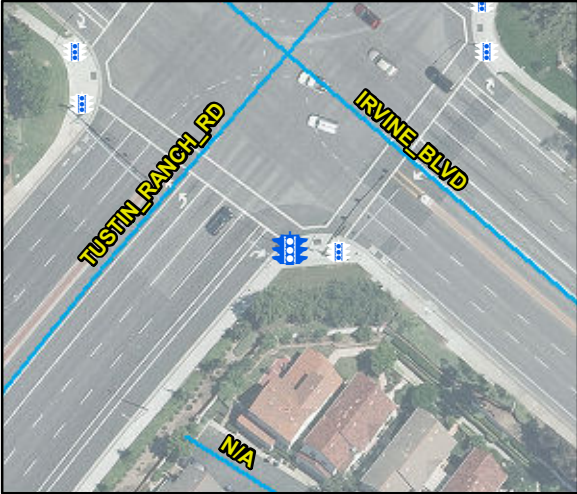
| N/A Is Button 1 APS or Non-APS? | APS | N/A Is Button 2 APS or Non-APS? | N/A | No B 1 Clear Floor Space Slope (%) | 2.1 |
| N/A B 1 VibroTact Arrow? | Yes | N/A B 2 VibroTact Arrow? | N/A | No B 1 Clear Floor Space XSlope (%) | 2.5 |

| | | Possible Solutions: Remove and Replace Clear Space. | | | |
| Total Cost: | | \$ | 378 | | |

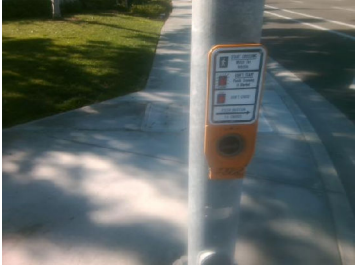
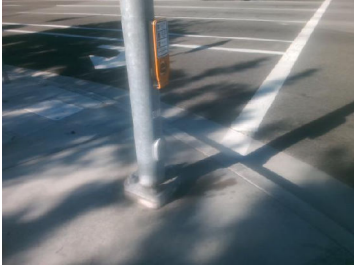
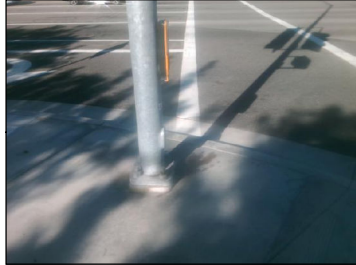
| N/A B 1 VibroTact Contrast | Yes | N/A B 2 VibroTact Contrast | N/A | Yes B 1 Height (in) | 38 |
| N/A B 1 Locator Tone? | Yes | N/A B 2 Locator Tone? | N/A | Yes B 1 DistanceTo XWalk (in) | 6 |
| N/A B 1 Tone Audible Range? | Yes | N/A B 2 Tone Audible Range? | N/A | Yes B 1 DistanceTo Curb (in) | 32 |
