# OC PUBLIC WORKS DEPARTMENT

## CANADA CHANNEL

REHABILITATION

## PROJECT CROSS SECTIONS

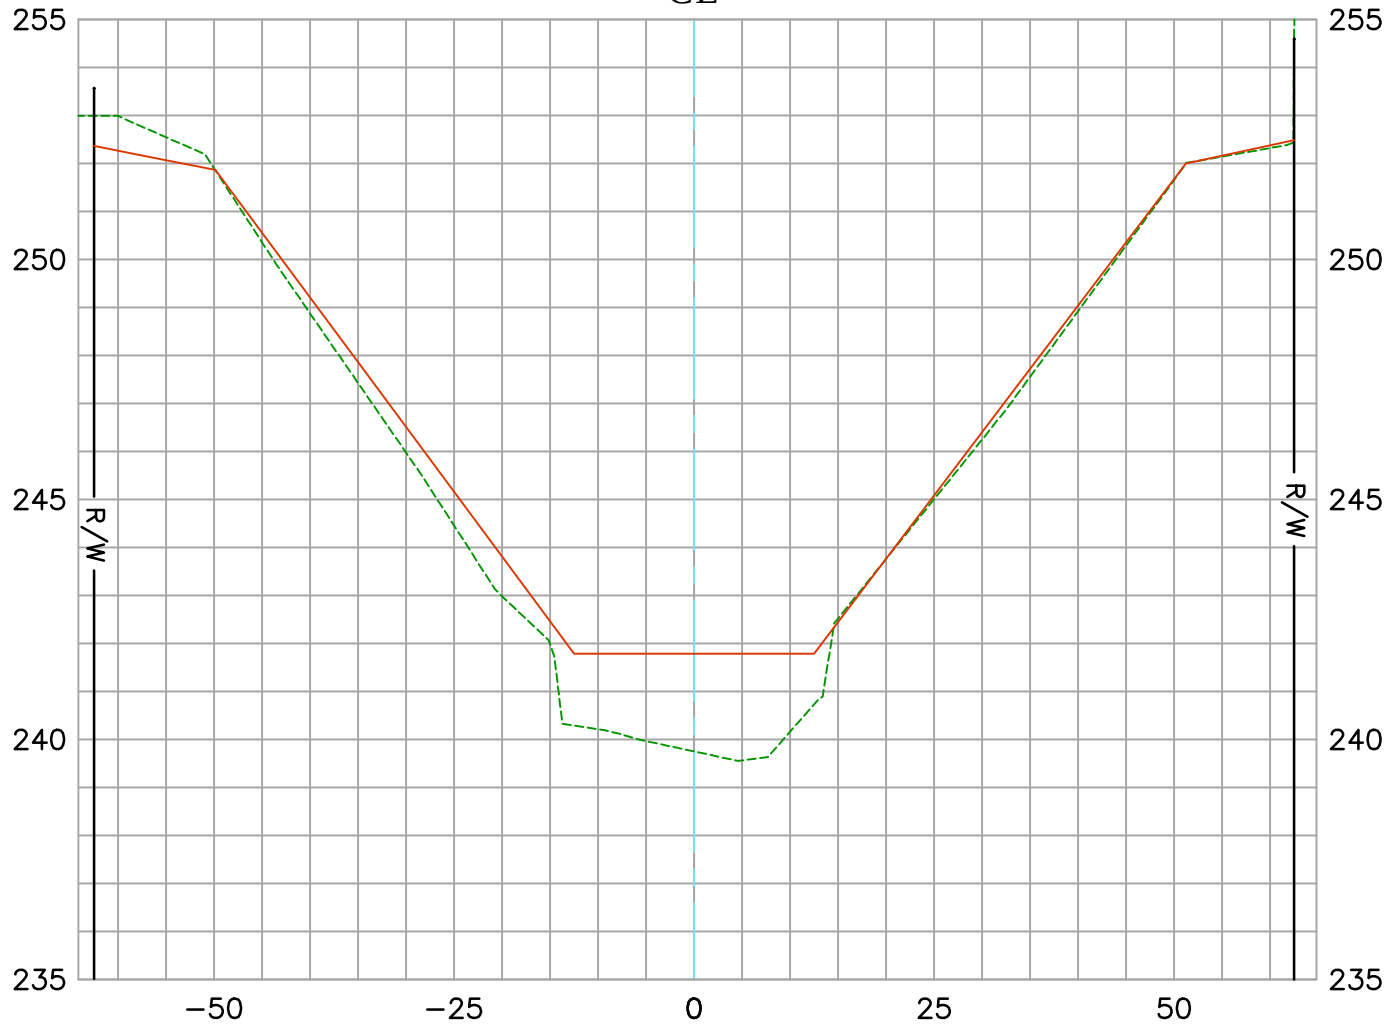
6+24.53

EXISTING CONDITION 03/18/2021  
RECORD DRAWINGS:  
F23-701-1, F23-701-2, & F23-701-3  
DATE PREPARED: 11/01/2021

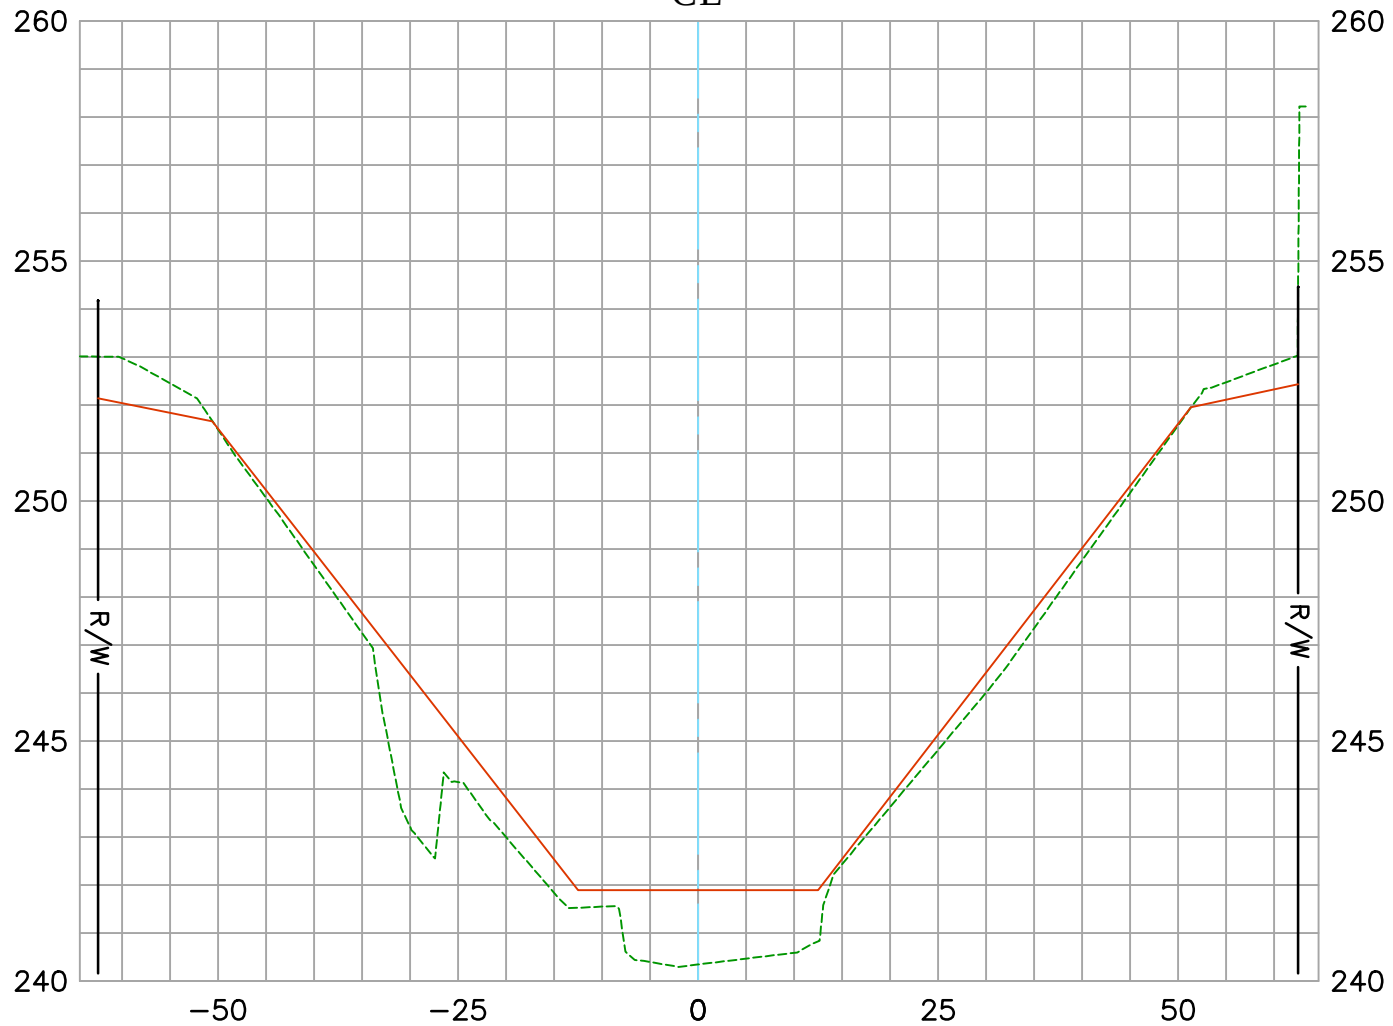
6+50.00

EXISTING CONDITION 03/18/2021  
RECORD DRAWINGS:  
F23-701-1, F23-701-2, & F23-701-3  
DATE PREPARED: 11/01/2021

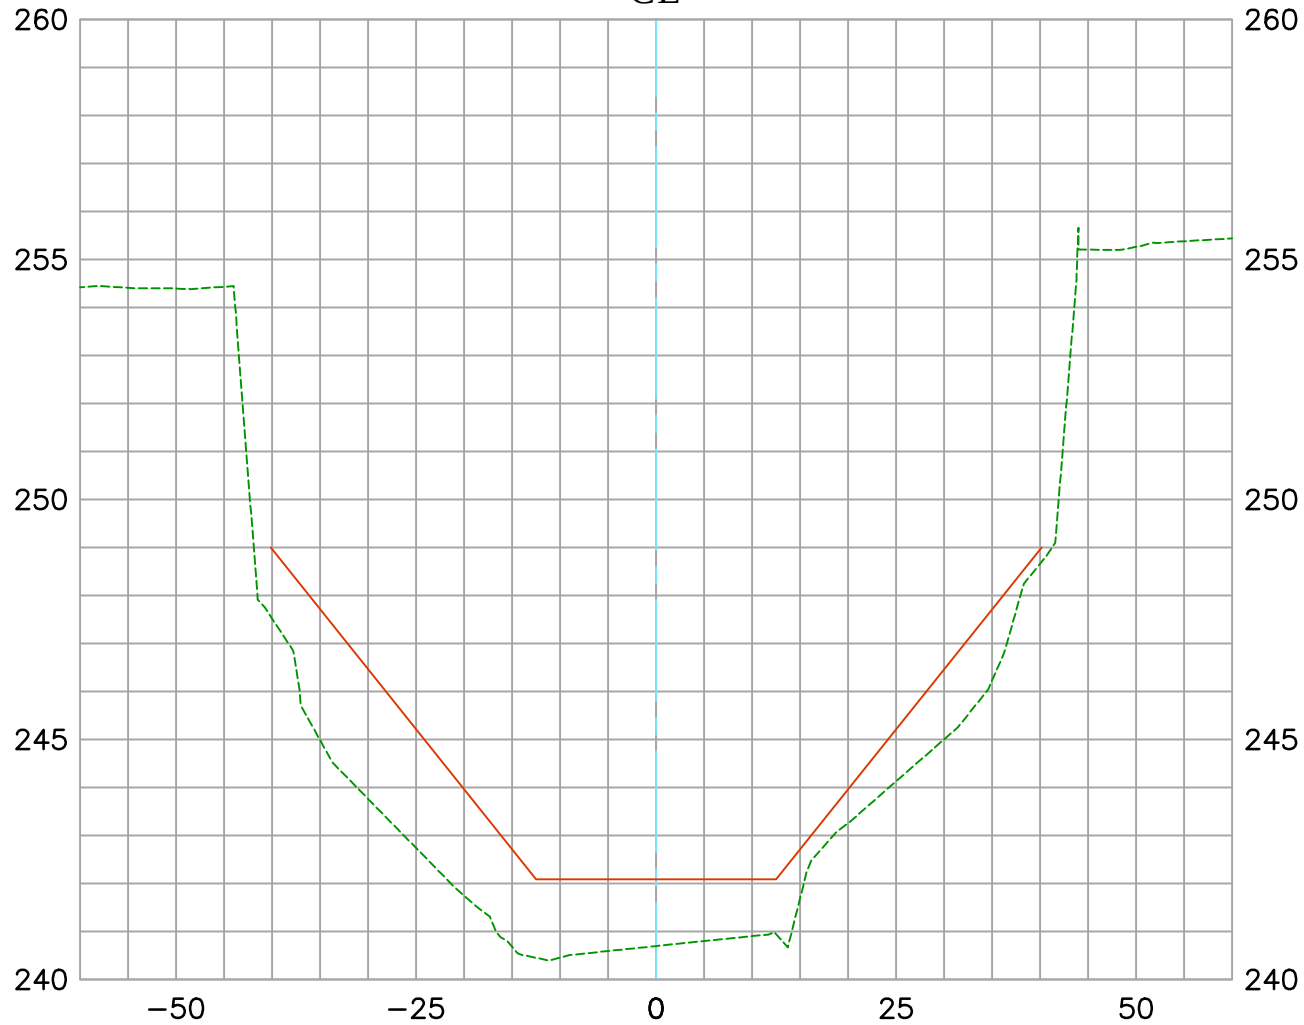
7+00.00

EXISTING CONDITION 03/18/2021  
RECORD DRAWINGS:  
F23-701-1, F23-701-2, & F23-701-3  
DATE PREPARED: 11/01/2021

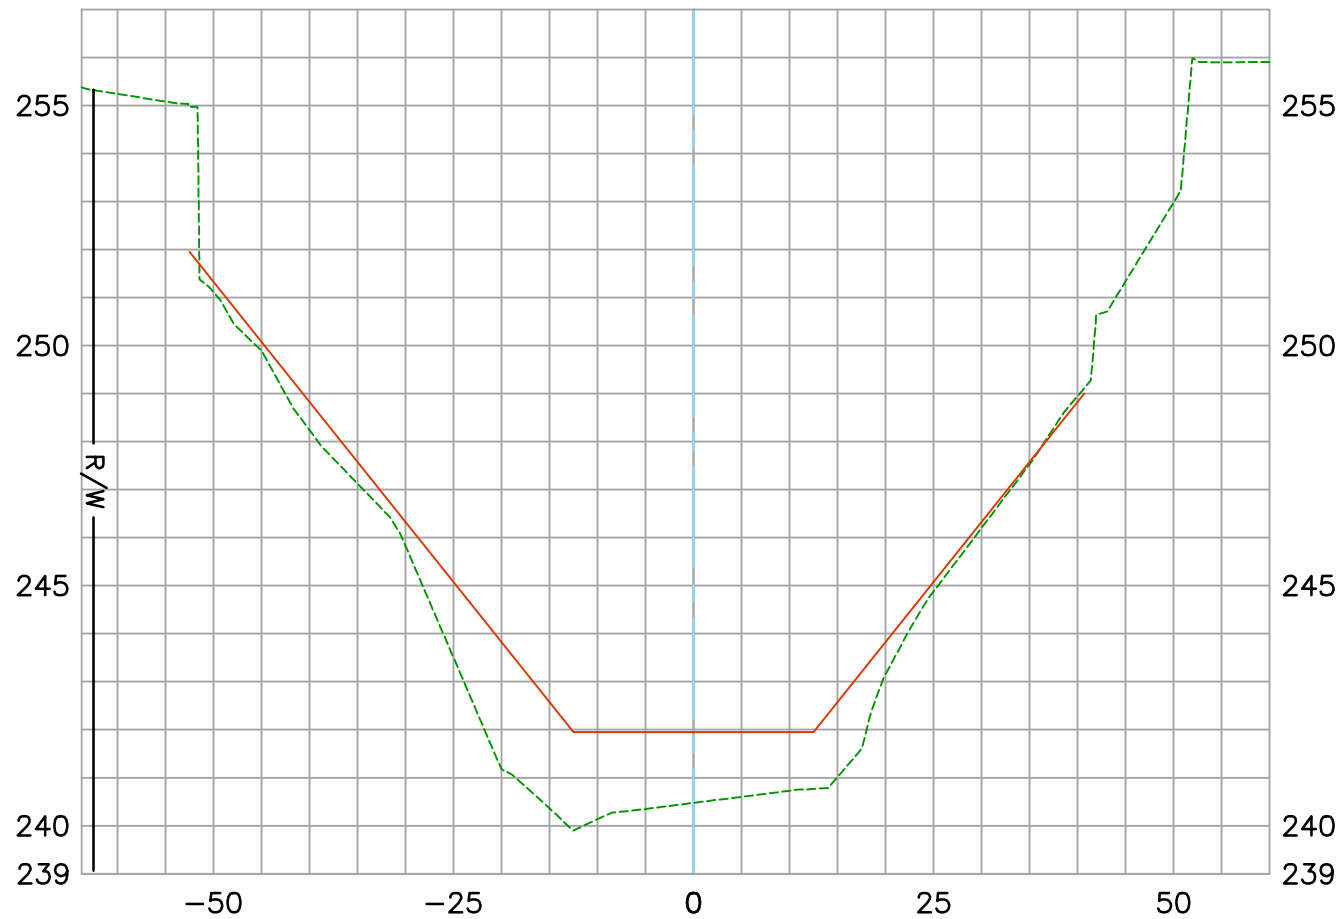
7+50.00

EXISTING CONDITION 03/18/2021  
RECORD DRAWINGS:  
F23-701-1, F23-701-2, & F23-701-3  
DATE PREPARED: 11/01/2021

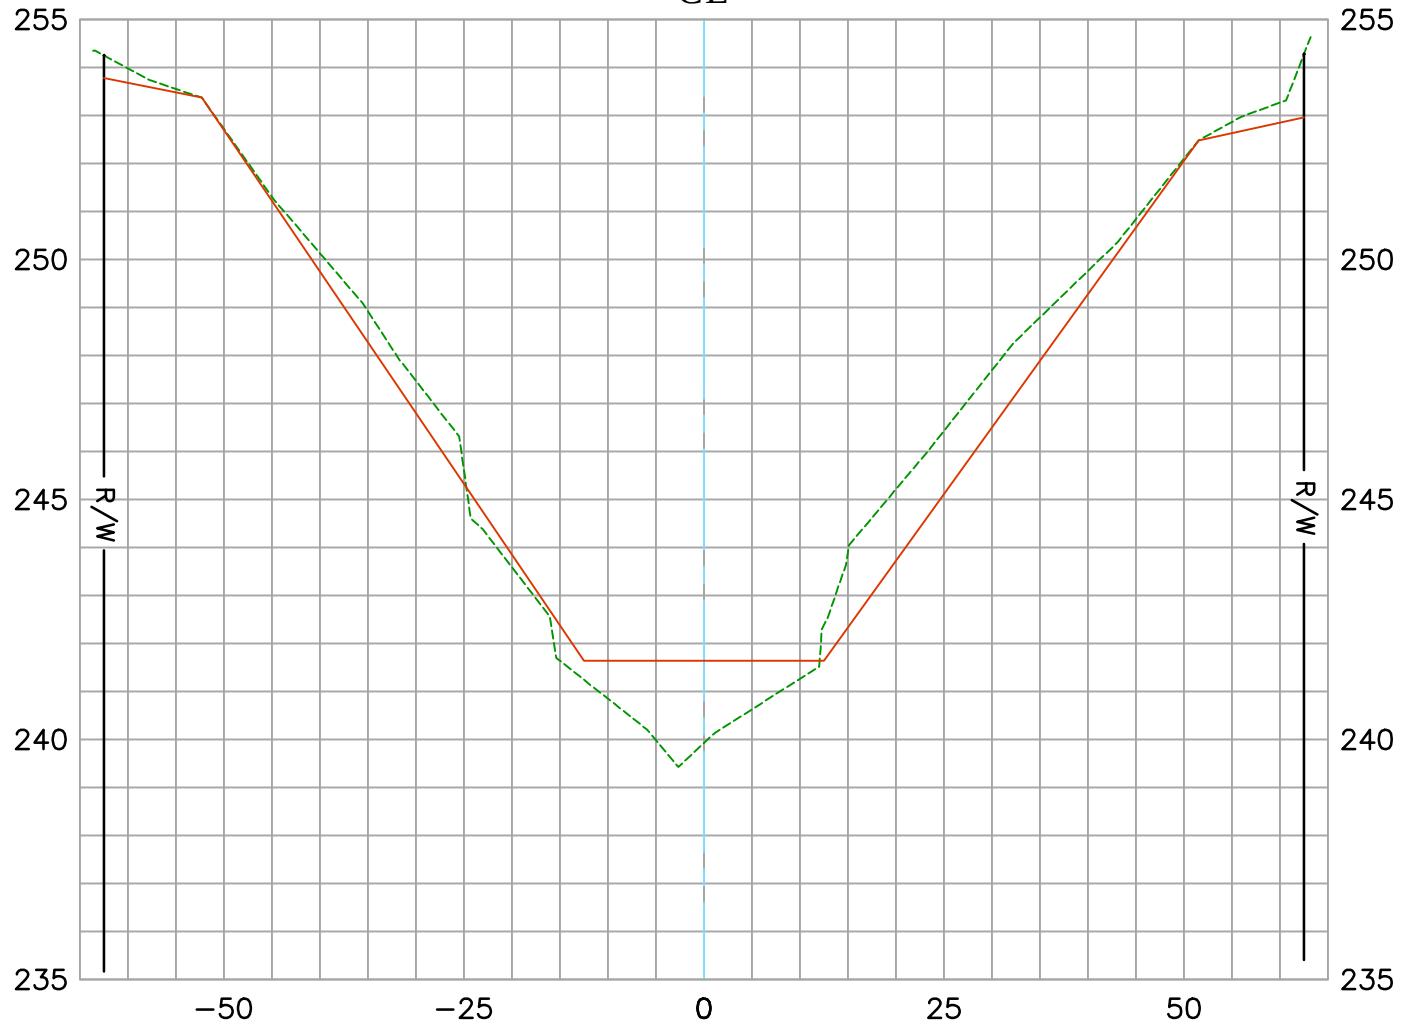
8+00.00

EXISTING CONDITION 03/18/2021  
RECORD DRAWINGS:  
F23-701-1, F23-701-2, & F23-701-3  
DATE PREPARED: 11/01/2021

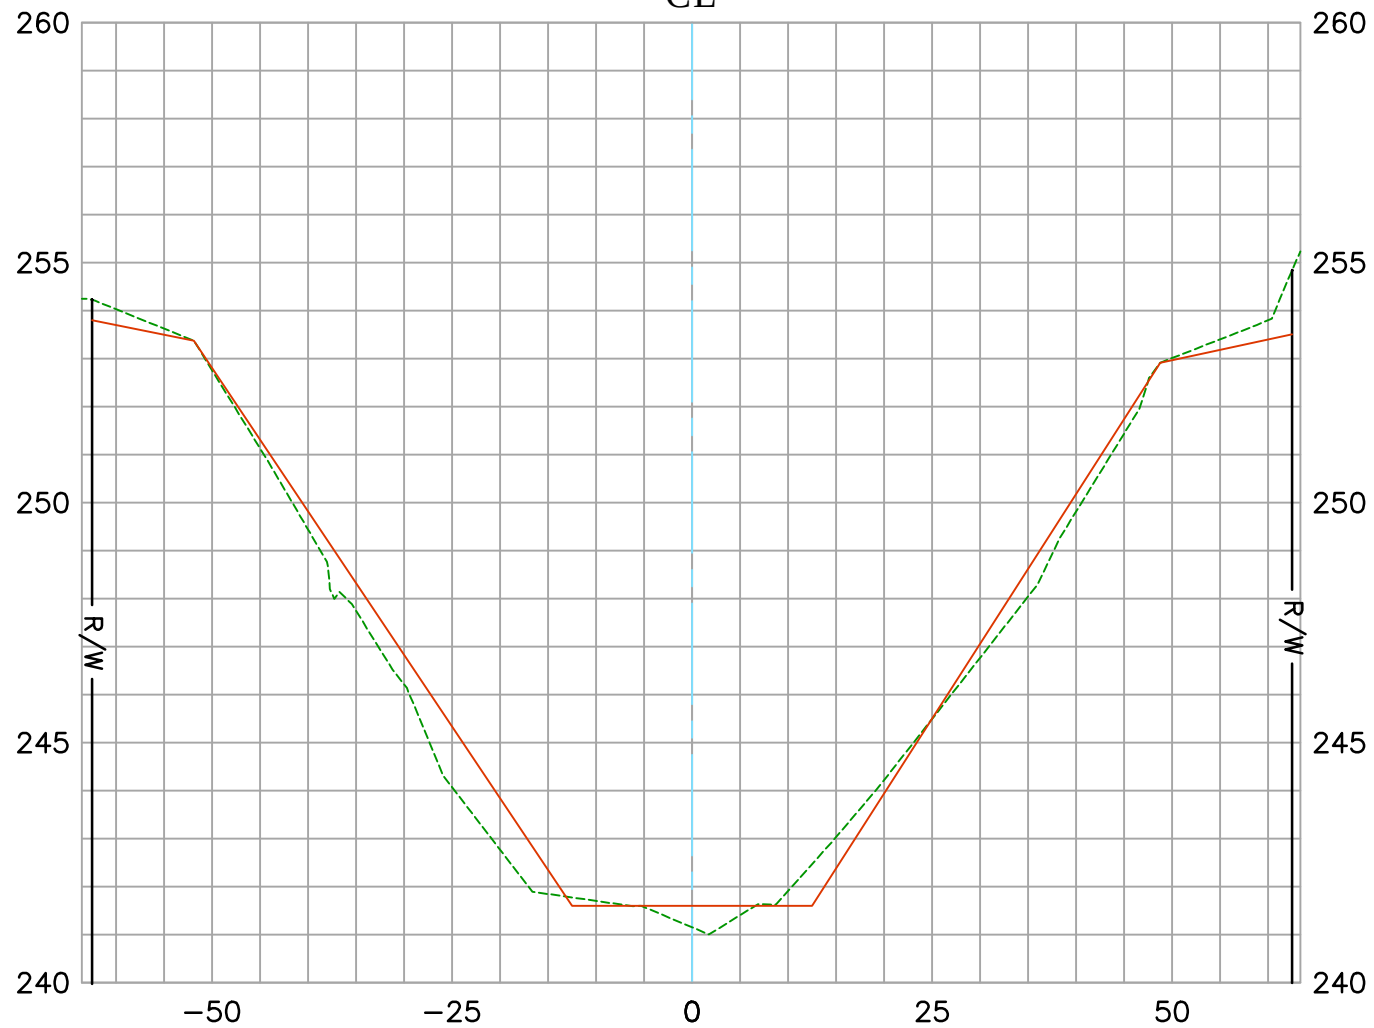
8+50.00

EXISTING CONDITION 03/18/2021  
RECORD DRAWINGS:  
F23-701-1, F23-701-2, & F23-701-3  
DATE PREPARED: 11/01/2021

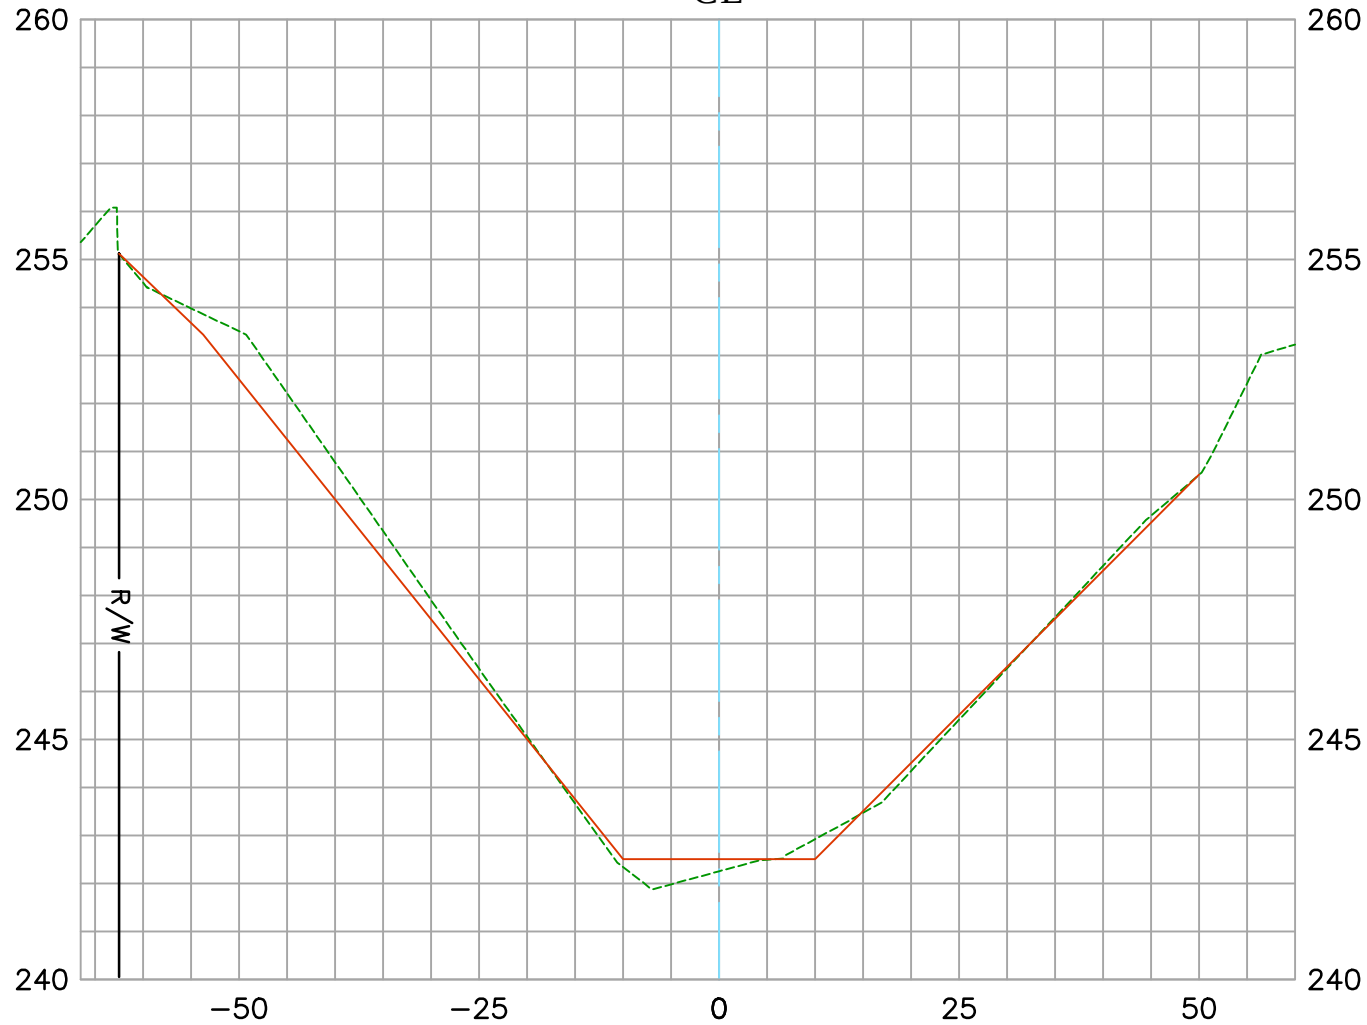
9+00.00

EXISTING CONDITION 03/18/2021

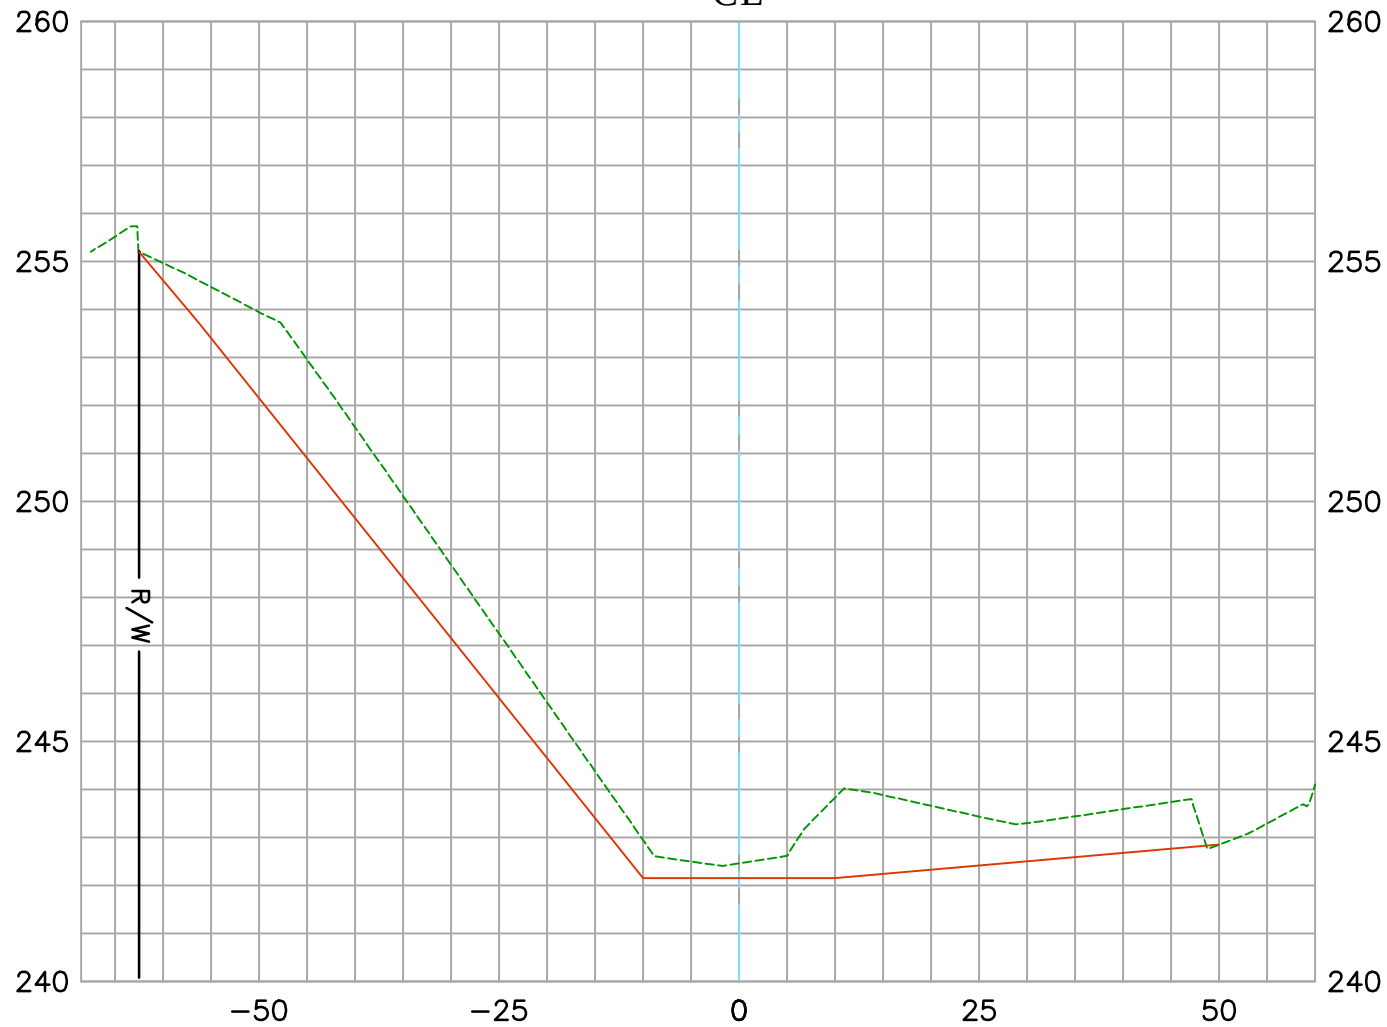
9+50.00

EXISTING CONDITION 03/18/2021  
RECORD DRAWINGS:  
F23-701-1, F23-701-2, & F23-701-3  
DATE PREPARED: 11/01/2021

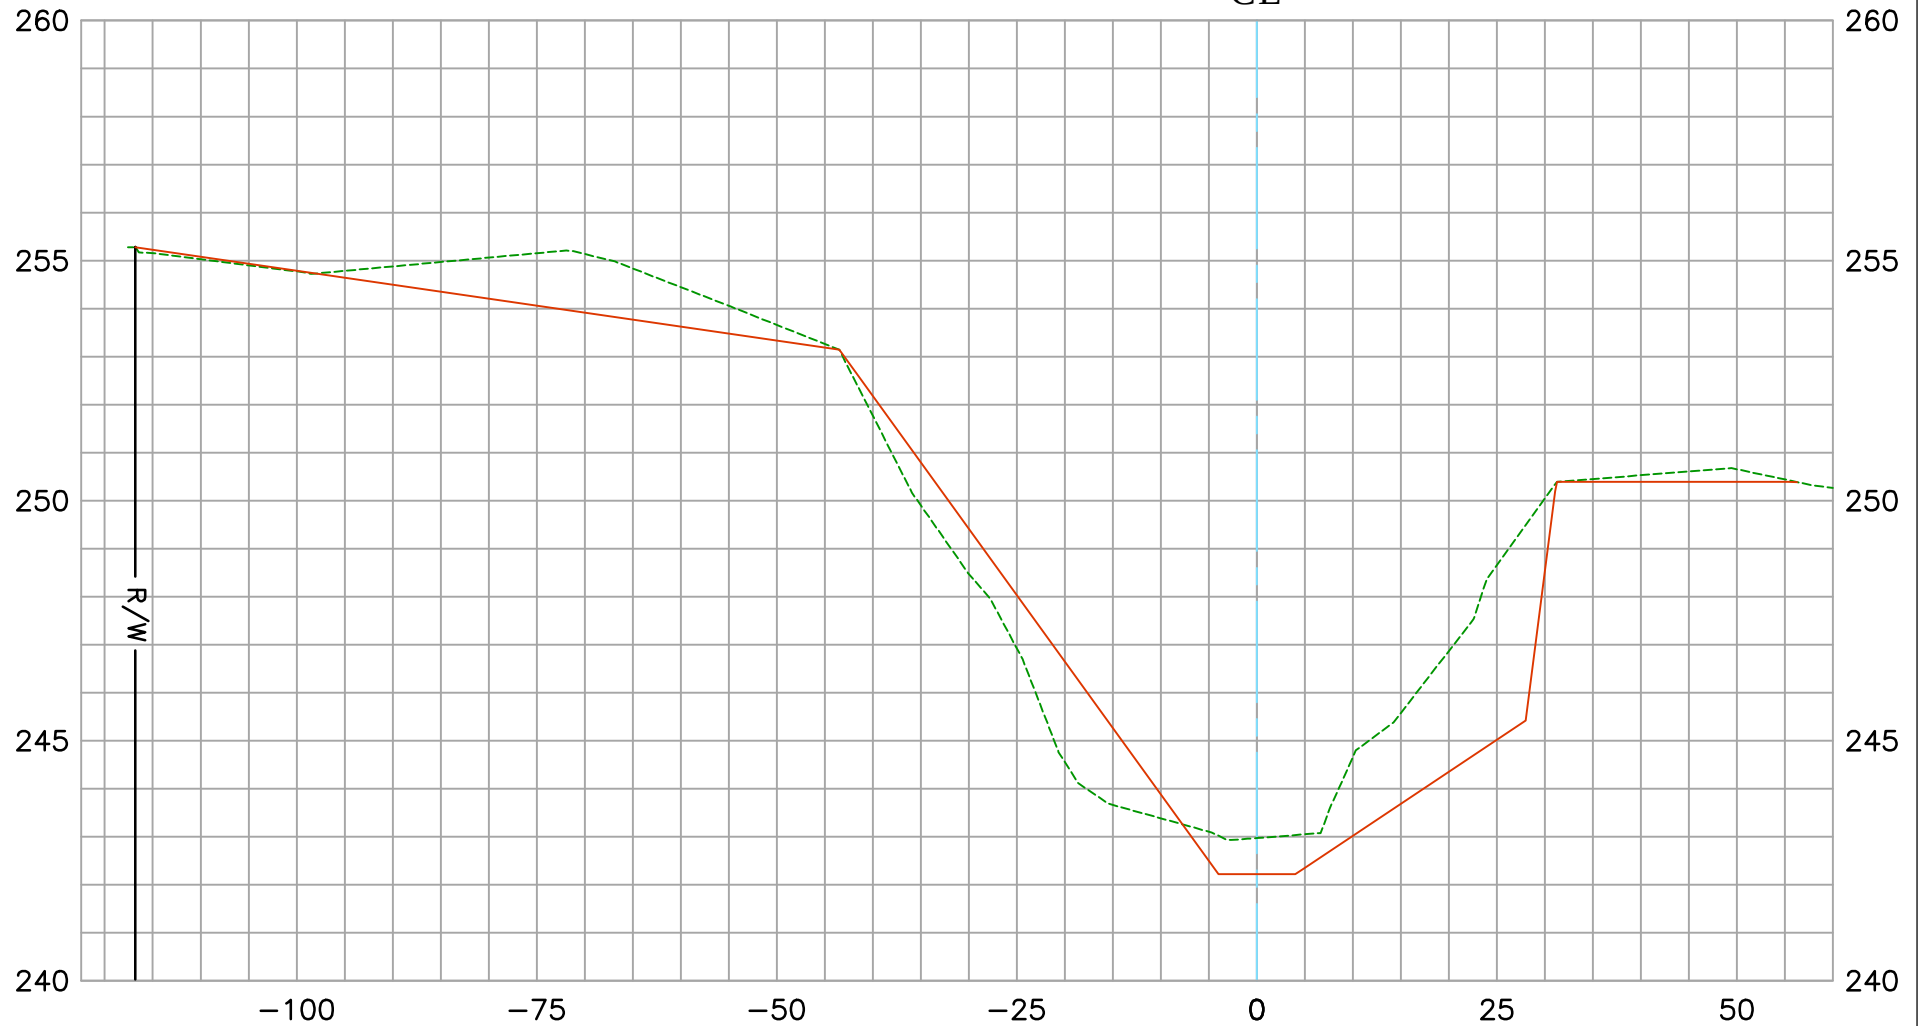
10+16.94

EXISTING CONDITION 03/18/2021  
RECORD DRAWINGS:  
F23-701-1, F23-701-2, & F23-701-3  
DATE PREPARED: 11/01/2021

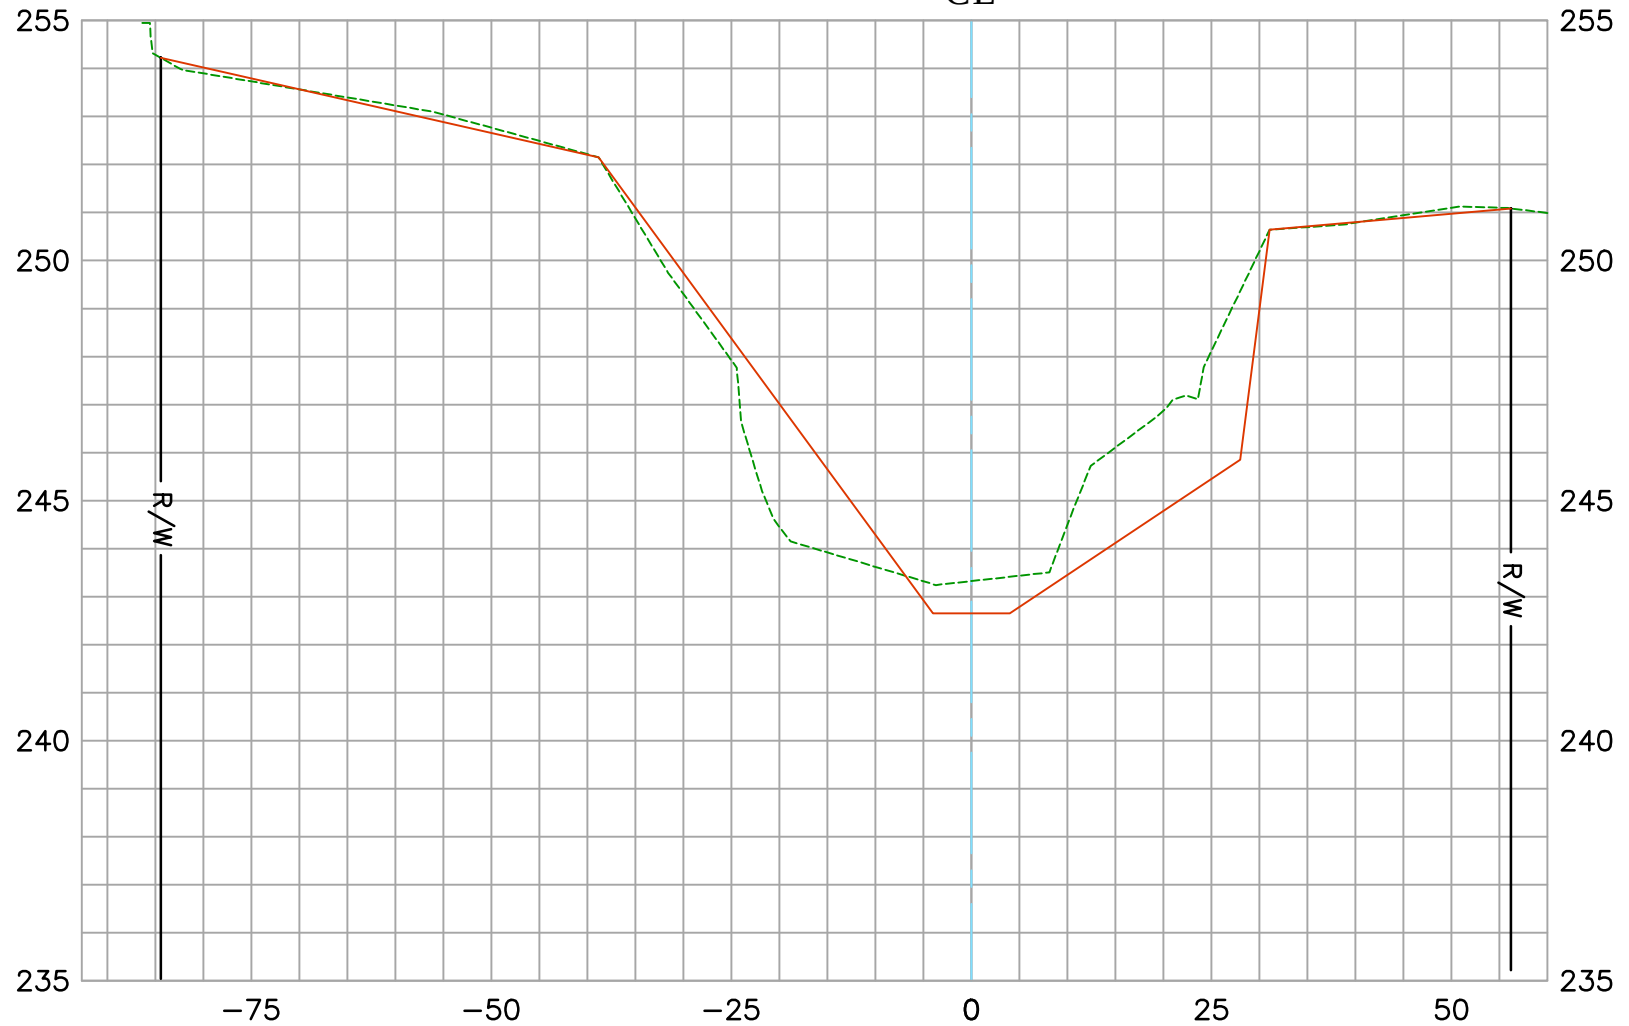
10+50.00

EXISTING CONDITION 03/18/2021  
RECORD DRAWINGS:  
F23-701-1, F23-701-2, & F23-701-3  
DATE PREPARED: 11/01/2021

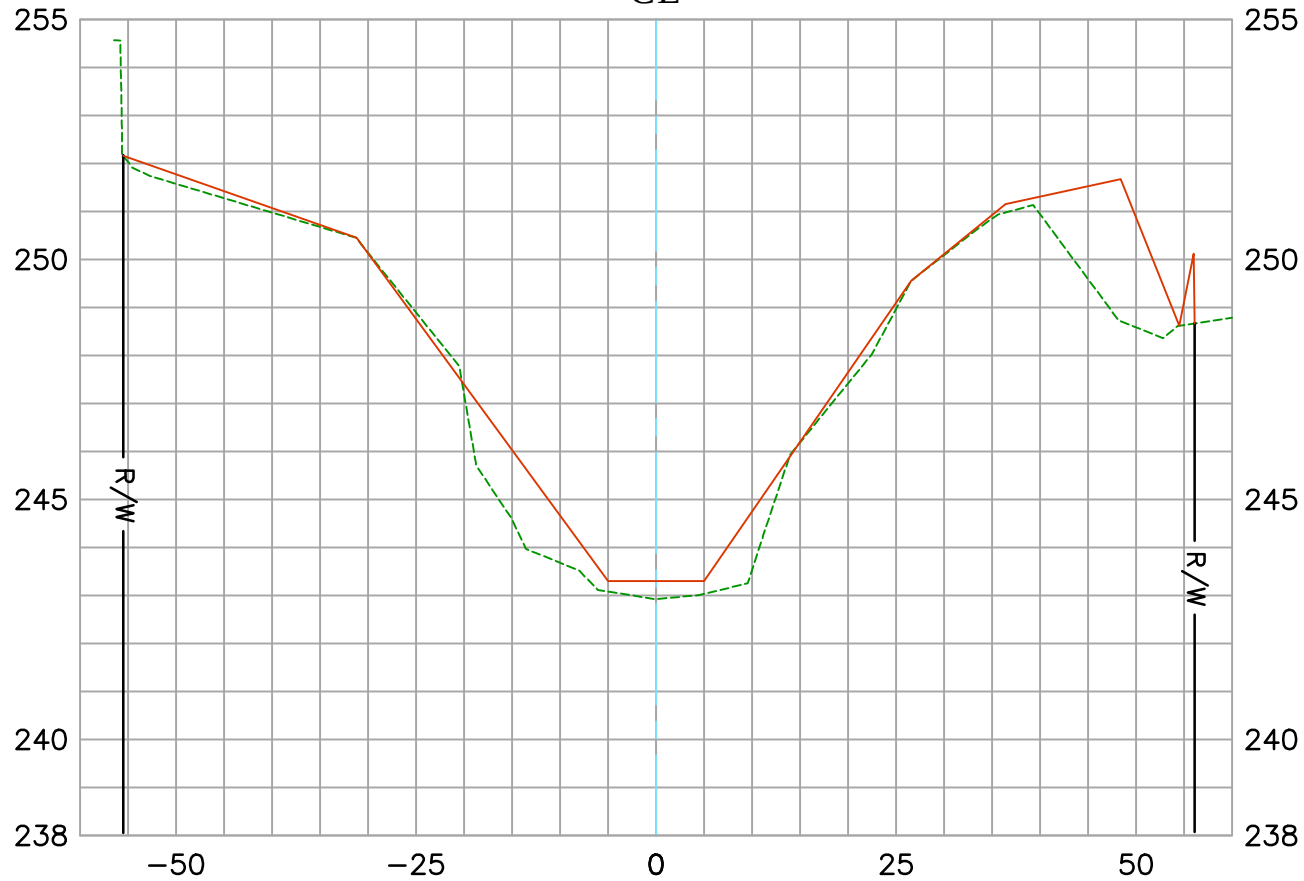
11+00.00

EXISTING CONDITION 03/18/2021  
RECORD DRAWINGS:  
F23-701-1, F23-701-2, & F23-701-3  
DATE PREPARED: 11/01/2021

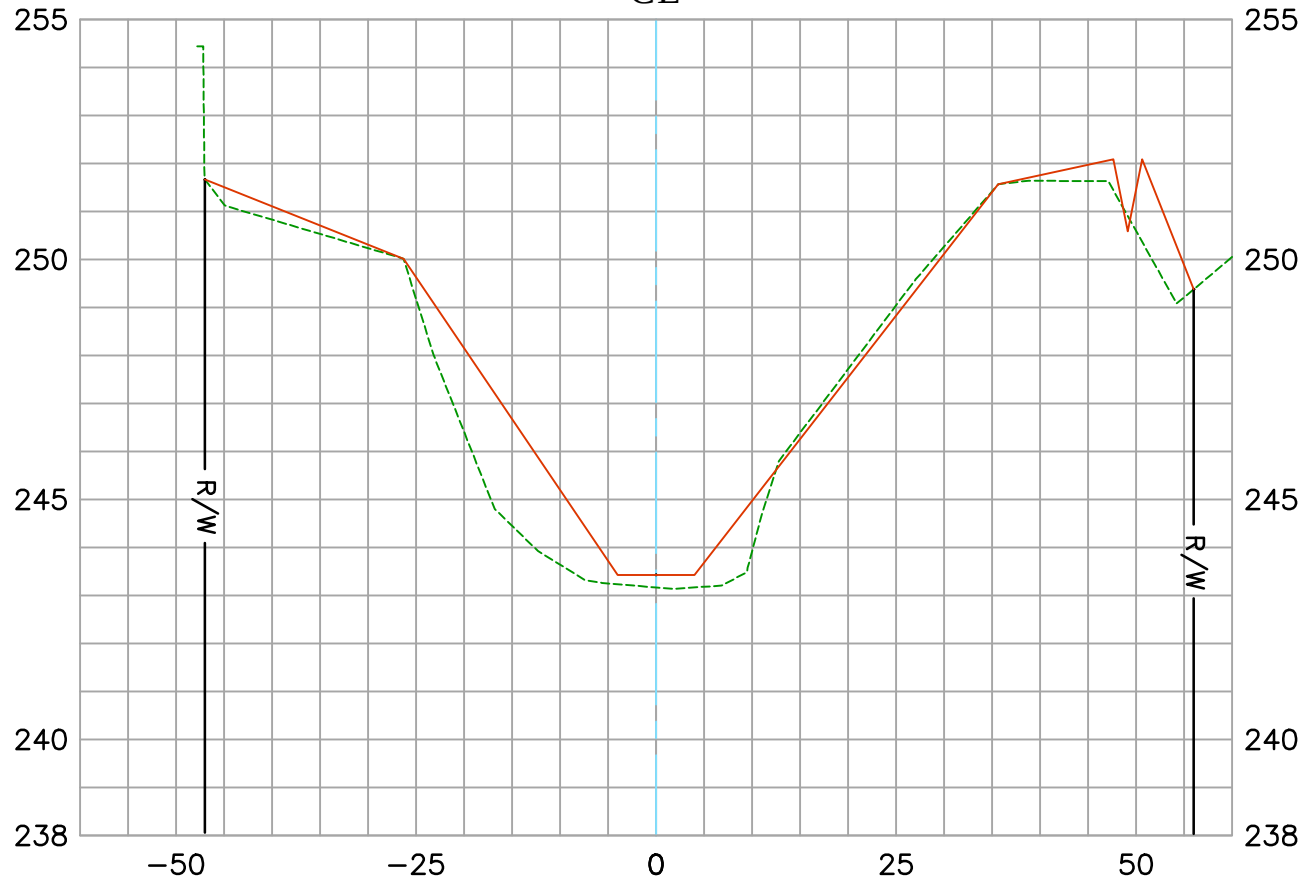
11+50.00

EXISTING CONDITION 03/18/2021  
RECORD DRAWINGS:  
F23-701-1, F23-701-2, & F23-701-3  
DATE PREPARED: 11/01/2021

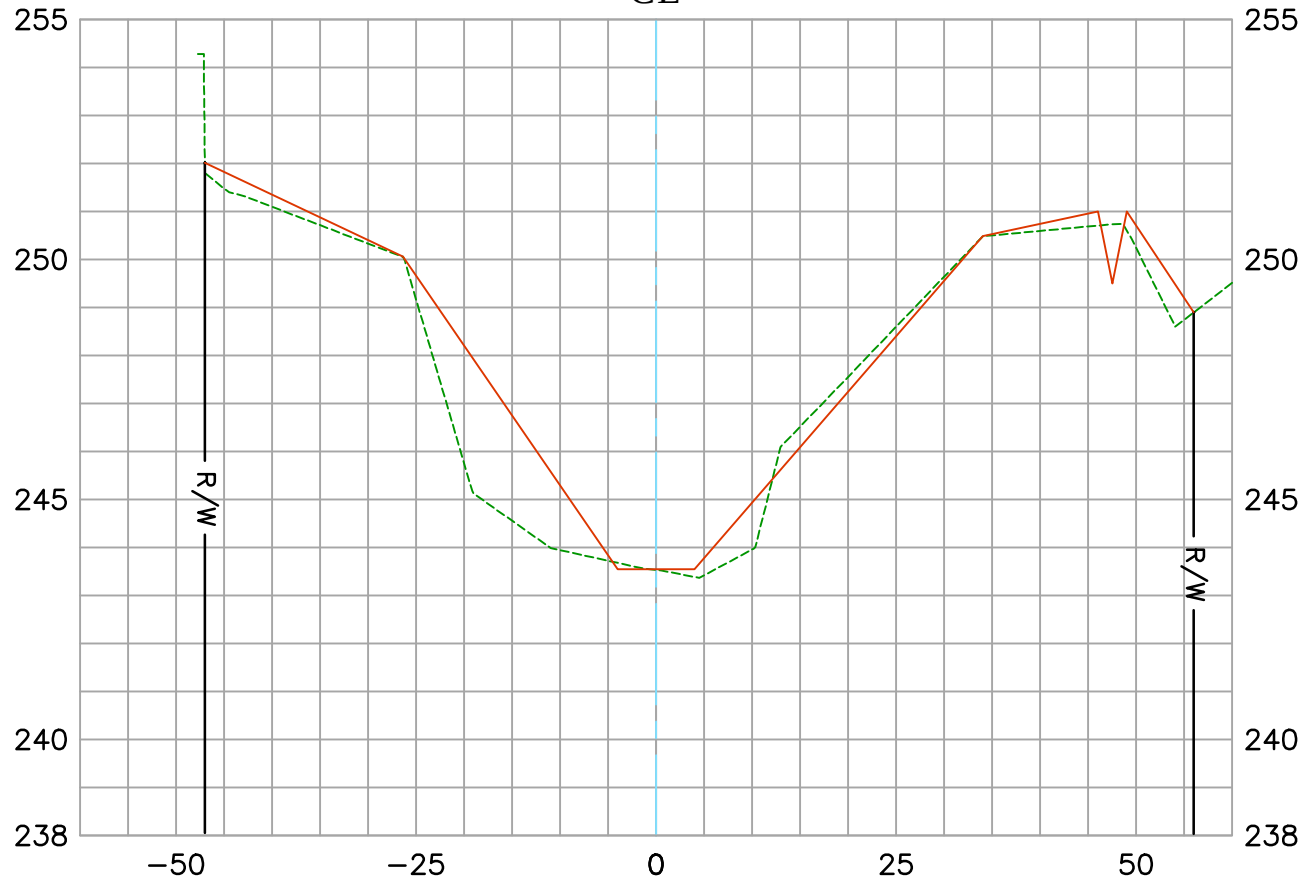
12+00.00

EXISTING CONDITION 03/18/2021  
RECORD DRAWINGS:  
F23-701-1, F23-701-2, & F23-701-3  
DATE PREPARED: 11/01/2021

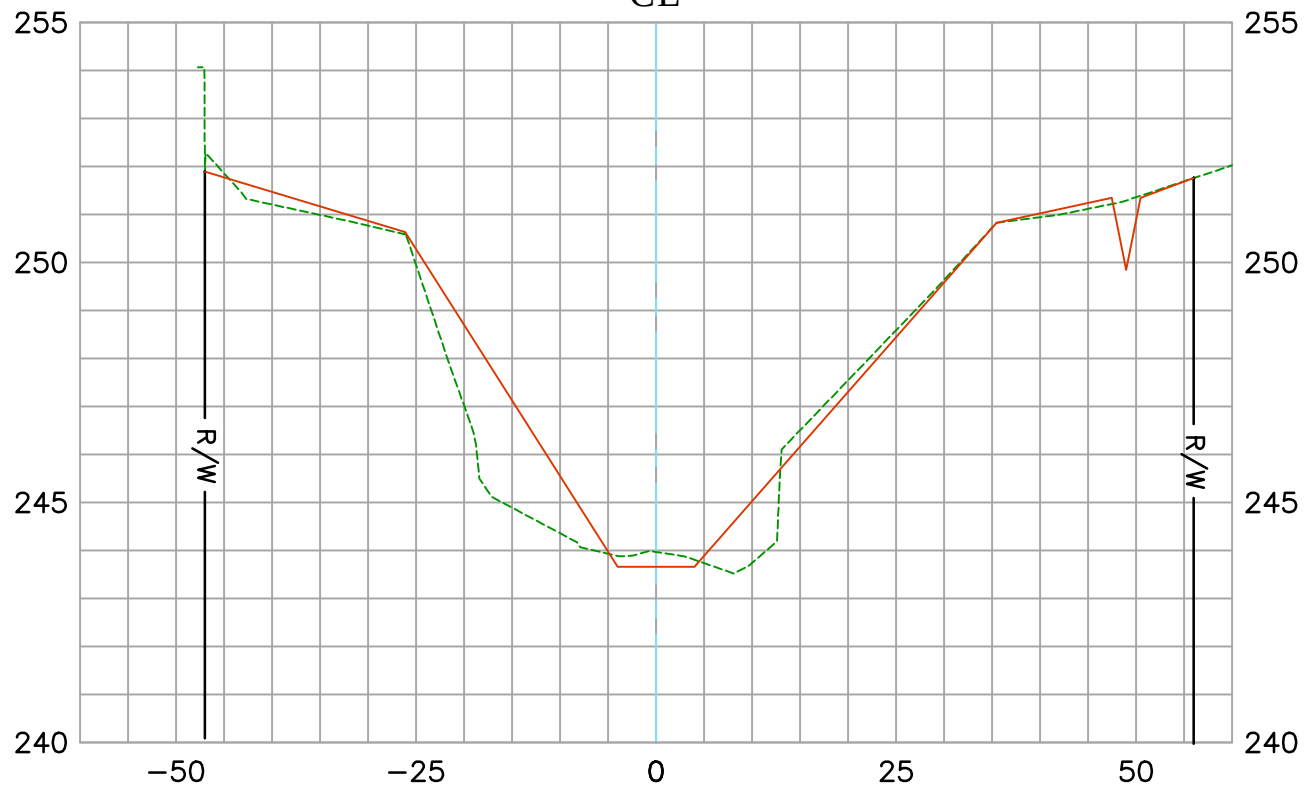
12+50.00

EXISTING CONDITION 03/18/2021  
RECORD DRAWINGS:  
F23-701-1, F23-701-2, & F23-701-3  
DATE PREPARED: 11/01/2021

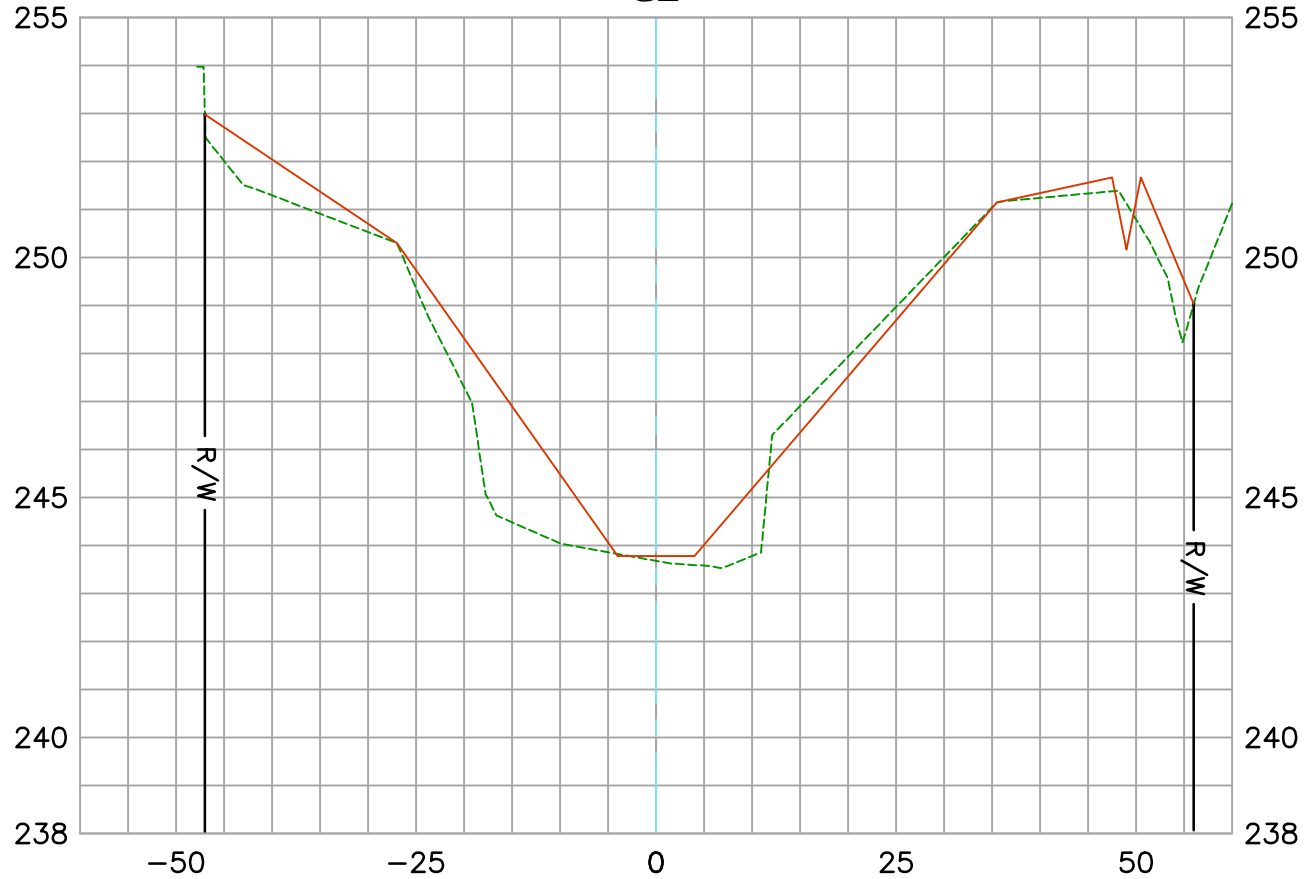
13+00.00

EXISTING CONDITION 03/18/2021  
RECORD DRAWINGS:  
F23-701-1, F23-701-2, & F23-701-3  
DATE PREPARED: 11/01/2021

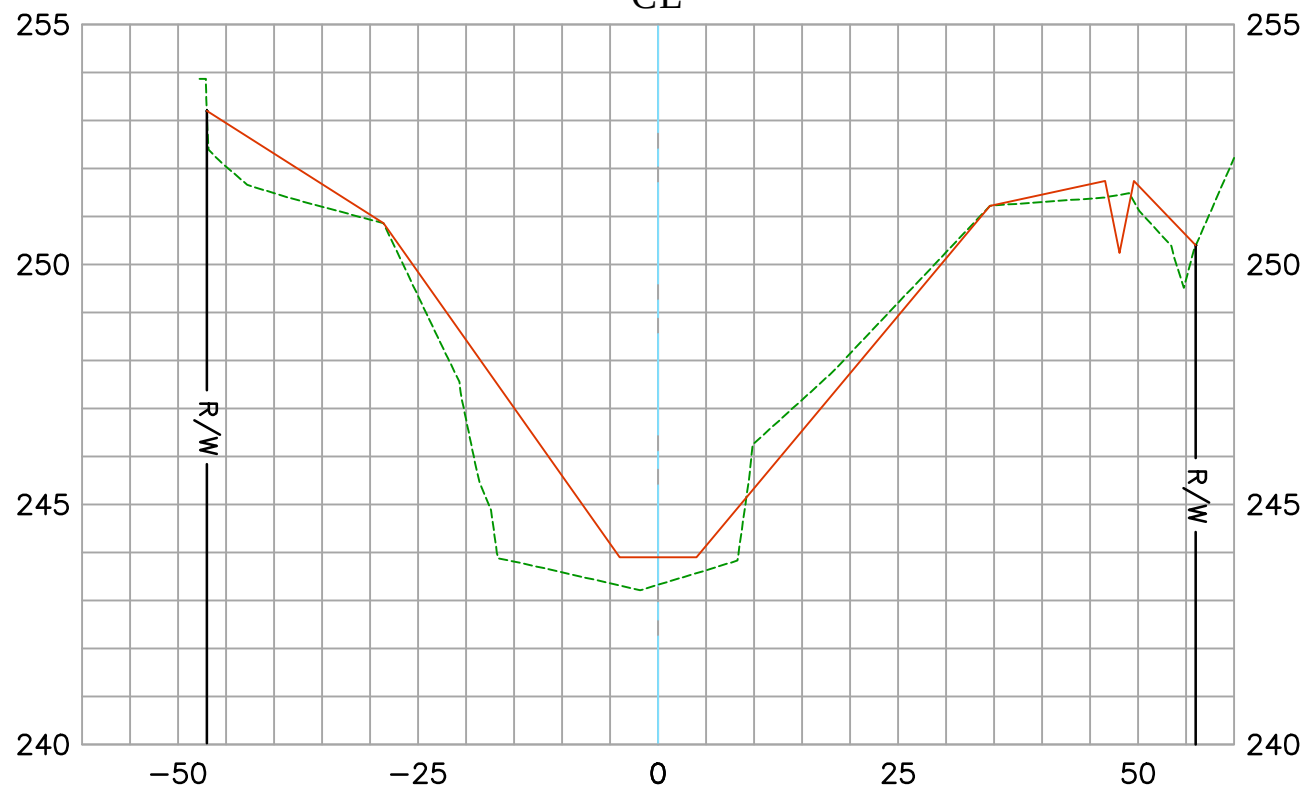
13+50.00

EXISTING CONDITION 03/18/2021  
RECORD DRAWINGS:  
F23-701-1, F23-701-2, & F23-701-3  
DATE PREPARED: 11/01/2021

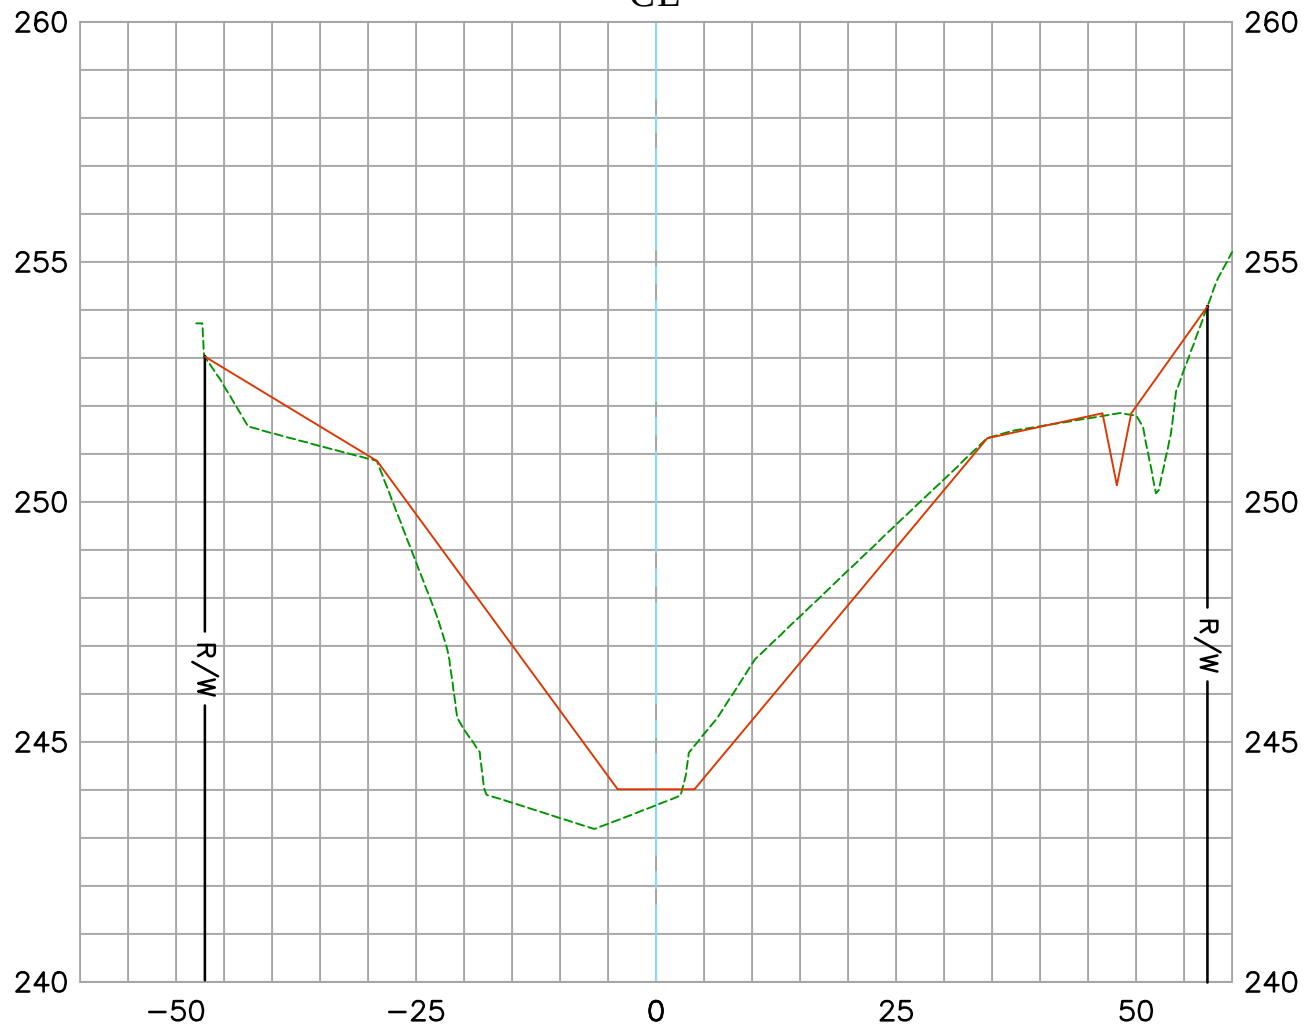
14+00.00

EXISTING CONDITION 03/18/2021  
RECORD DRAWINGS:  
F23-701-1, F23-701-2, & F23-701-3  
DATE PREPARED: 11/01/2021
