# OC PUBLIC WORKS DEPARTMENT

## CANADA CHANNEL

REHABILITATION

## PROJECT CROSS SECTIONS

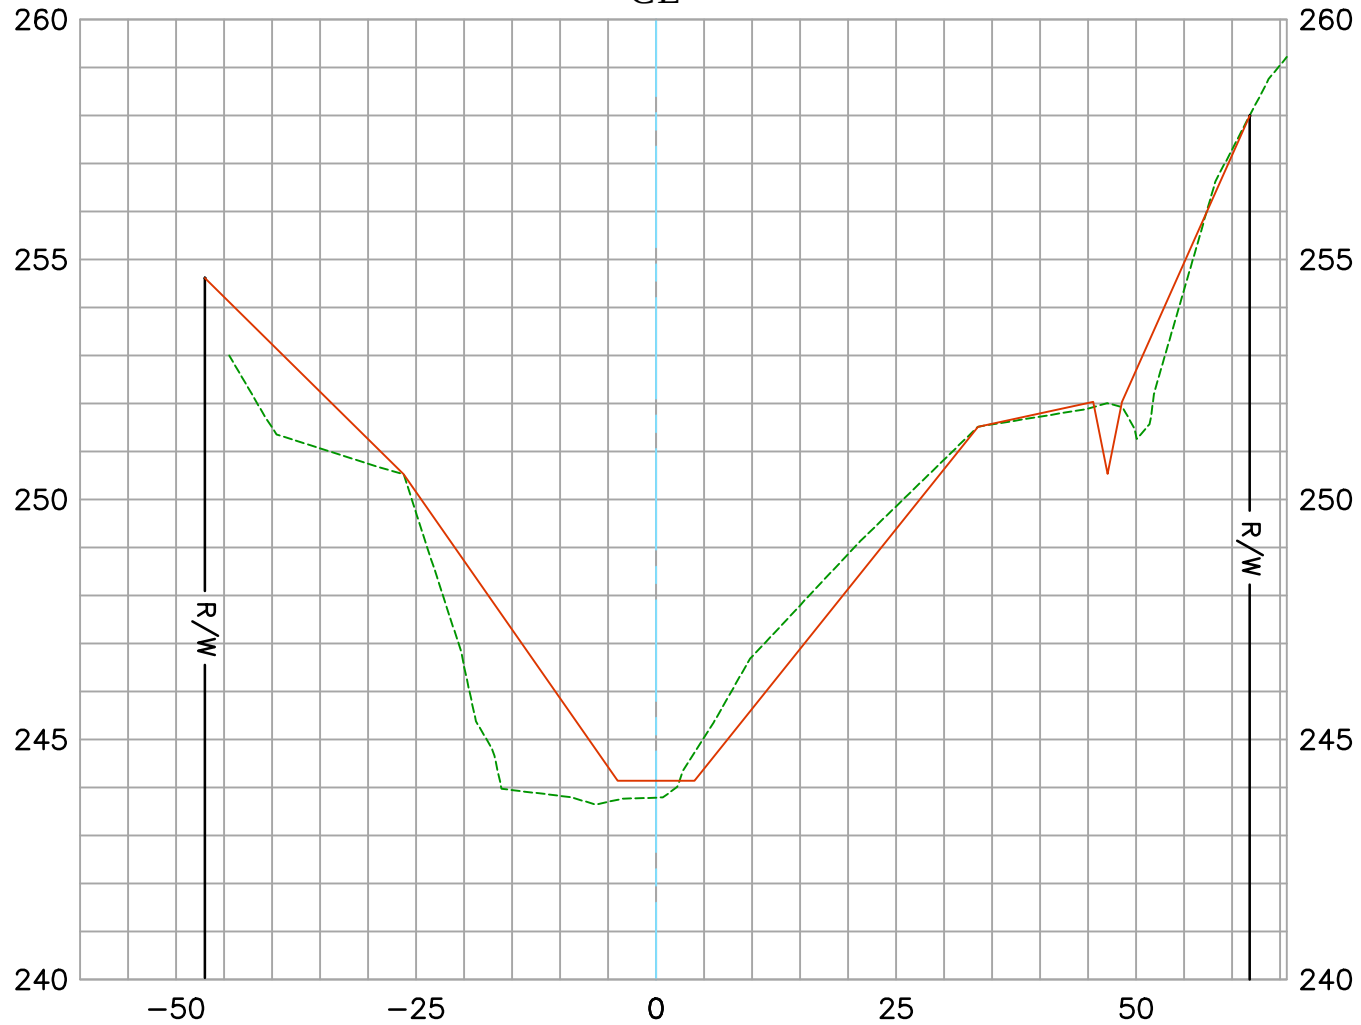
14+50.00

EXISTING CONDITION 03/18/2021  
RECORD DRAWINGS:  
F23-701-1, F23-701-2, & F23-701-3  
DATE PREPARED: 11/01/2021

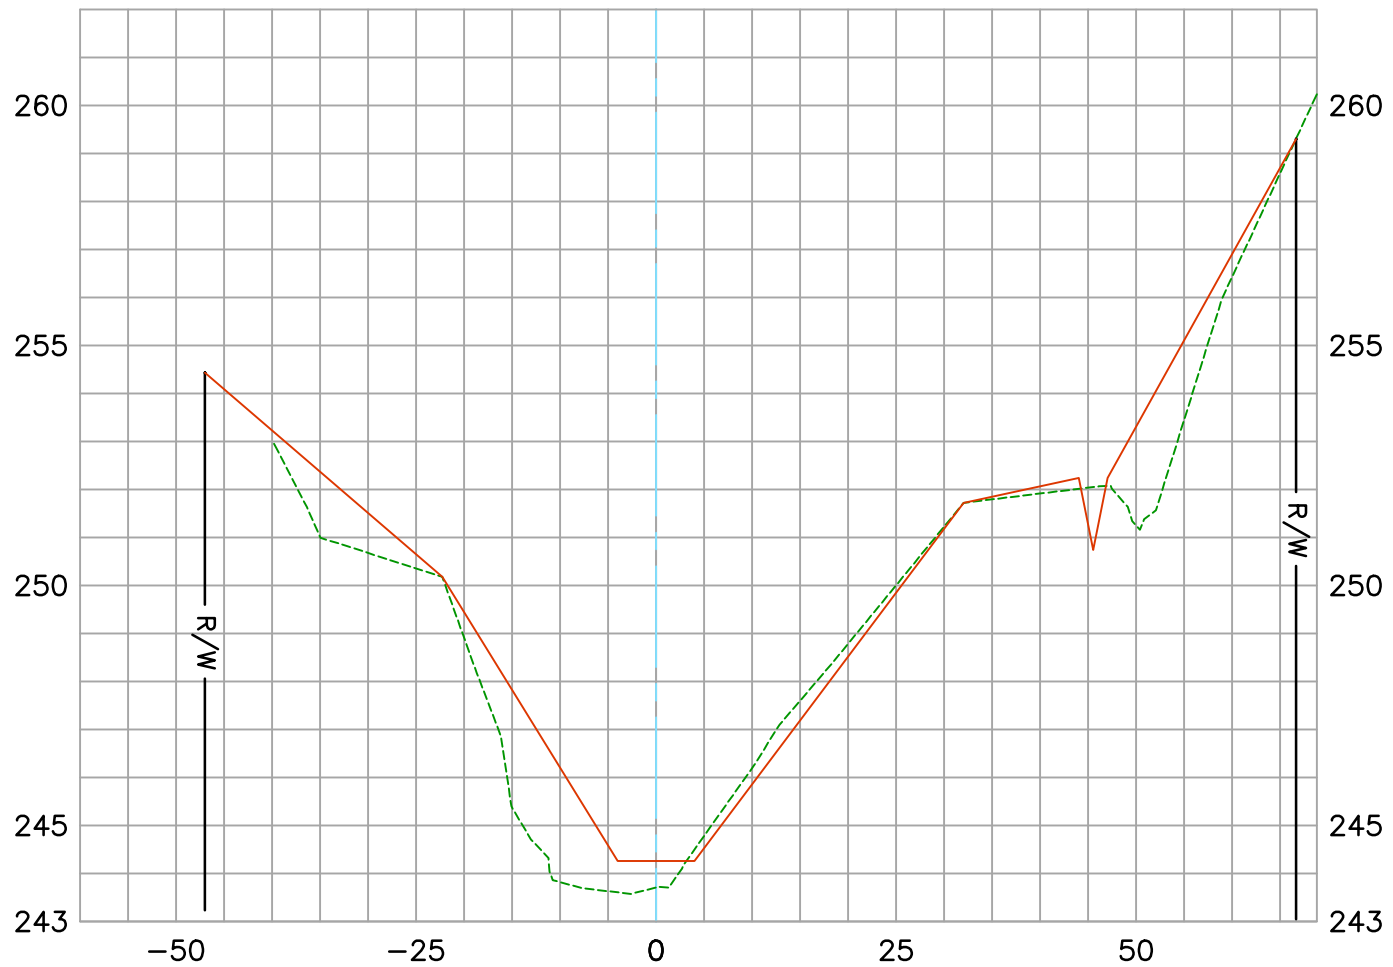
15+00.00

EXISTING CONDITION 03/18/2021  
RECORD DRAWINGS:  
F23-701-1, F23-701-2, & F23-701-3  
DATE PREPARED: 11/01/2021

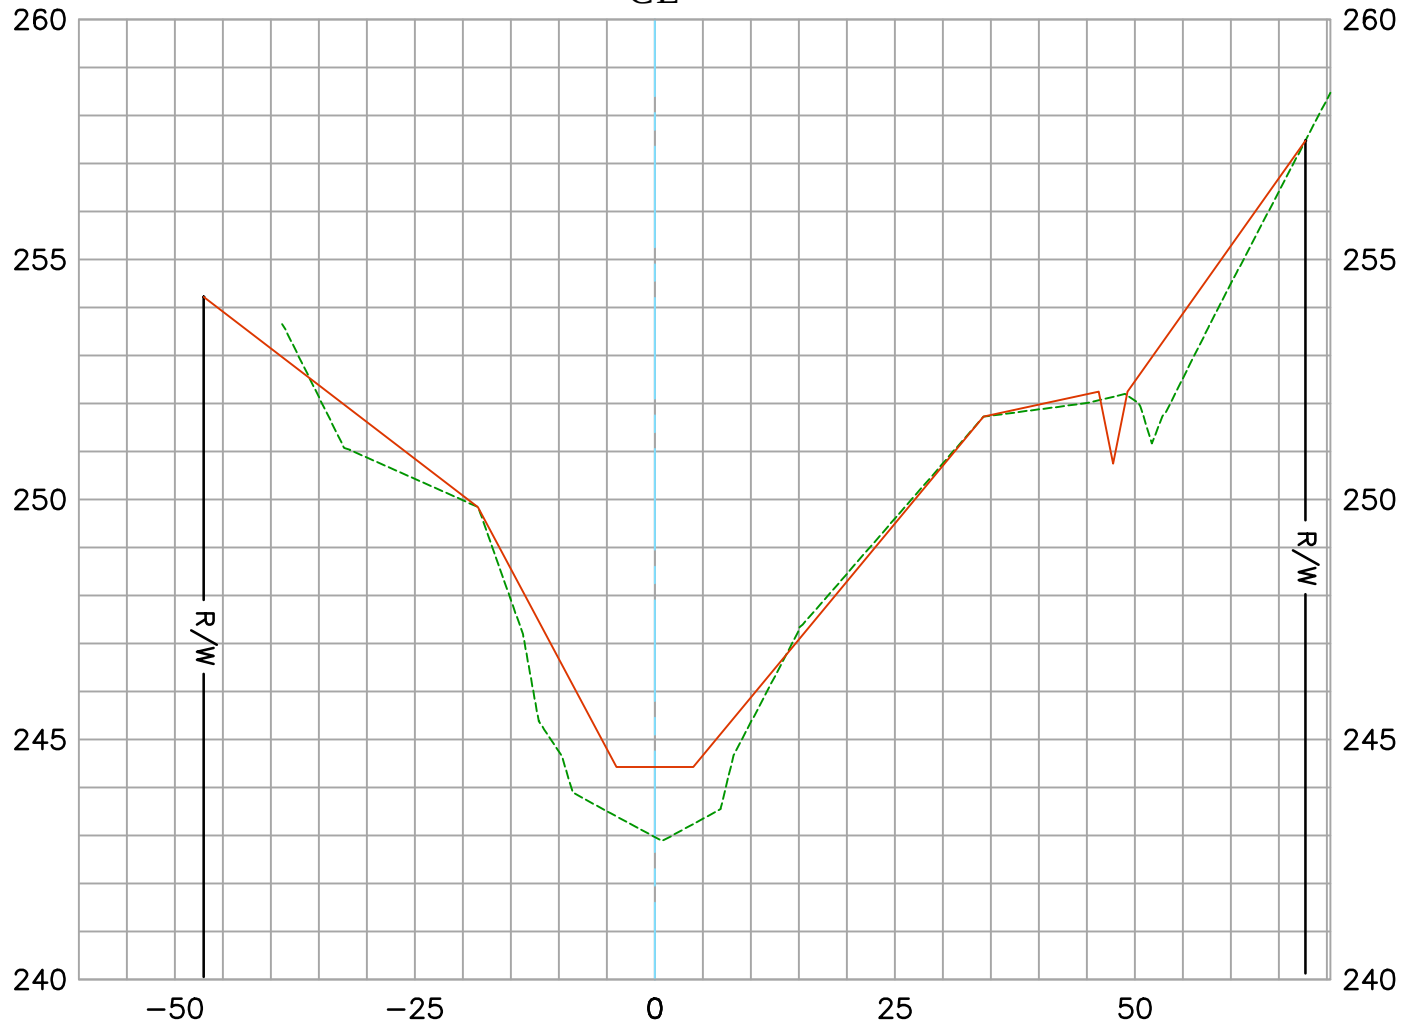
15+50.00

EXISTING CONDITION 03/18/2021  
RECORD DRAWINGS:  
F23-701-1, F23-701-2, & F23-701-3  
DATE PREPARED: 11/01/2021

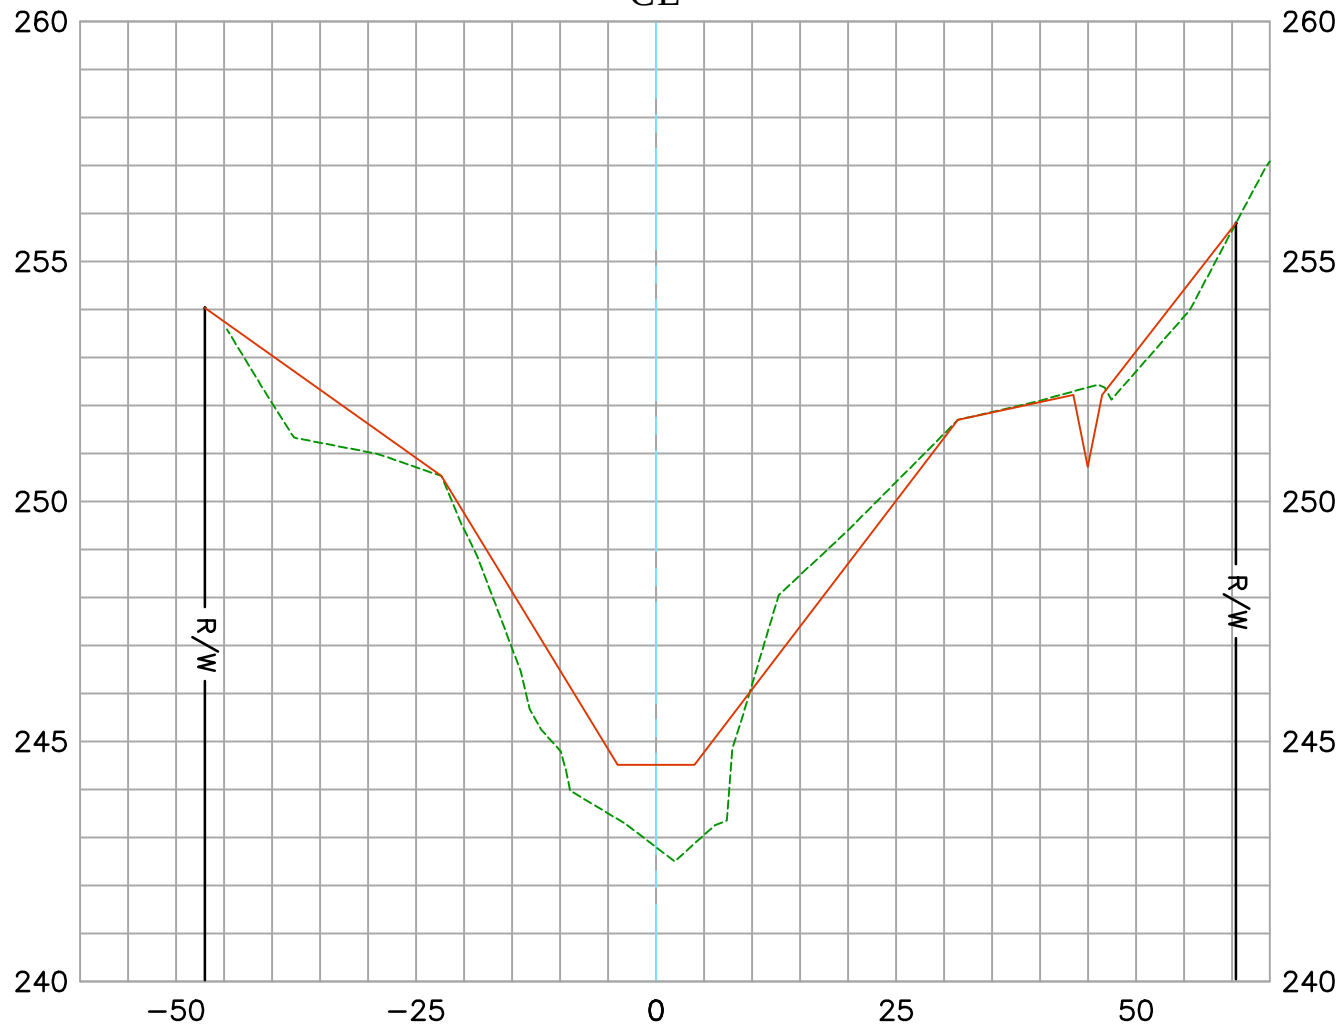
16+00.00

EXISTING CONDITION 03/18/2021  
RECORD DRAWINGS:  
F23-701-1, F23-701-2, & F23-701-3  
DATE PREPARED: 11/01/2021

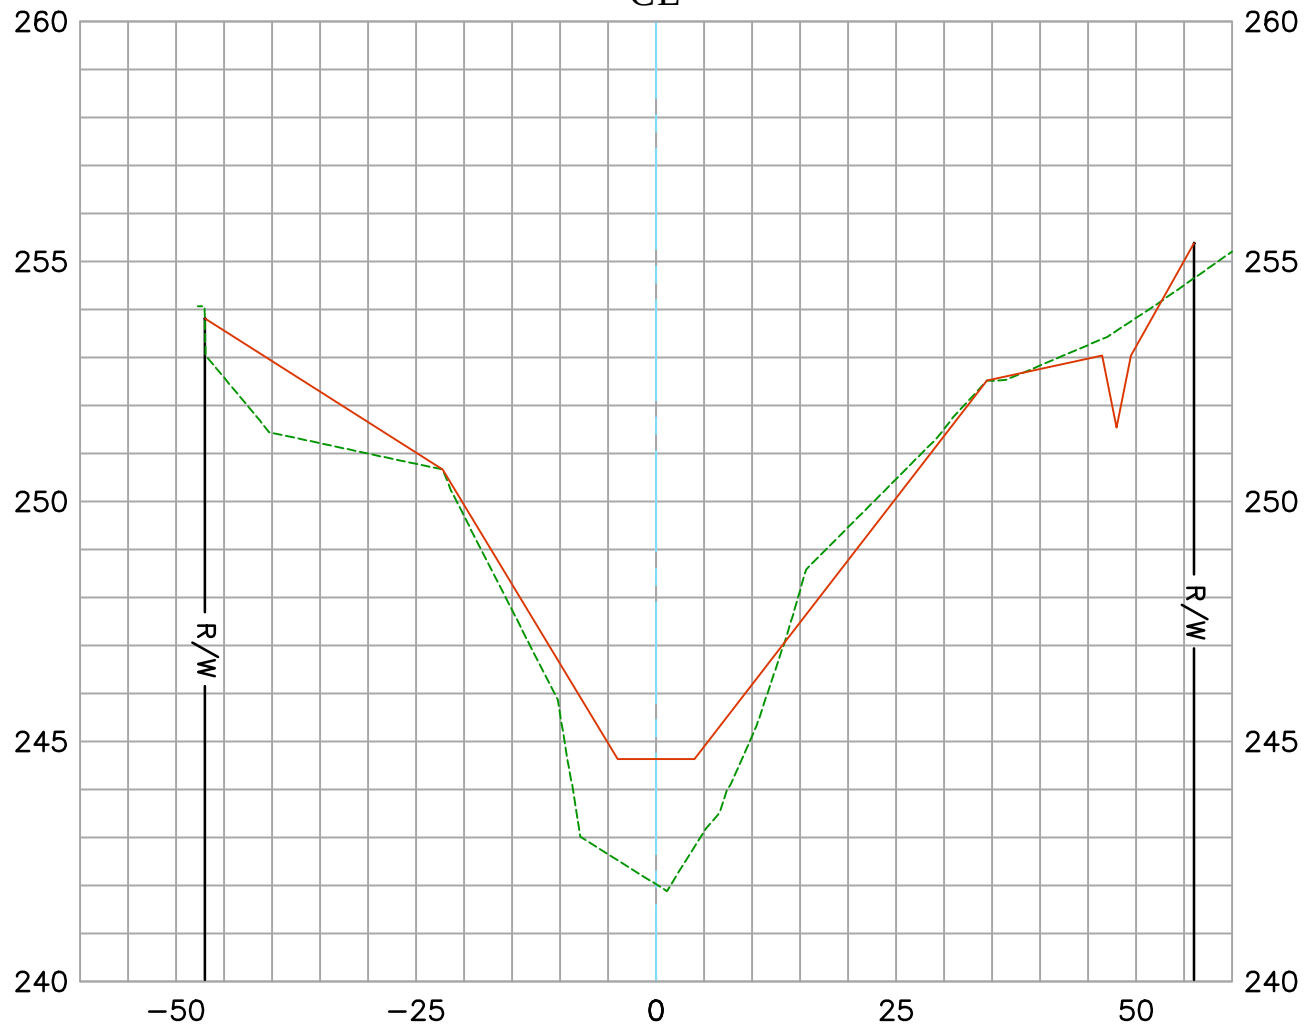
16+50.00

EXISTING CONDITION 03/18/2021  
RECORD DRAWINGS:  
F23-701-1, F23-701-2, & F23-701-3  
DATE PREPARED: 11/01/2021

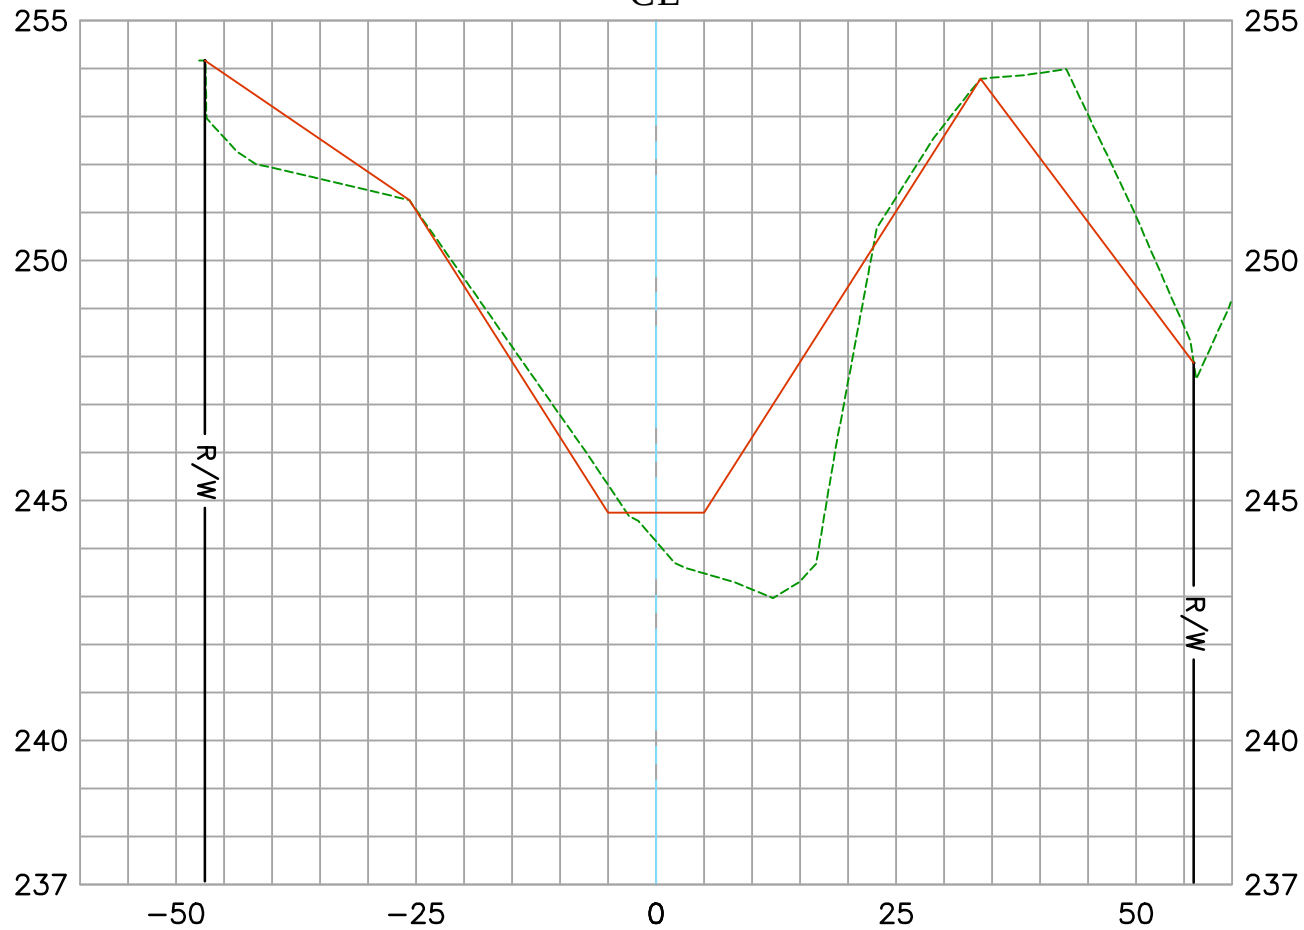
17+00.00

EXISTING CONDITION 03/18/2021  
RECORD DRAWINGS:  
F23-701-1, F23-701-2, & F23-701-3  
DATE PREPARED: 11/01/2021

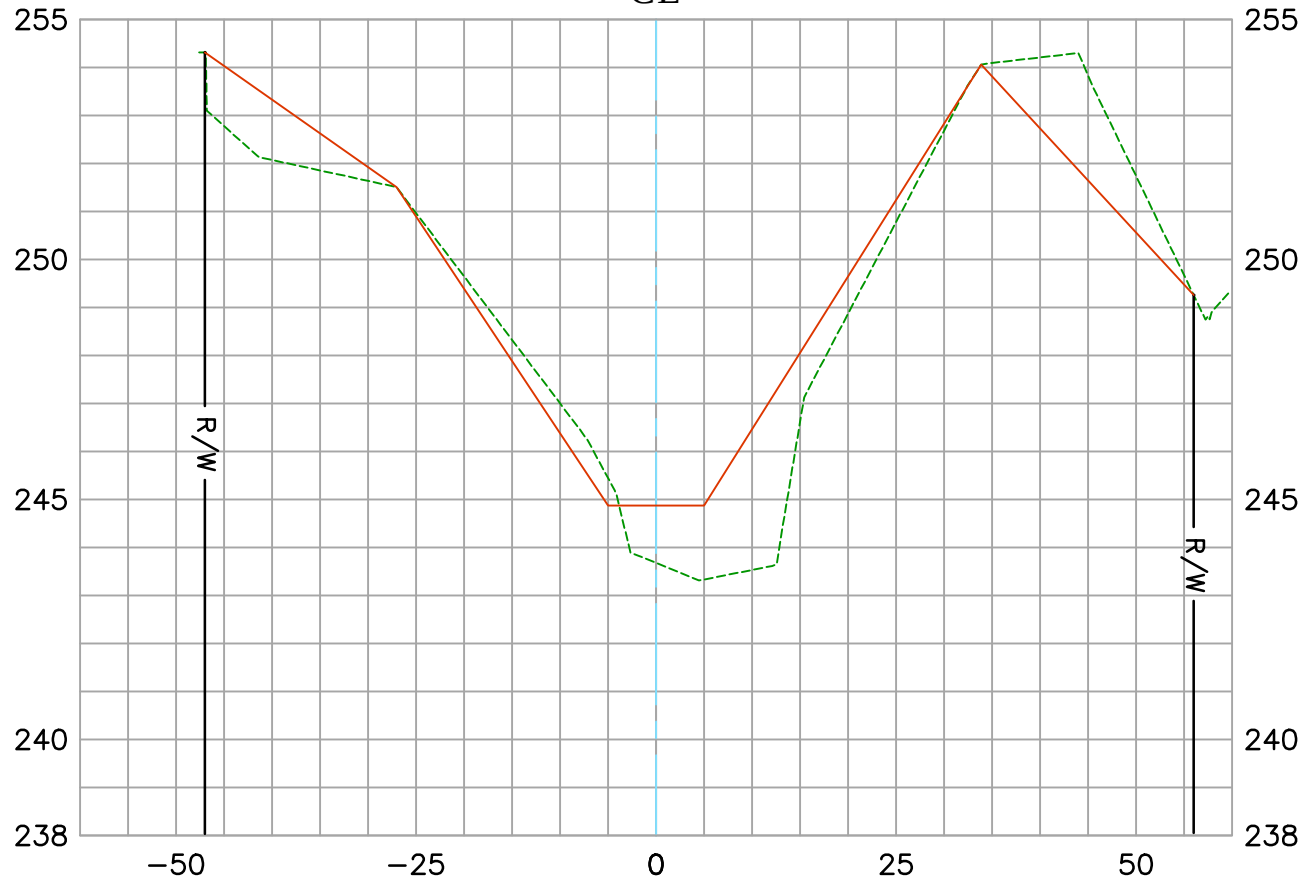
17+50.00

EXISTING CONDITION 03/18/2021  
RECORD DRAWINGS:  
F23-701-1, F23-701-2, & F23-701-3  
DATE PREPARED: 11/01/2021

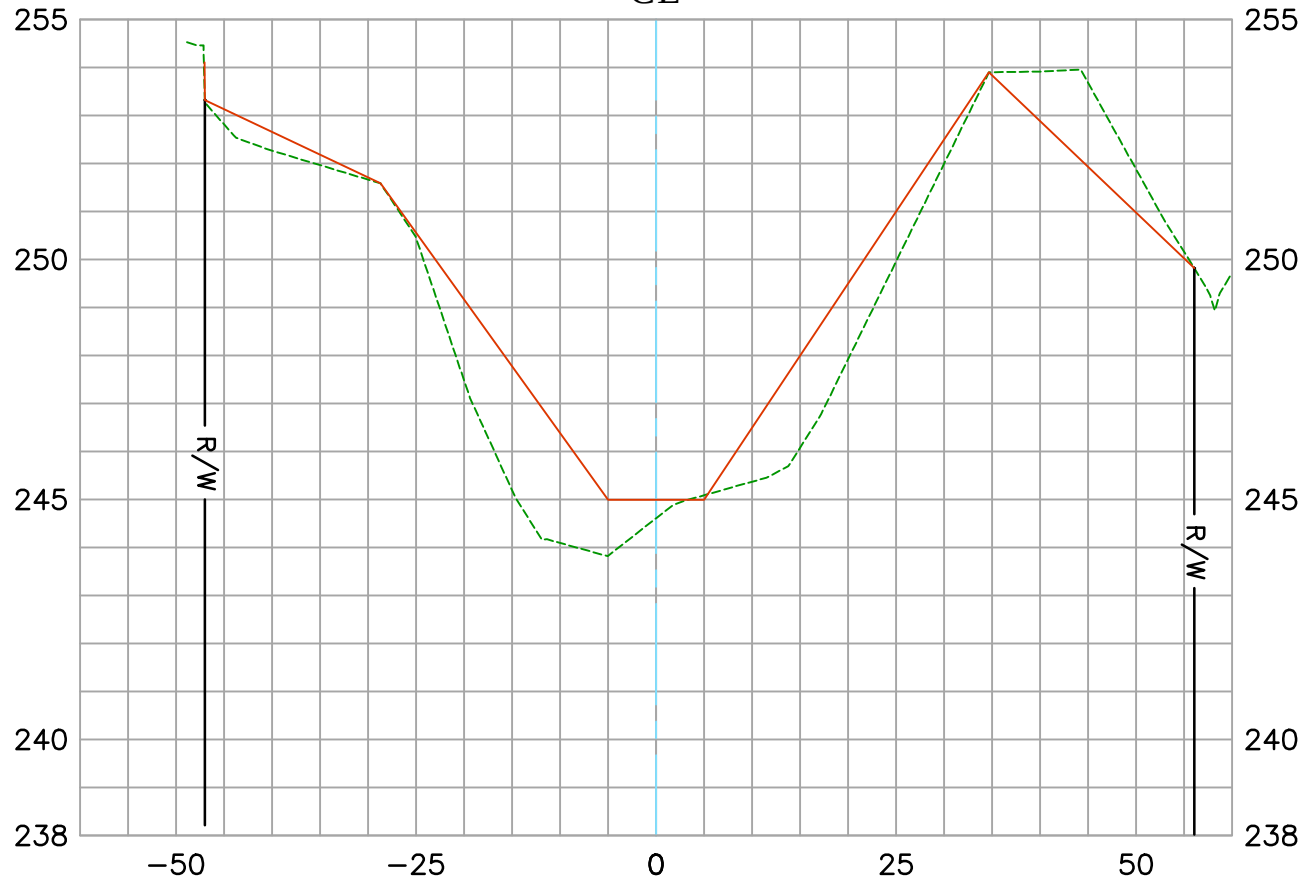
18+00.00

EXISTING CONDITION 03/18/2021  
RECORD DRAWINGS:  
F23-701-1, F23-701-2, & F23-701-3  
DATE PREPARED: 11/01/2021

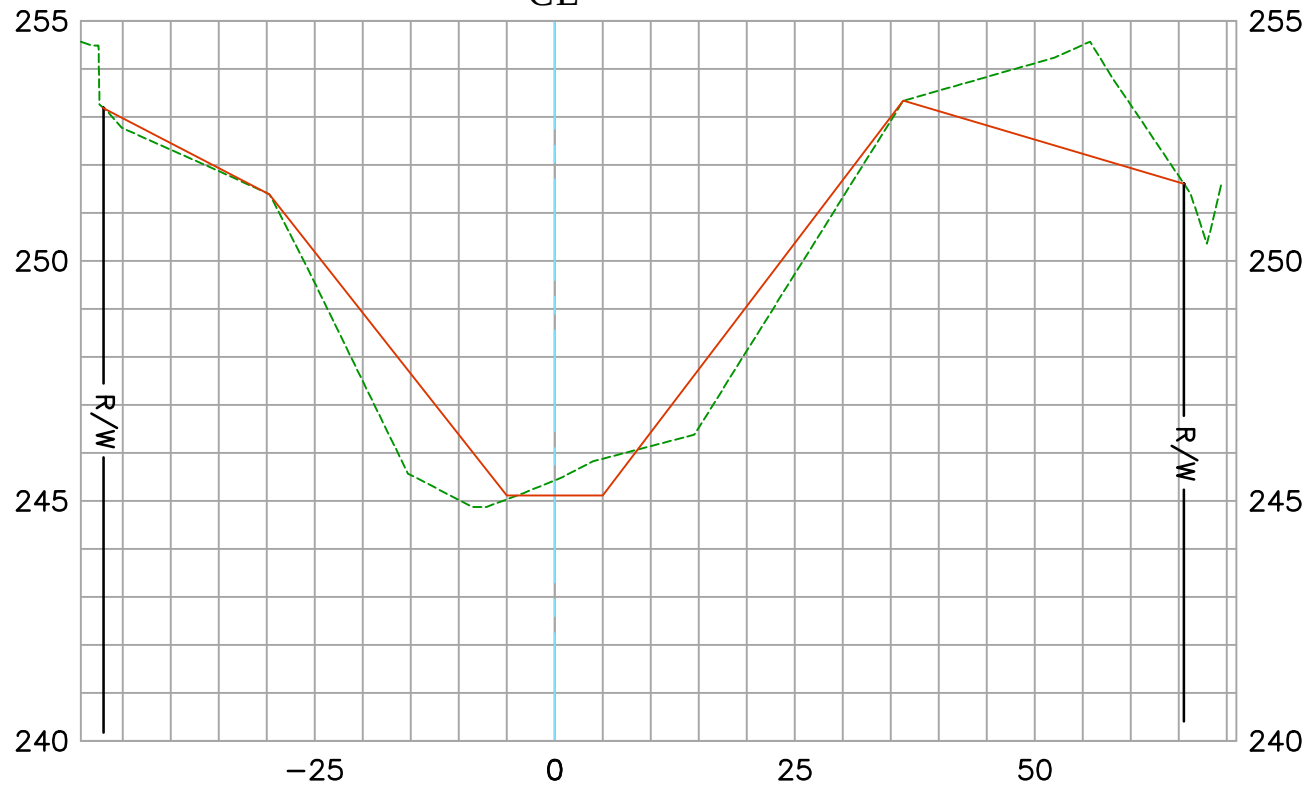
CAÑADA CHANNEL (F23)  
18+50.00  
CL

EXISTING CONDITION 03/18/2021  
RECORD DRAWINGS:  
F23-701-1, F23-701-2, & F23-701-3  
DATE PREPARED: 11/01/2021

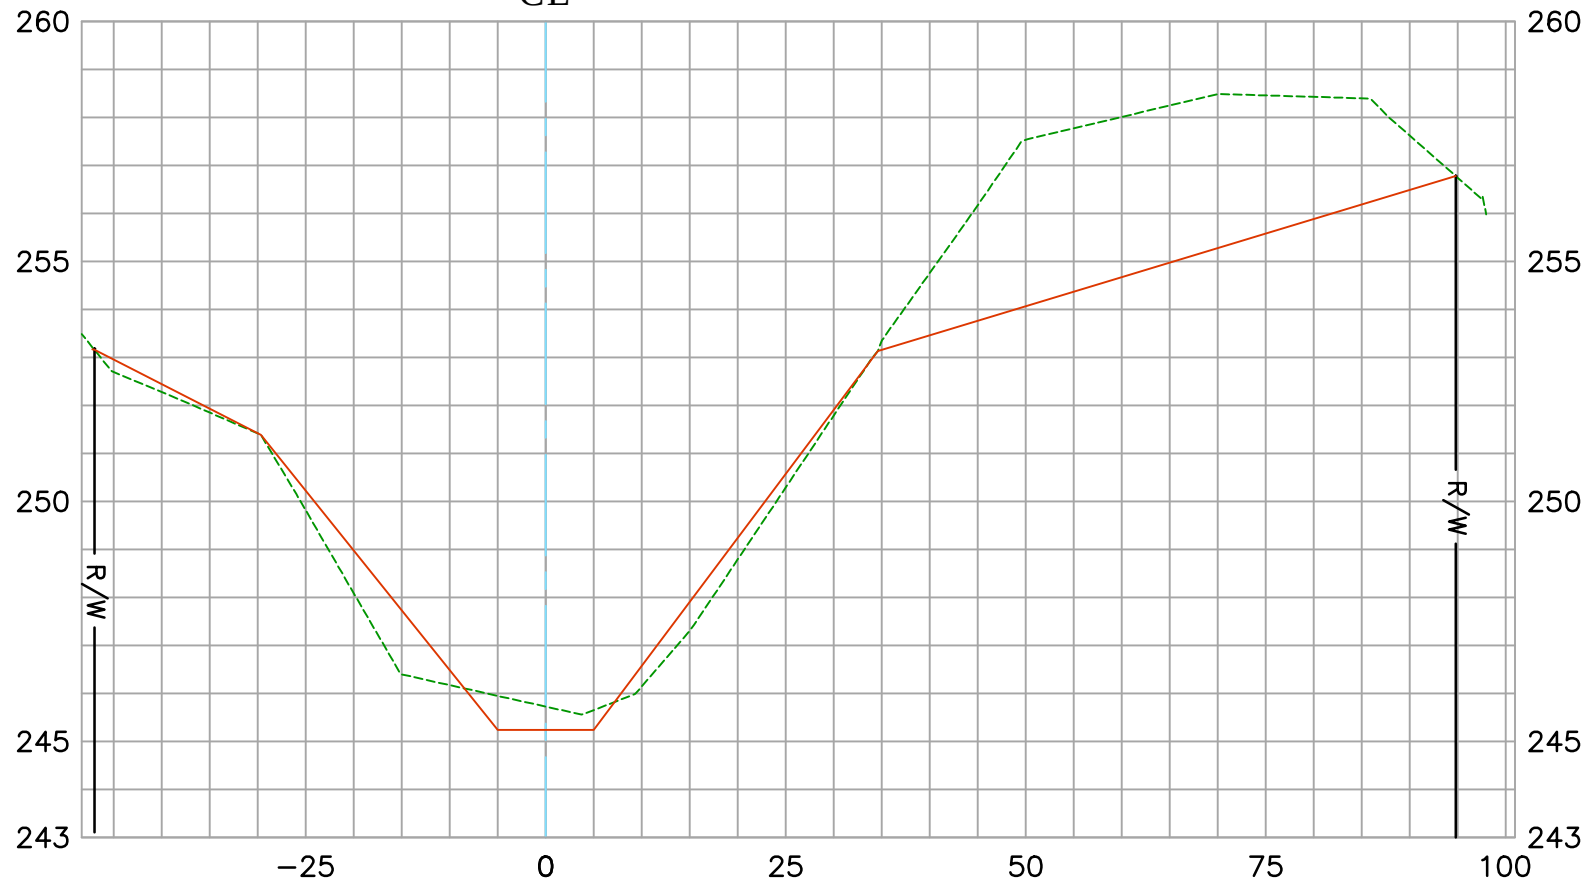
19+00.00

EXISTING CONDITION 03/18/2021  
RECORD DRAWINGS:  
F23-701-1, F23-701-2, & F23-701-3  
DATE PREPARED: 11/01/2021

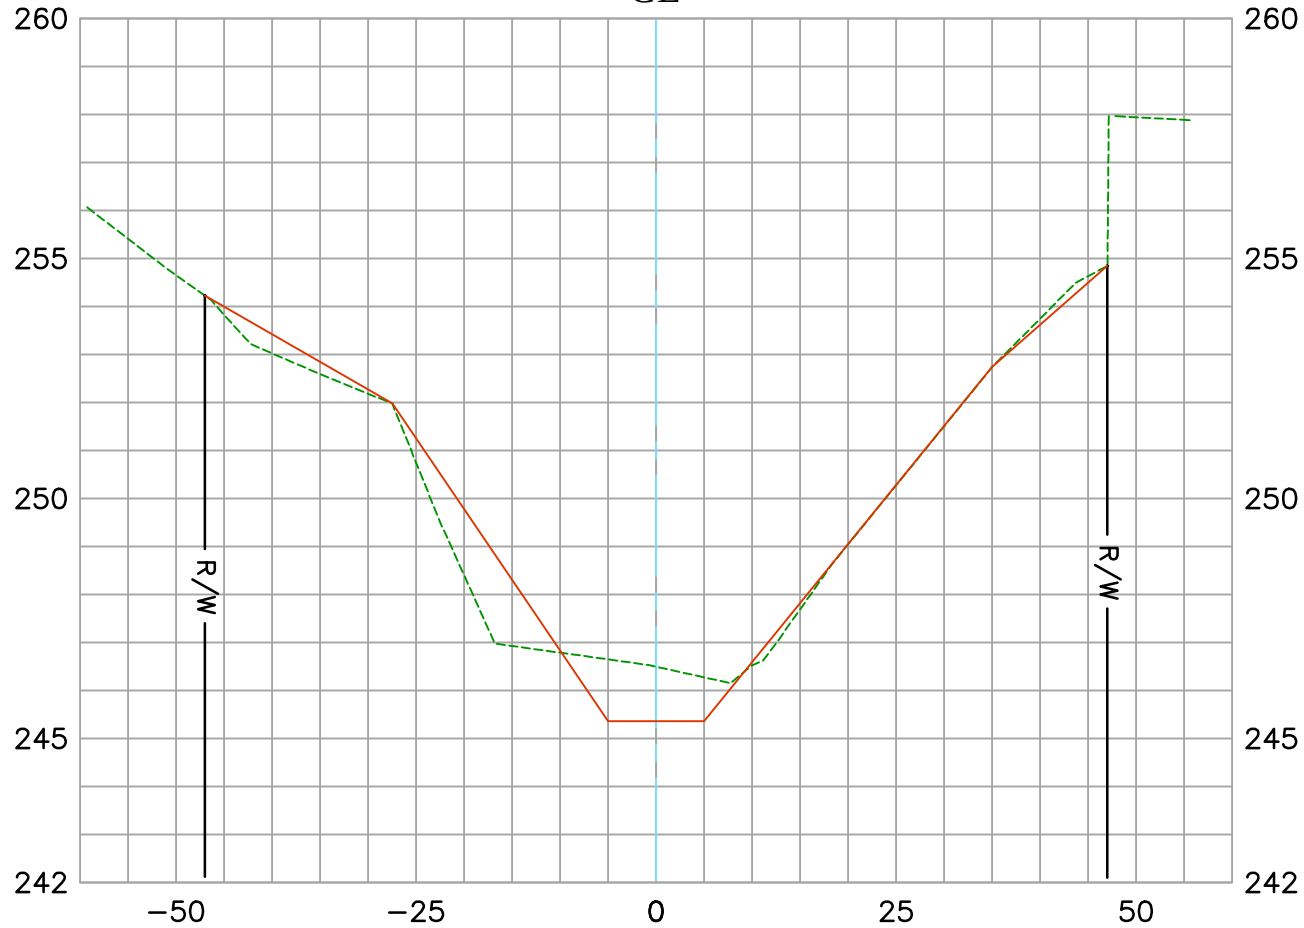
19+50.00

EXISTING CONDITION 03/18/2021  
RECORD DRAWINGS:  
F23-701-1, F23-701-2, & F23-701-3  
DATE PREPARED: 11/01/2021

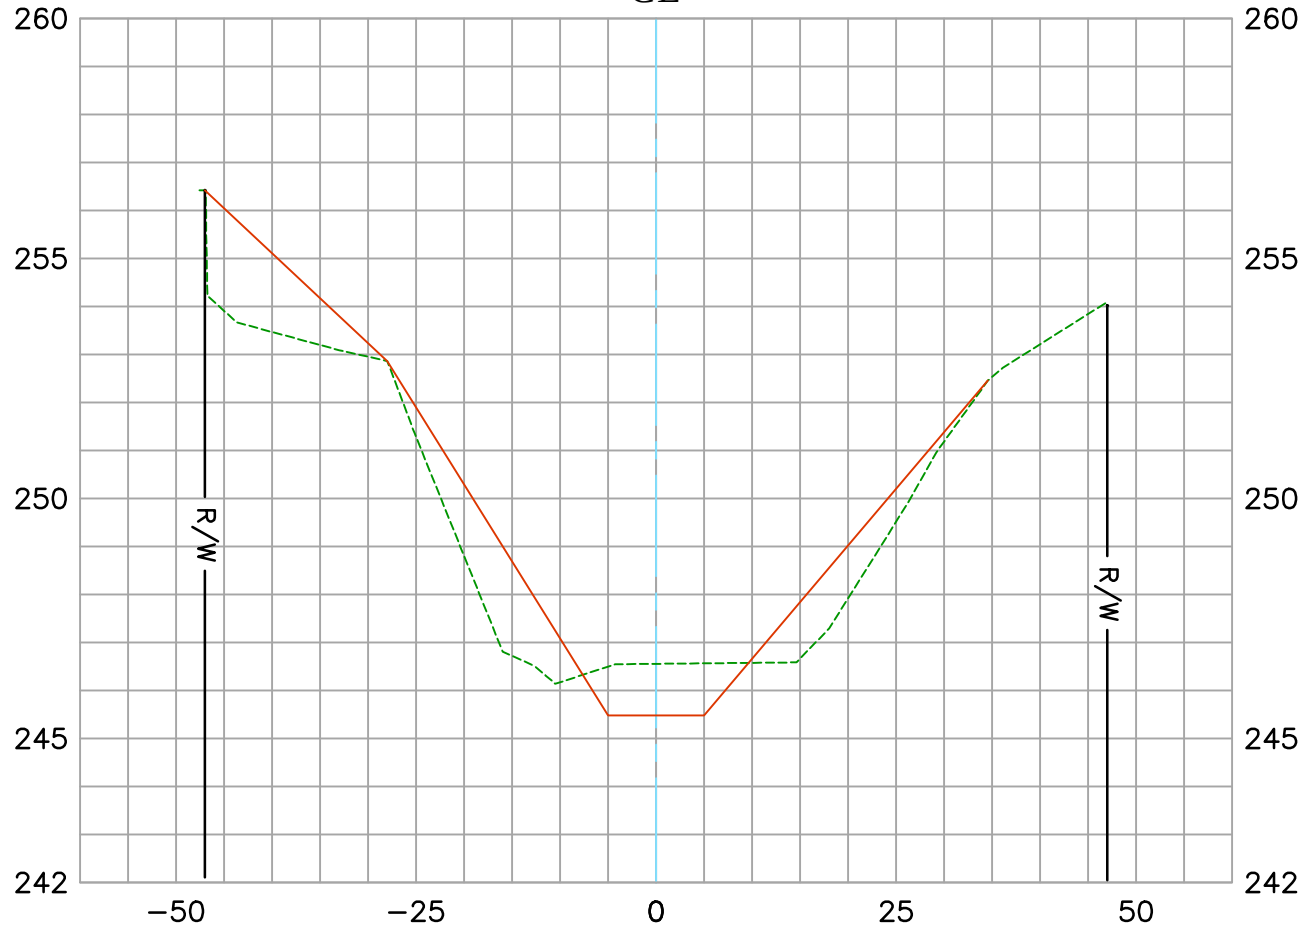
20+00.00

EXISTING CONDITION 03/18/2021  
RECORD DRAWINGS:  
F23-701-1, F23-701-2, & F23-701-3  
DATE PREPARED: 11/01/2021

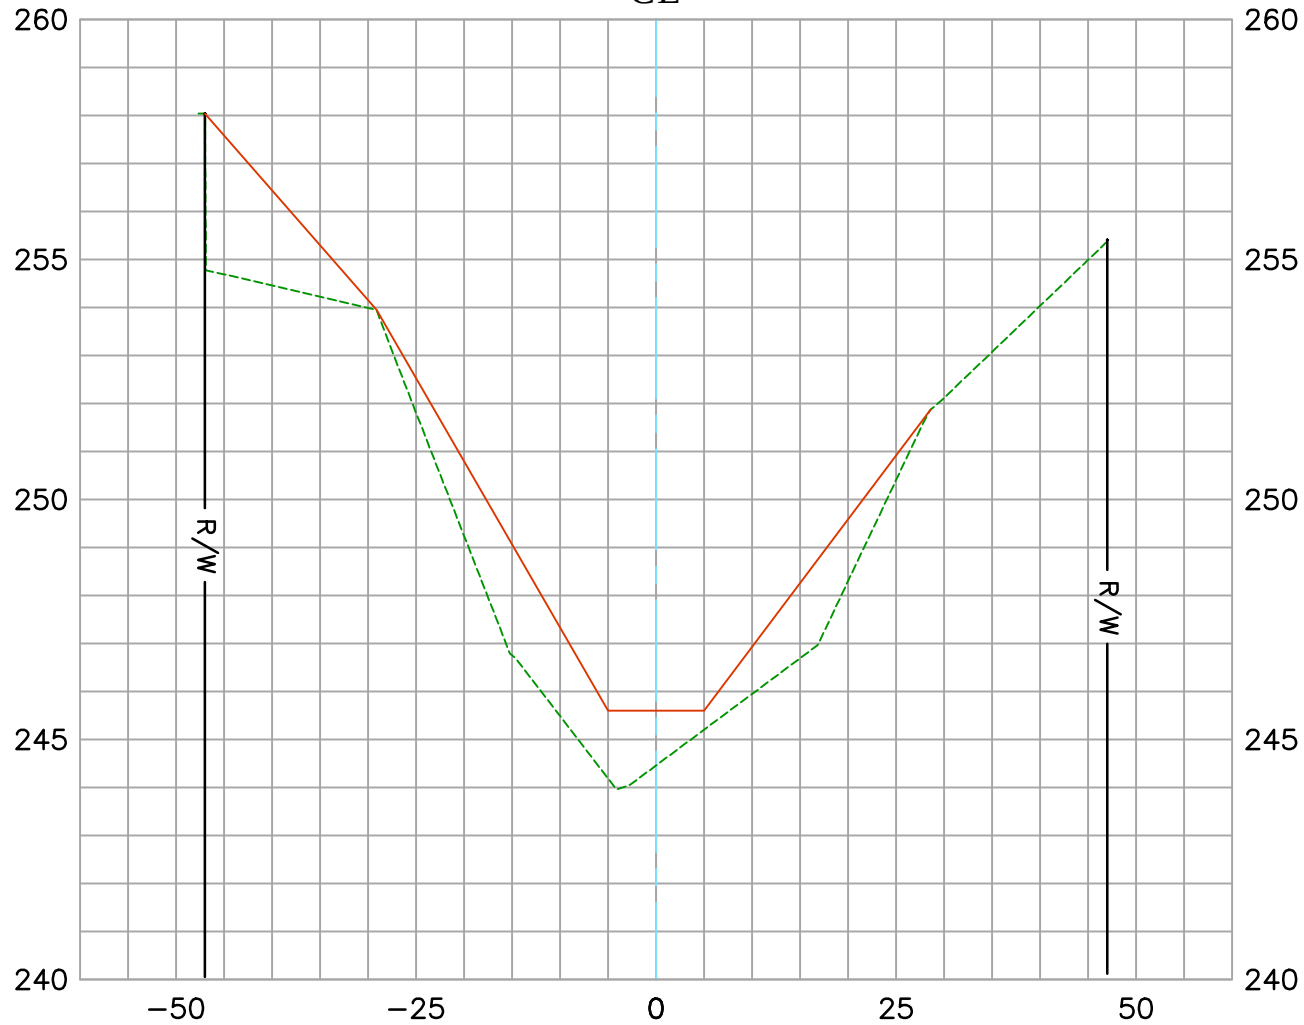
20+50.00

EXISTING CONDITION 03/18/2021  
RECORD DRAWINGS:  
F23-701-1, F23-701-2, & F23-701-3  
DATE PREPARED: 11/01/2021

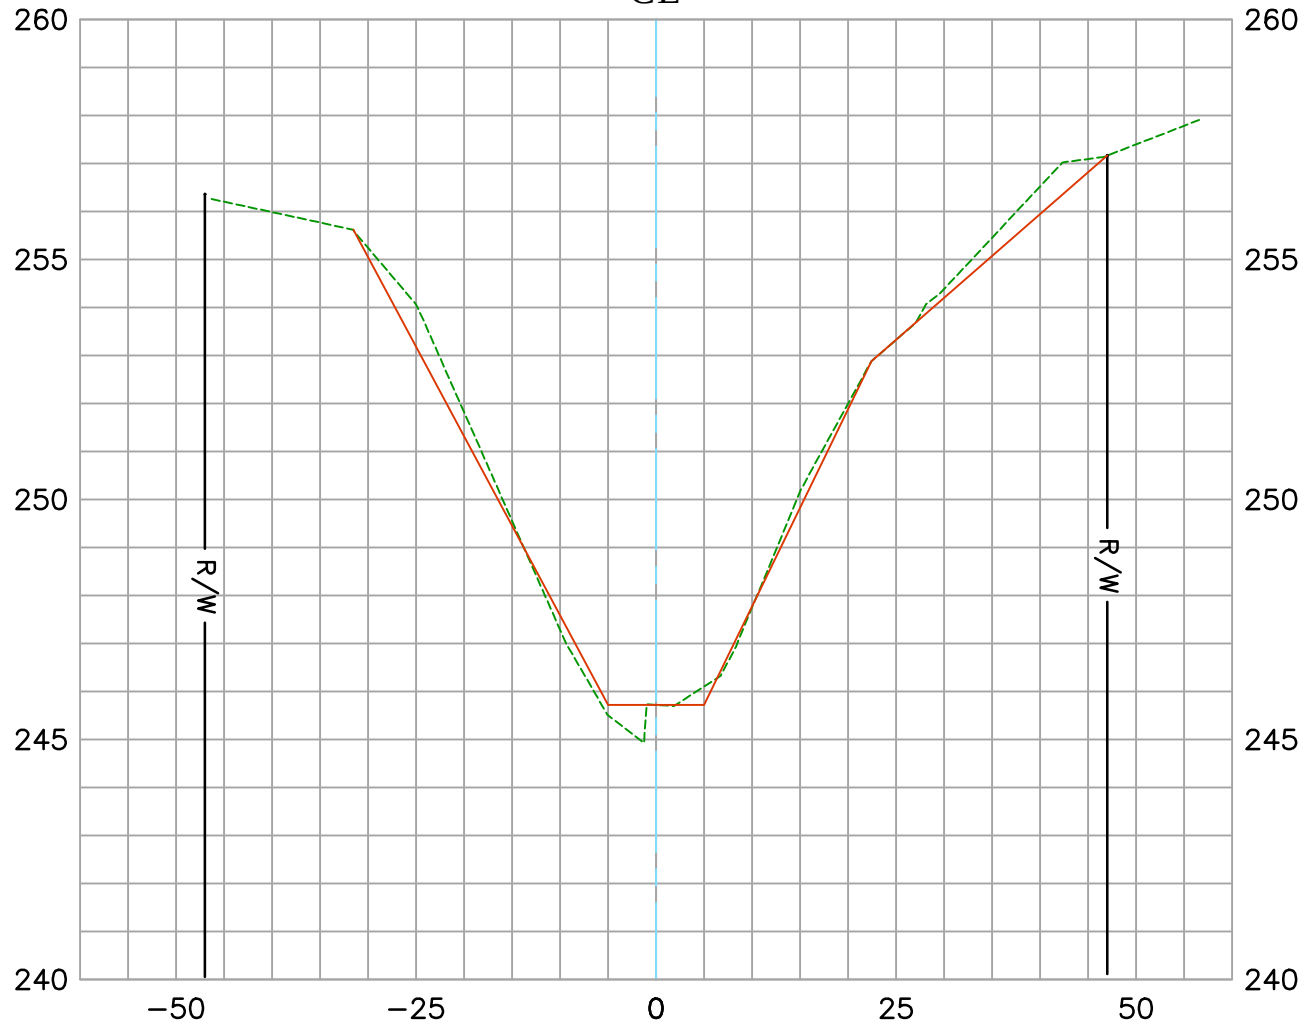
21+00.00

EXISTING CONDITION 03/18/2021  
RECORD DRAWINGS:  
F23-701-1, F23-701-2, & F23-701-3  
DATE PREPARED: 11/01/2021

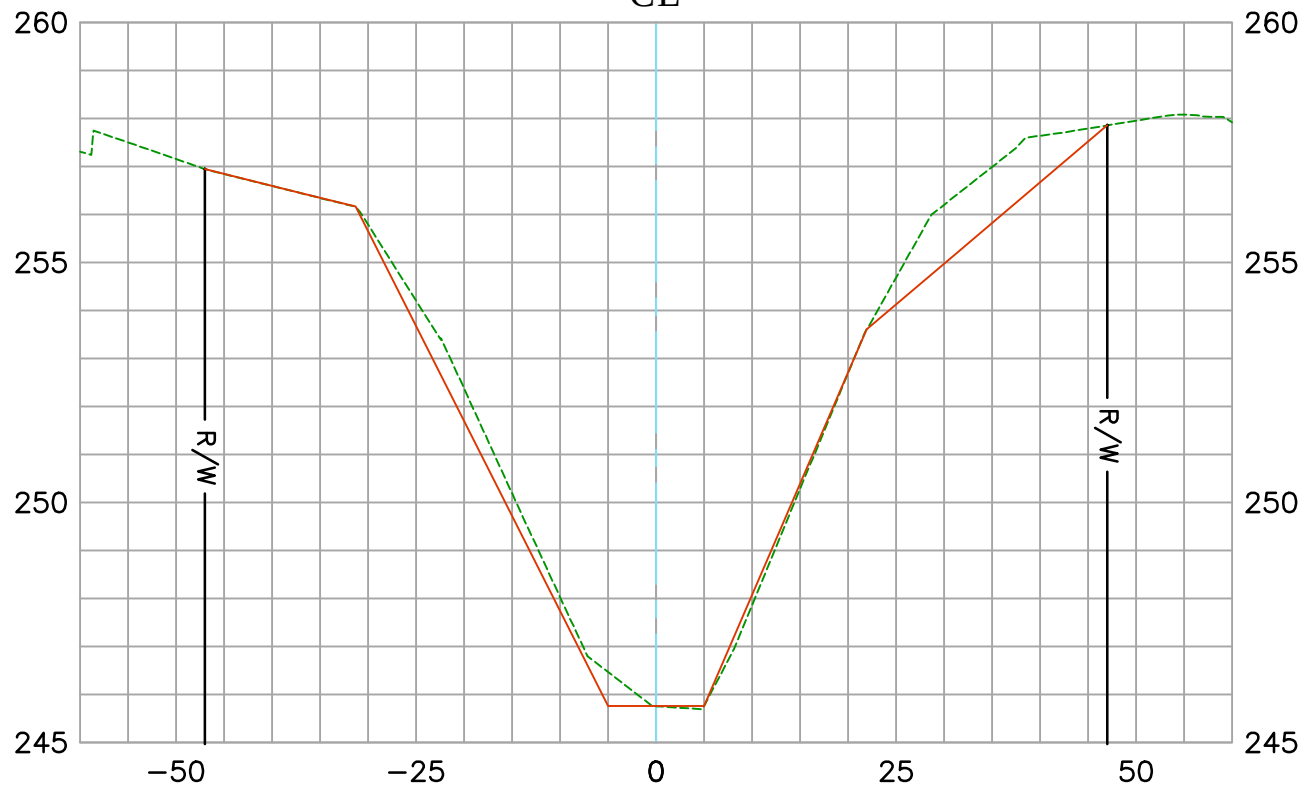
21+17.12

EXISTING CONDITION 03/18/2021  
RECORD DRAWINGS:  
F23-701-1, F23-701-2, & F23-701-3  
DATE PREPARED: 11/01/2021

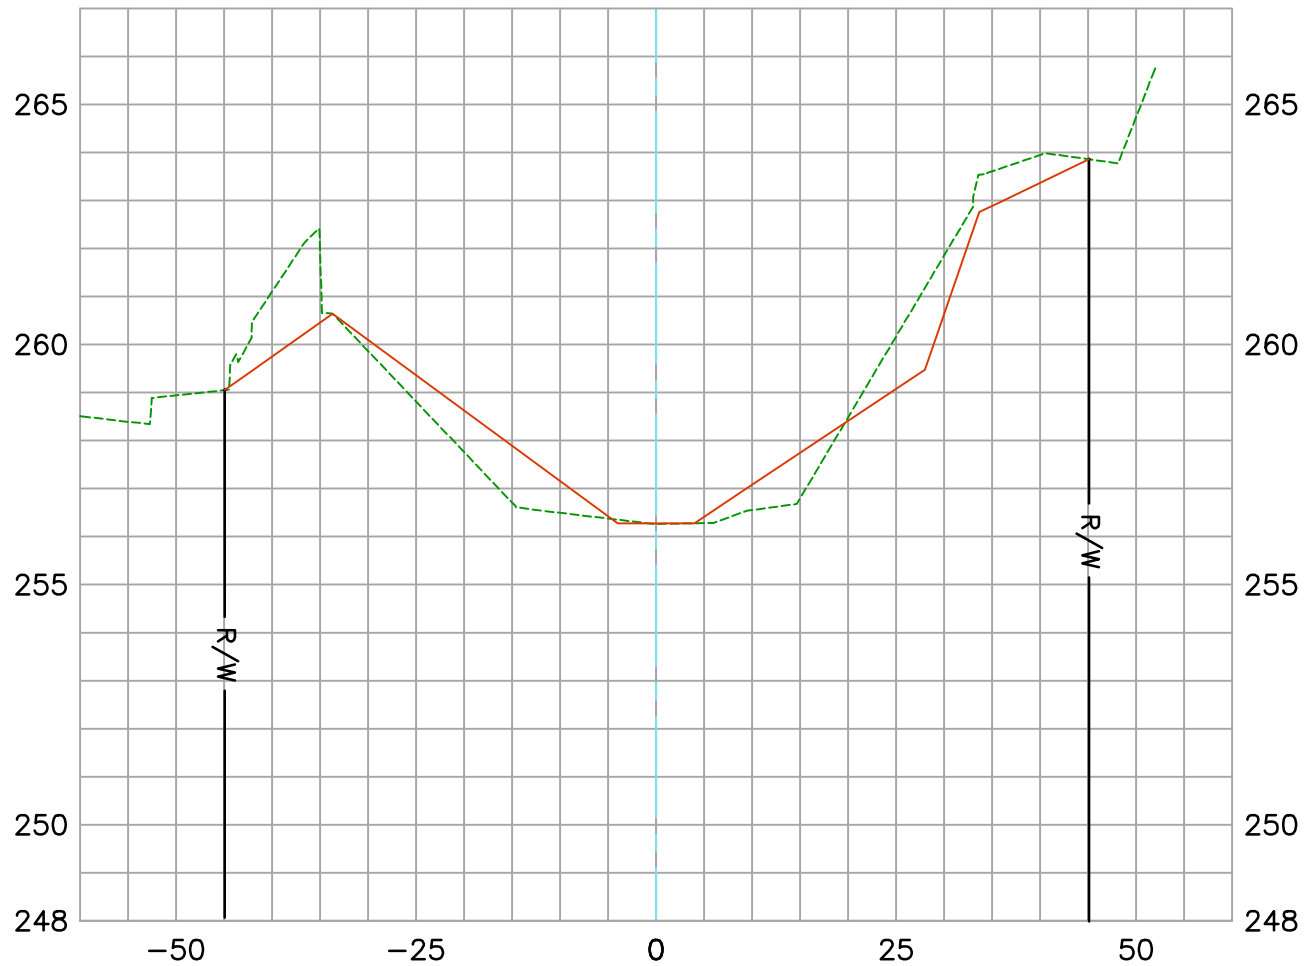
24+85.91

EXISTING CONDITION 03/18/2021

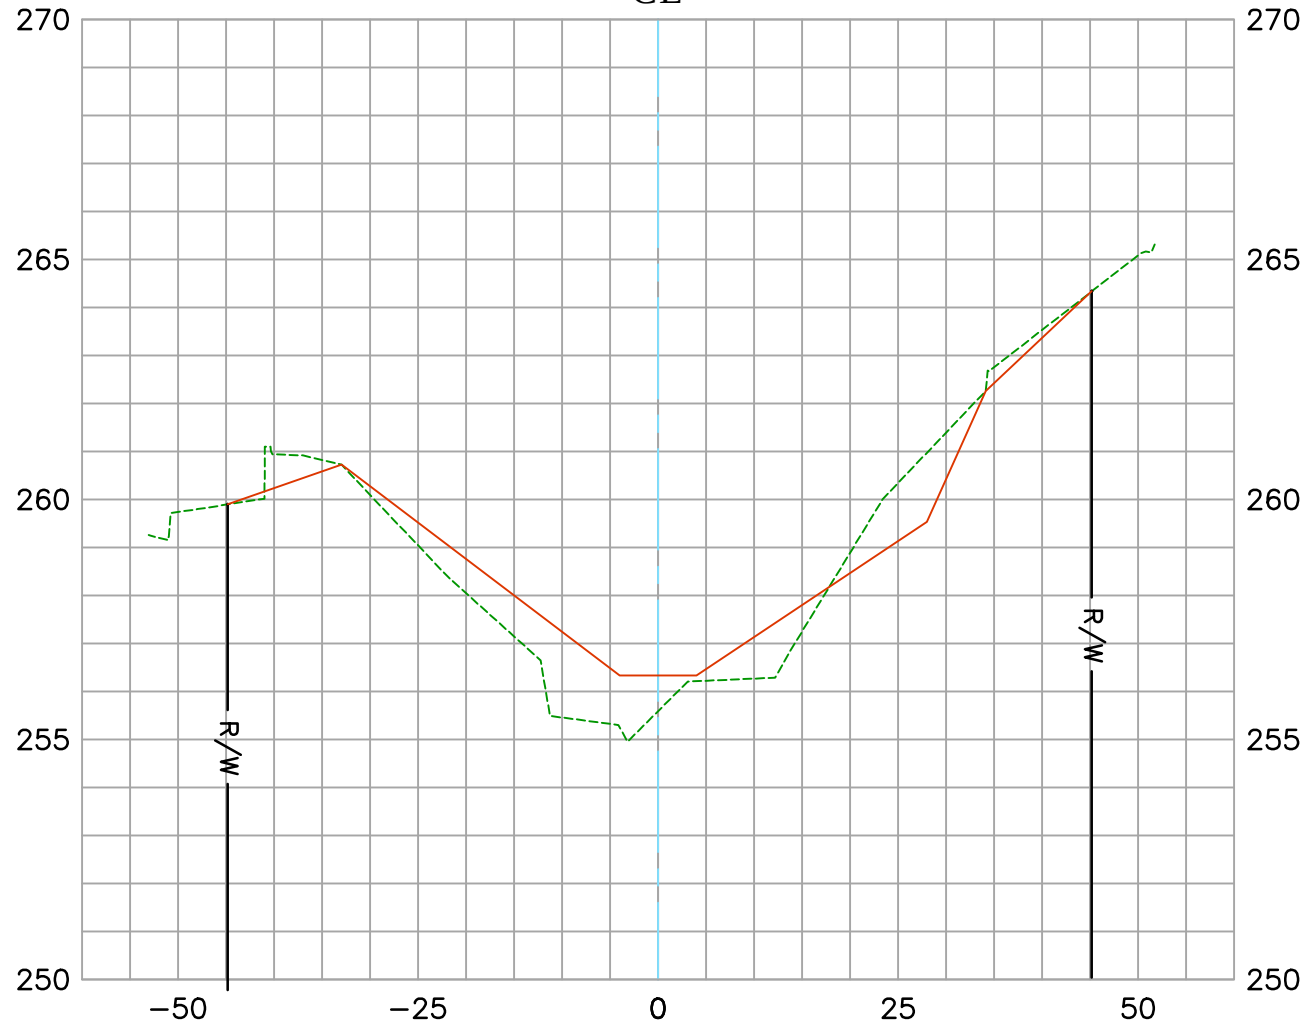
25+00.00

EXISTING CONDITION 03/18/2021  
RECORD DRAWINGS:  
F23-701-1, F23-701-2, & F23-701-3  
DATE PREPARED: 11/01/2021
