# OC PUBLIC WORKS DEPARTMENT

## CANADA CHANNEL

REHABILITATION

## PROJECT CROSS SECTIONS

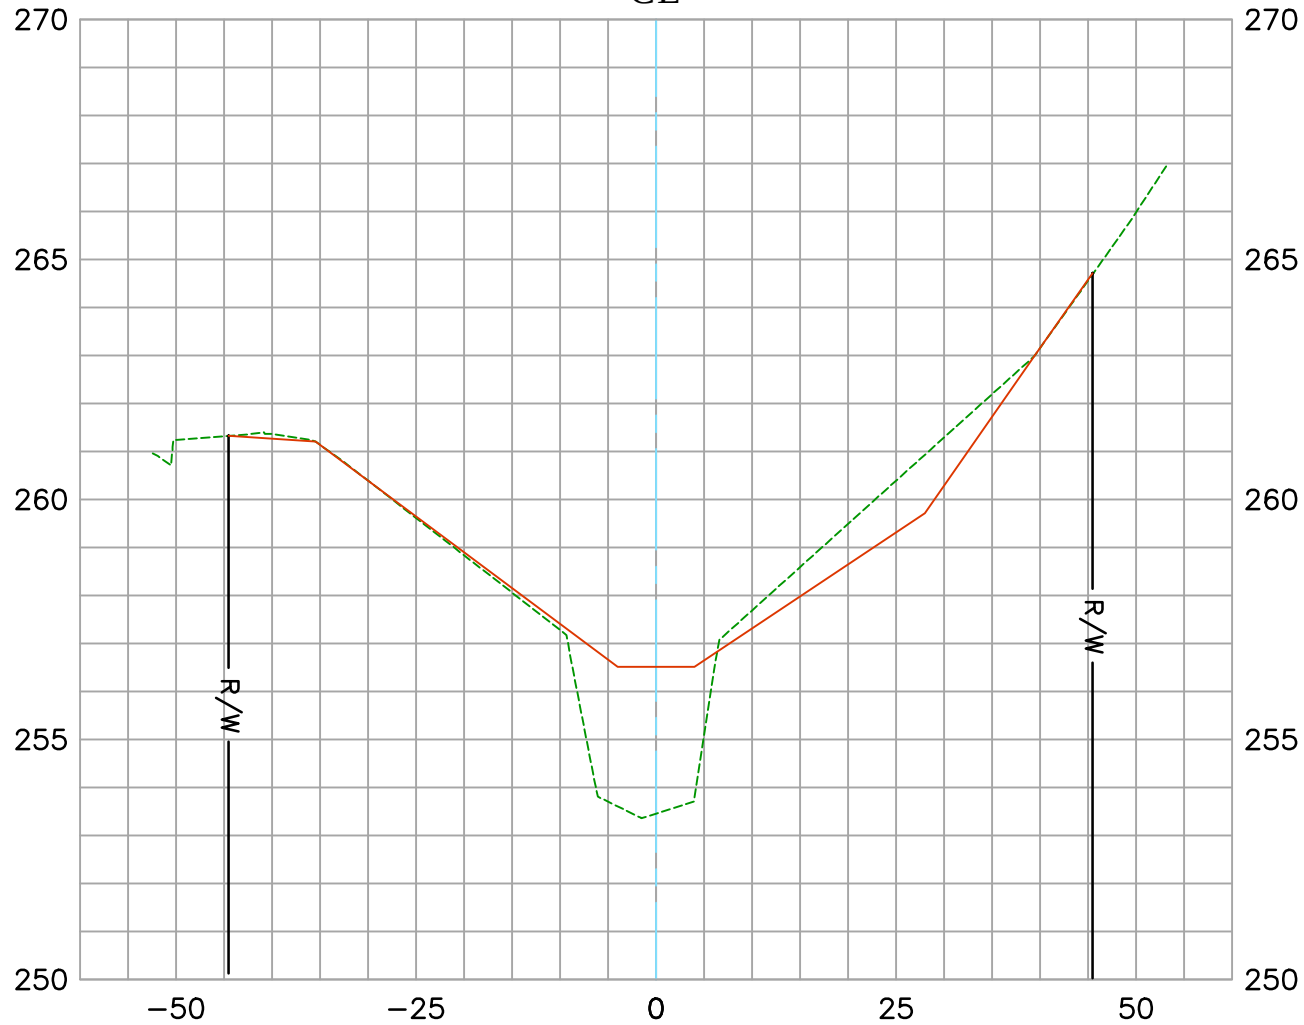
25+50.00

EXISTING CONDITION 03/18/2021  
RECORD DRAWINGS:  
F23-701-1, F23-701-2, & F23-701-3  
DATE PREPARED: 11/01/2021

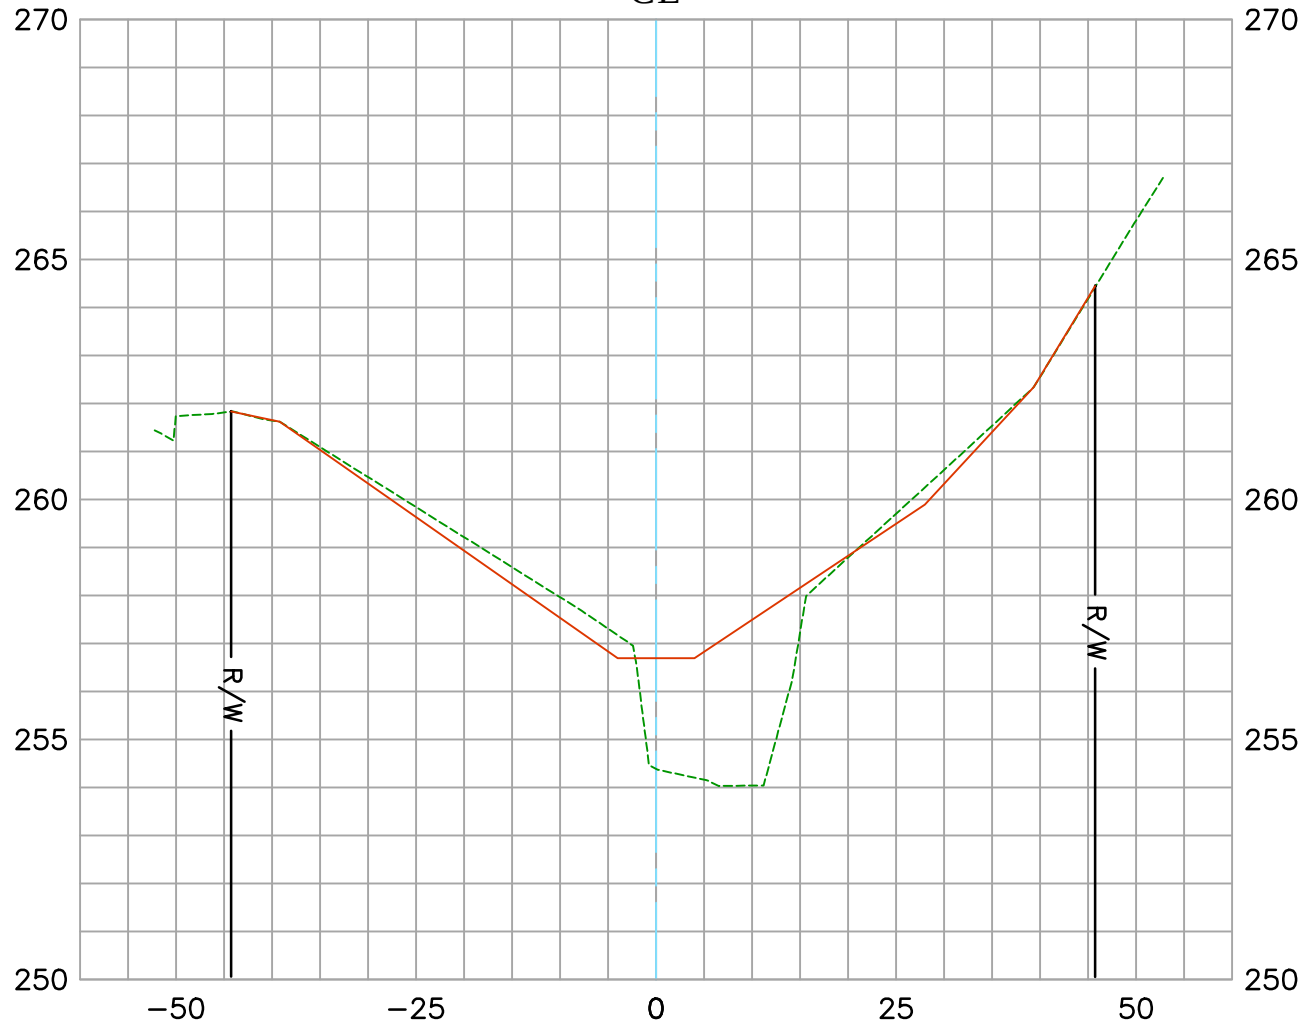
26+00.00

EXISTING CONDITION 03/18/2021  
RECORD DRAWINGS:  
F23-701-1, F23-701-2, & F23-701-3  
DATE PREPARED: 11/01/2021

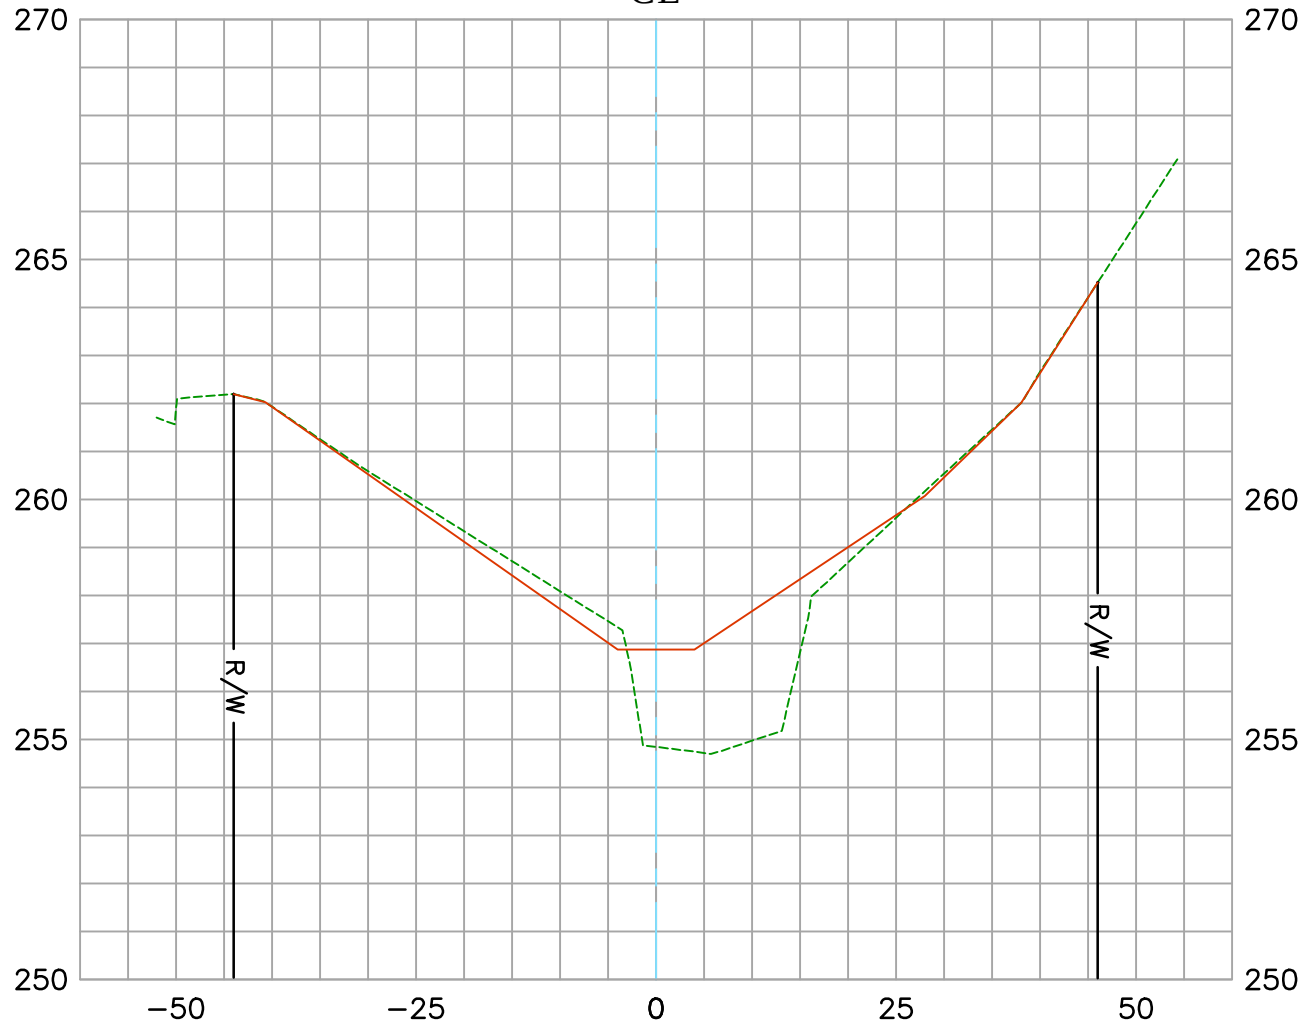
26+50.00

EXISTING CONDITION 03/18/2021  
RECORD DRAWINGS:  
F23-701-1, F23-701-2, & F23-701-3  
DATE PREPARED: 11/01/2021

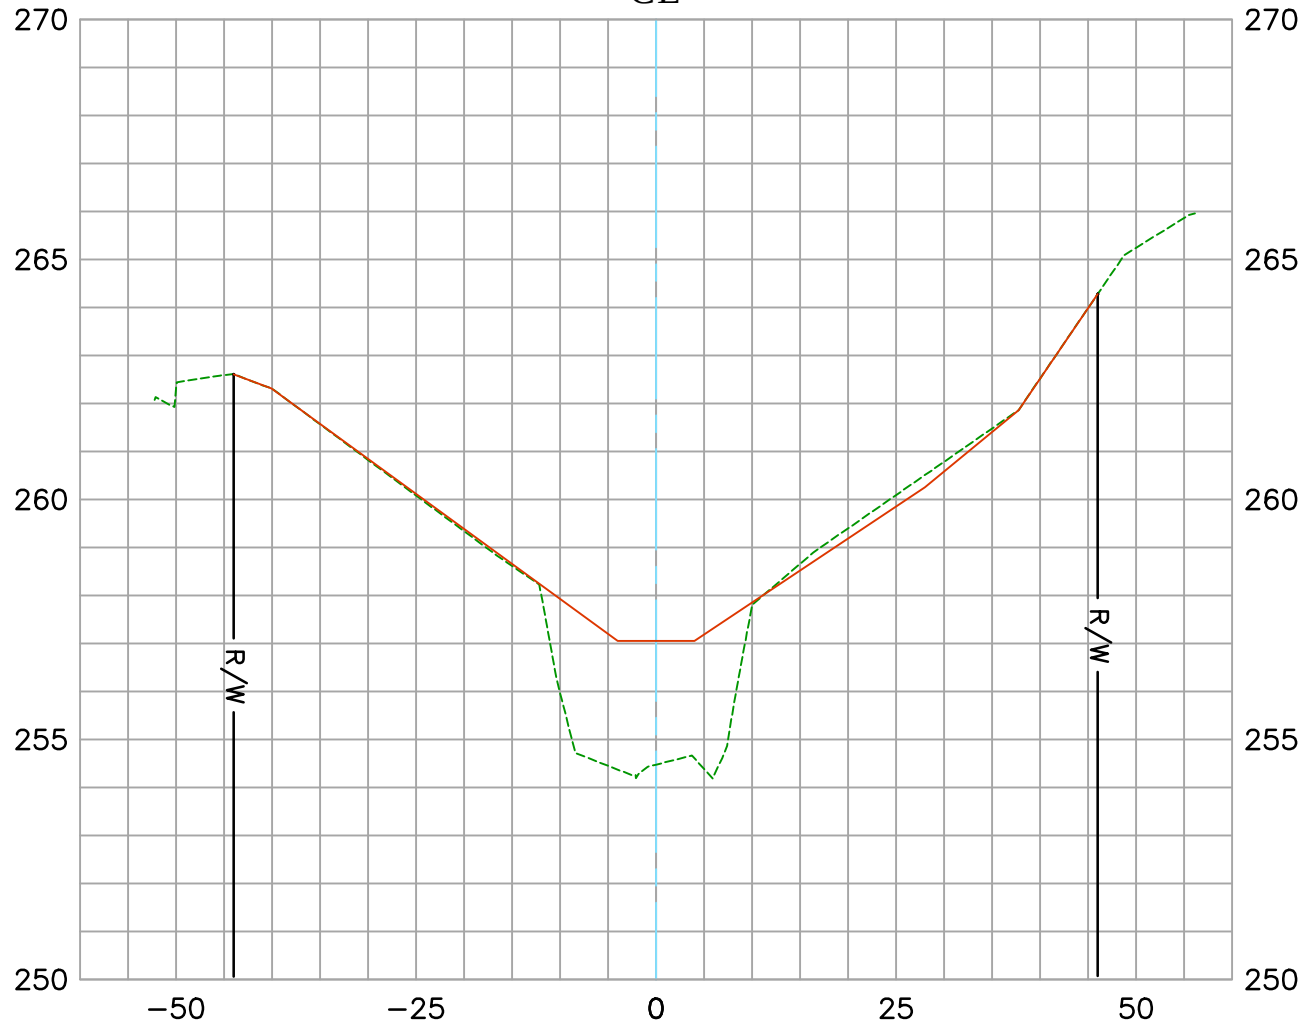
27+00.00

EXISTING CONDITION 03/18/2021  
RECORD DRAWINGS:  
F23-701-1, F23-701-2, & F23-701-3  
DATE PREPARED: 11/01/2021

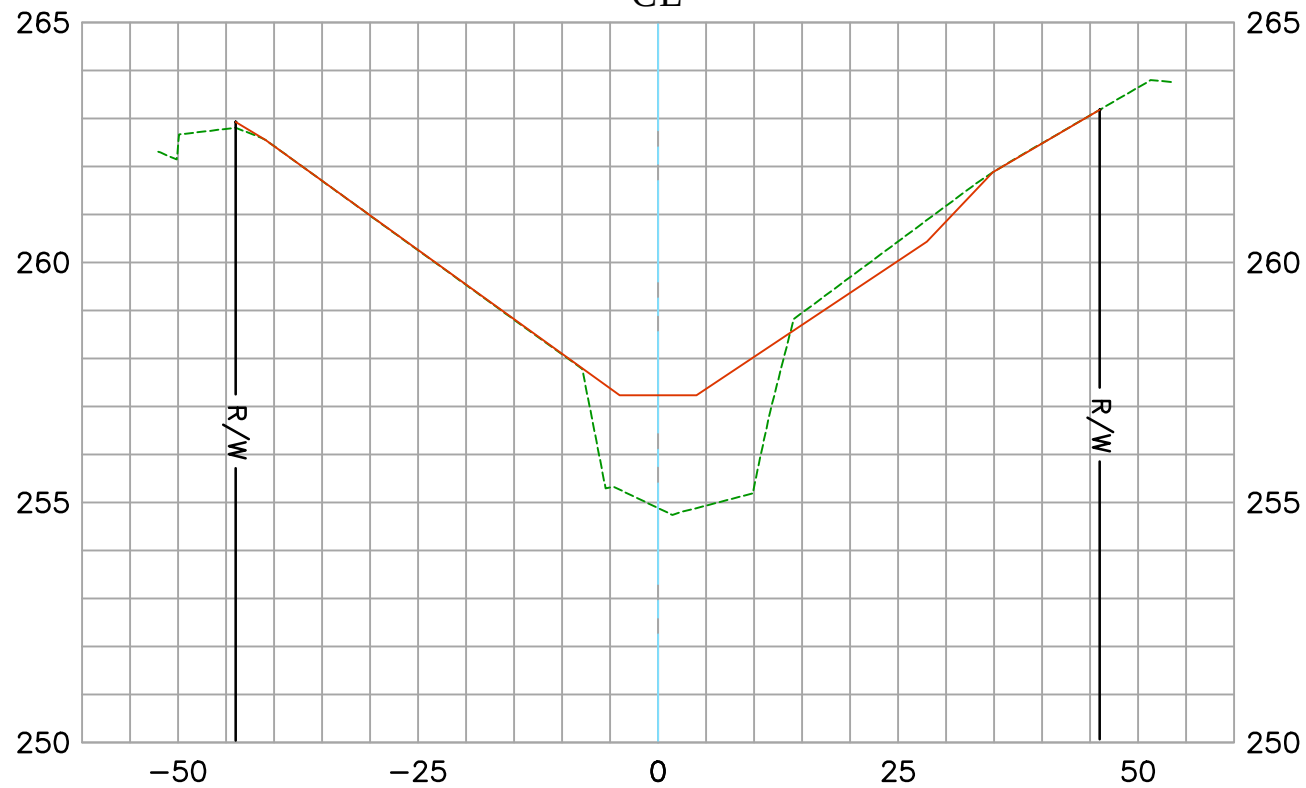
27+50.00

EXISTING CONDITION 03/18/2021  
RECORD DRAWINGS:  
F23-701-1, F23-701-2, & F23-701-3  
DATE PREPARED: 11/01/2021

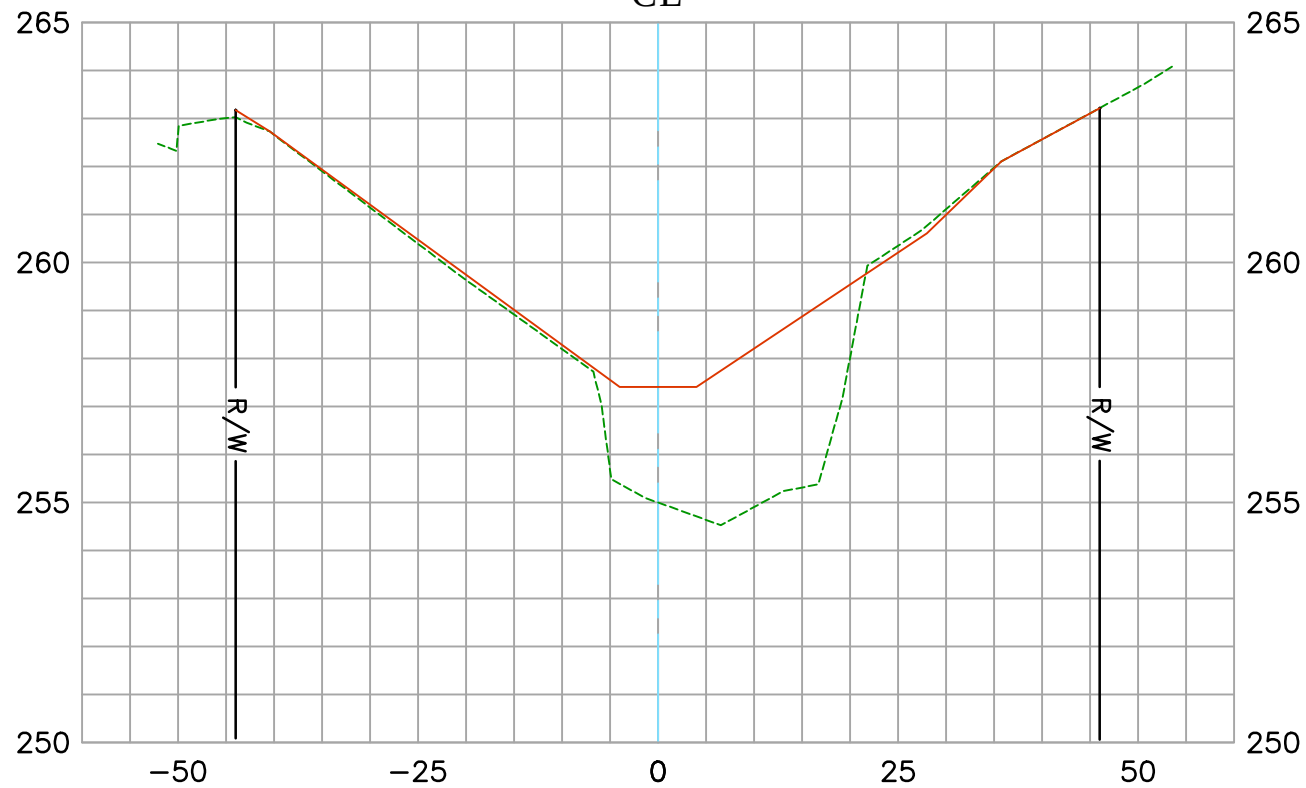
28+00.00

EXISTING CONDITION 03/18/2021  
RECORD DRAWINGS:  
F23-701-1, F23-701-2, & F23-701-3  
DATE PREPARED: 11/01/2021

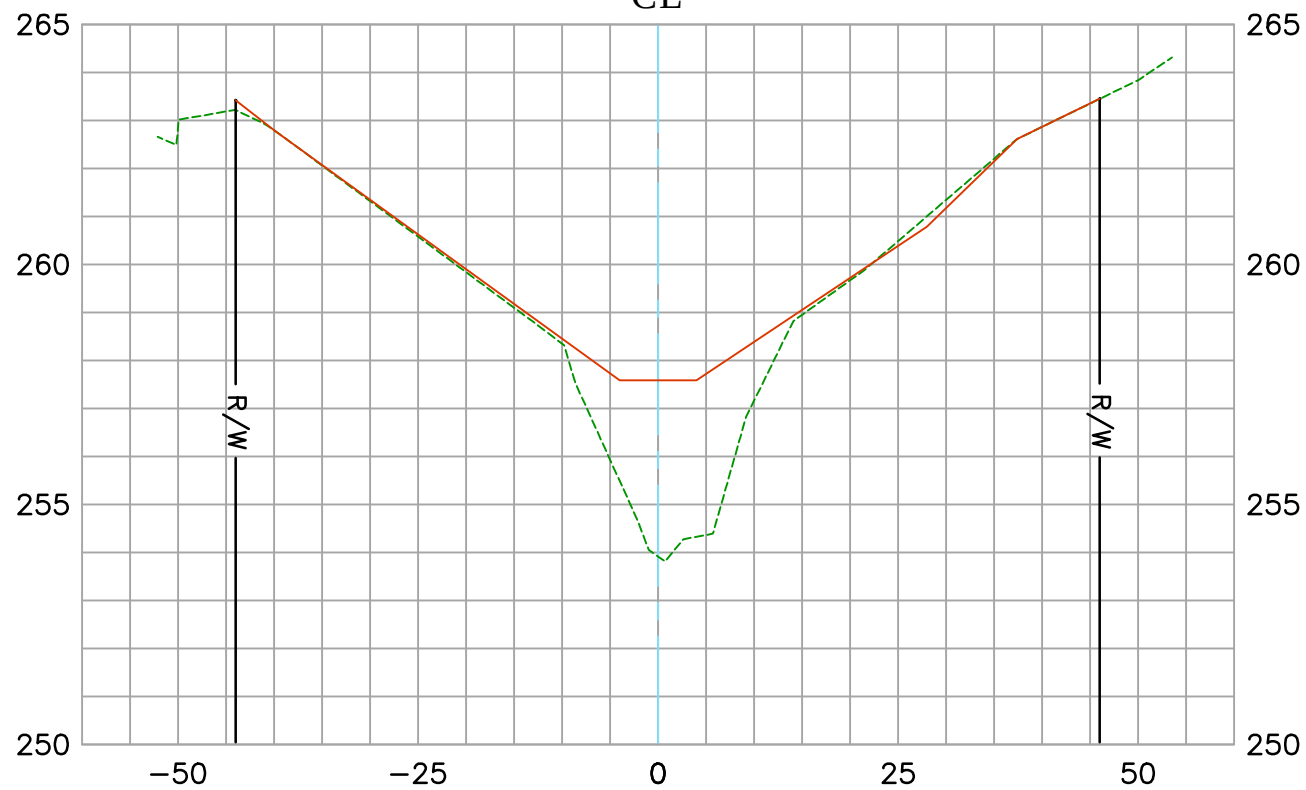
28+50.00

EXISTING CONDITION 03/18/2021  
RECORD DRAWINGS:  
F23-701-1, F23-701-2, & F23-701-3  
DATE PREPARED: 11/01/2021

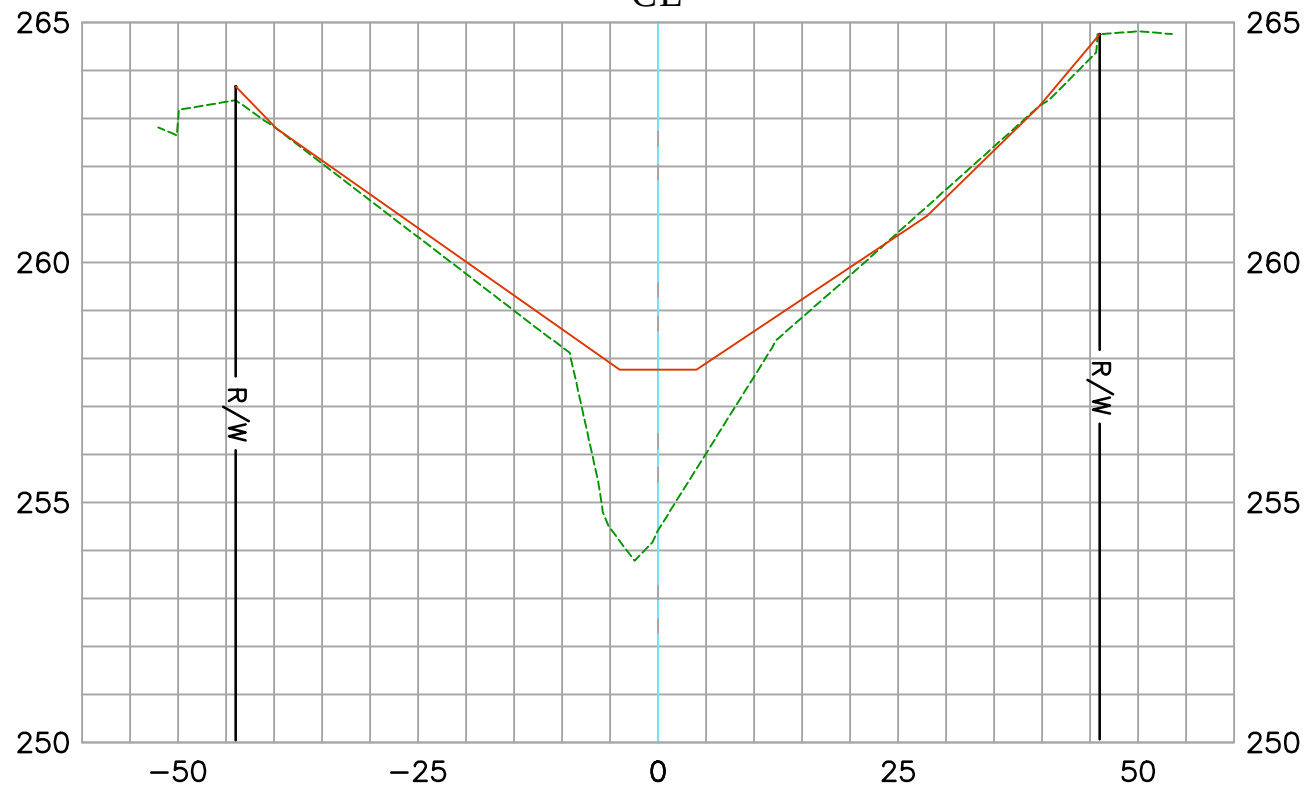
29+00.00

EXISTING CONDITION 03/18/2021  
RECORD DRAWINGS:  
F23-701-1, F23-701-2, & F23-701-3  
DATE PREPARED: 11/01/2021

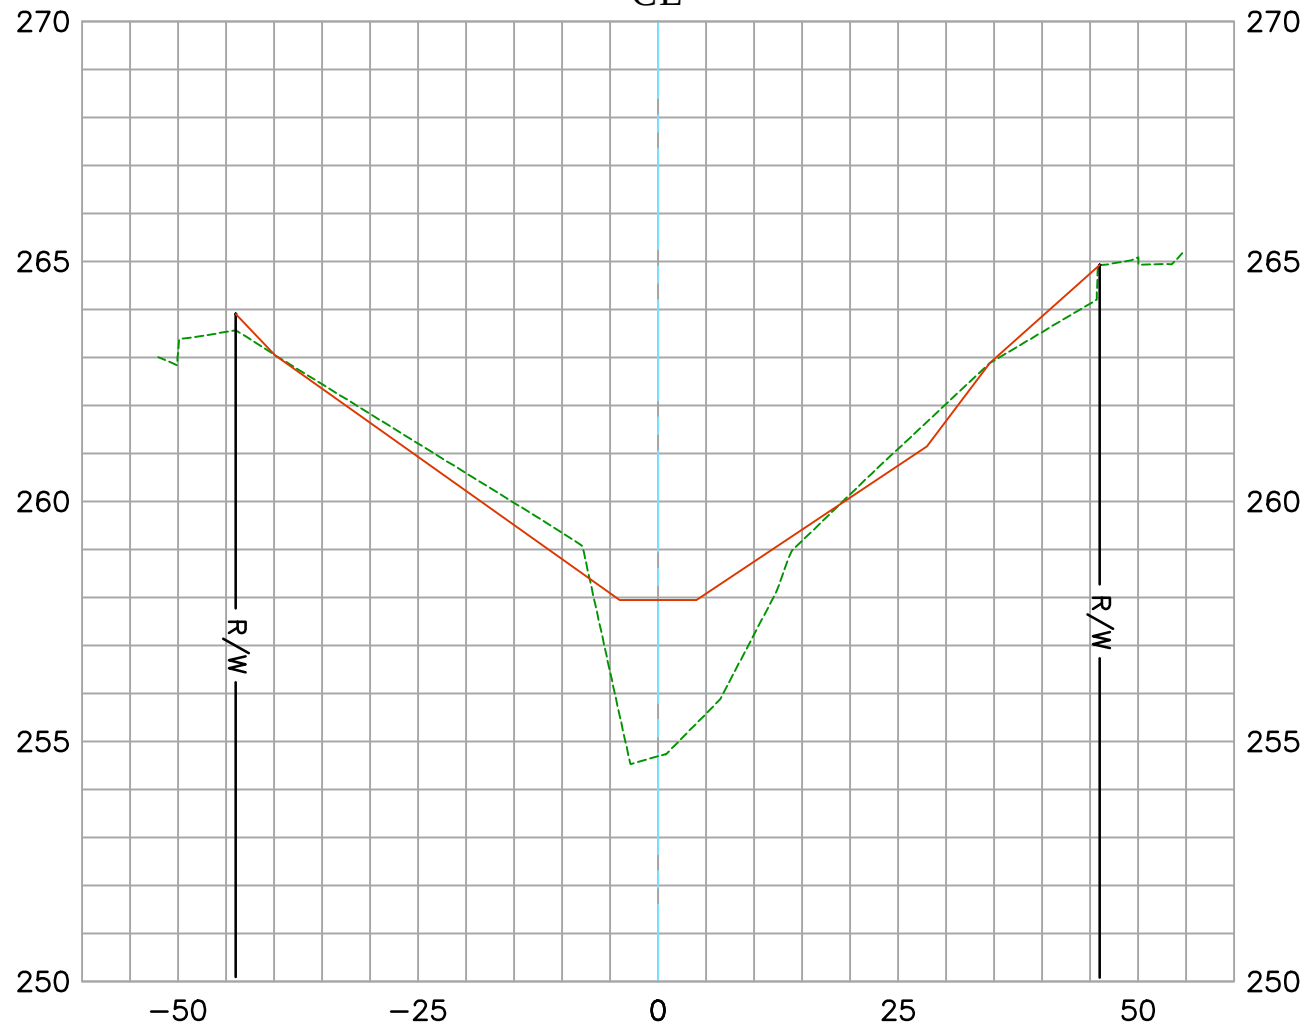
29+50.00

EXISTING CONDITION 03/18/2021  
RECORD DRAWINGS:  
F23-701-1, F23-701-2, & F23-701-3  
DATE PREPARED: 11/01/2021

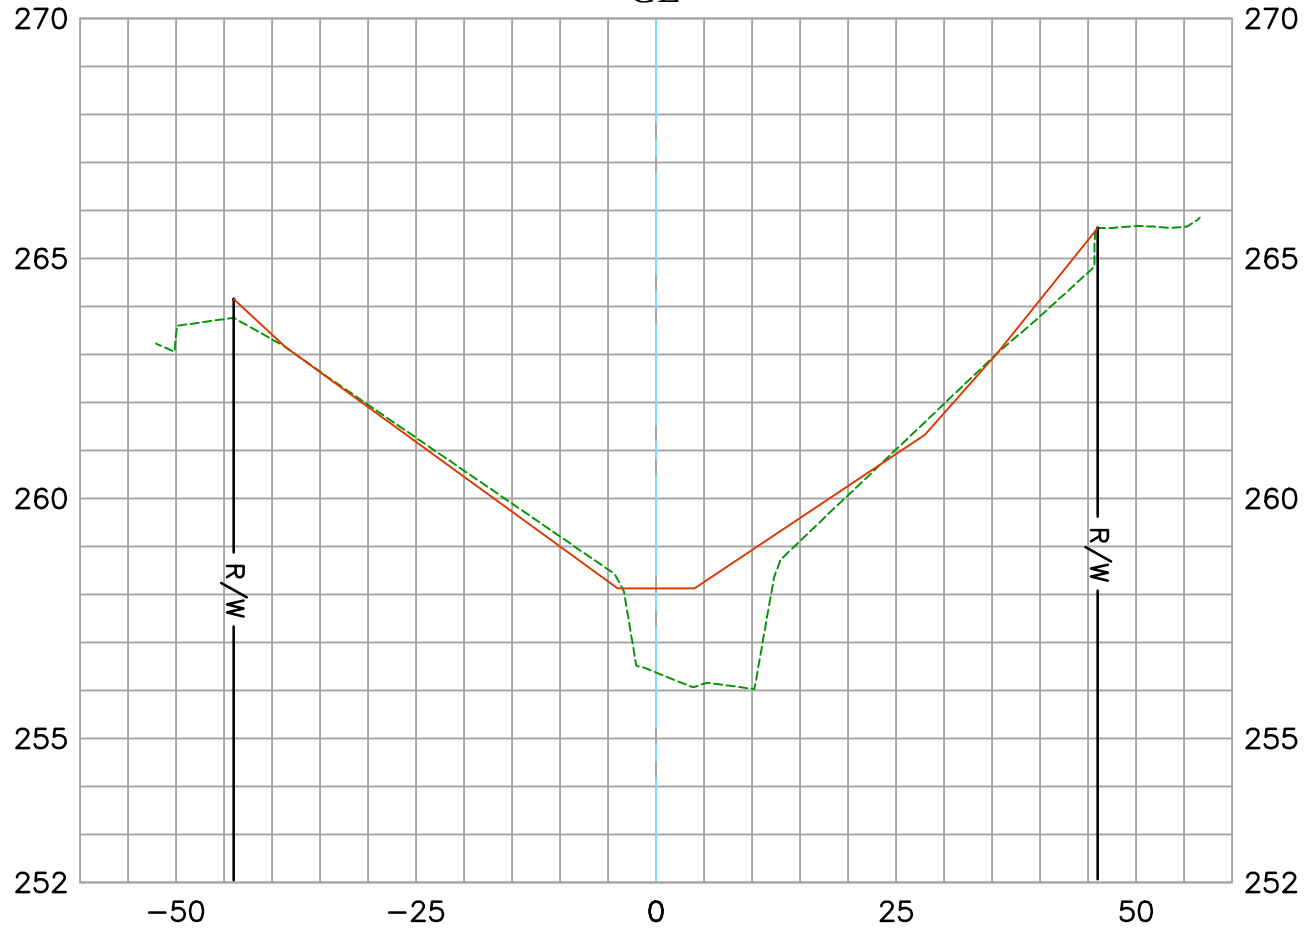
30+00.00

EXISTING CONDITION 03/18/2021  
RECORD DRAWINGS:  
F23-701-1, F23-701-2, & F23-701-3  
DATE PREPARED: 11/01/2021

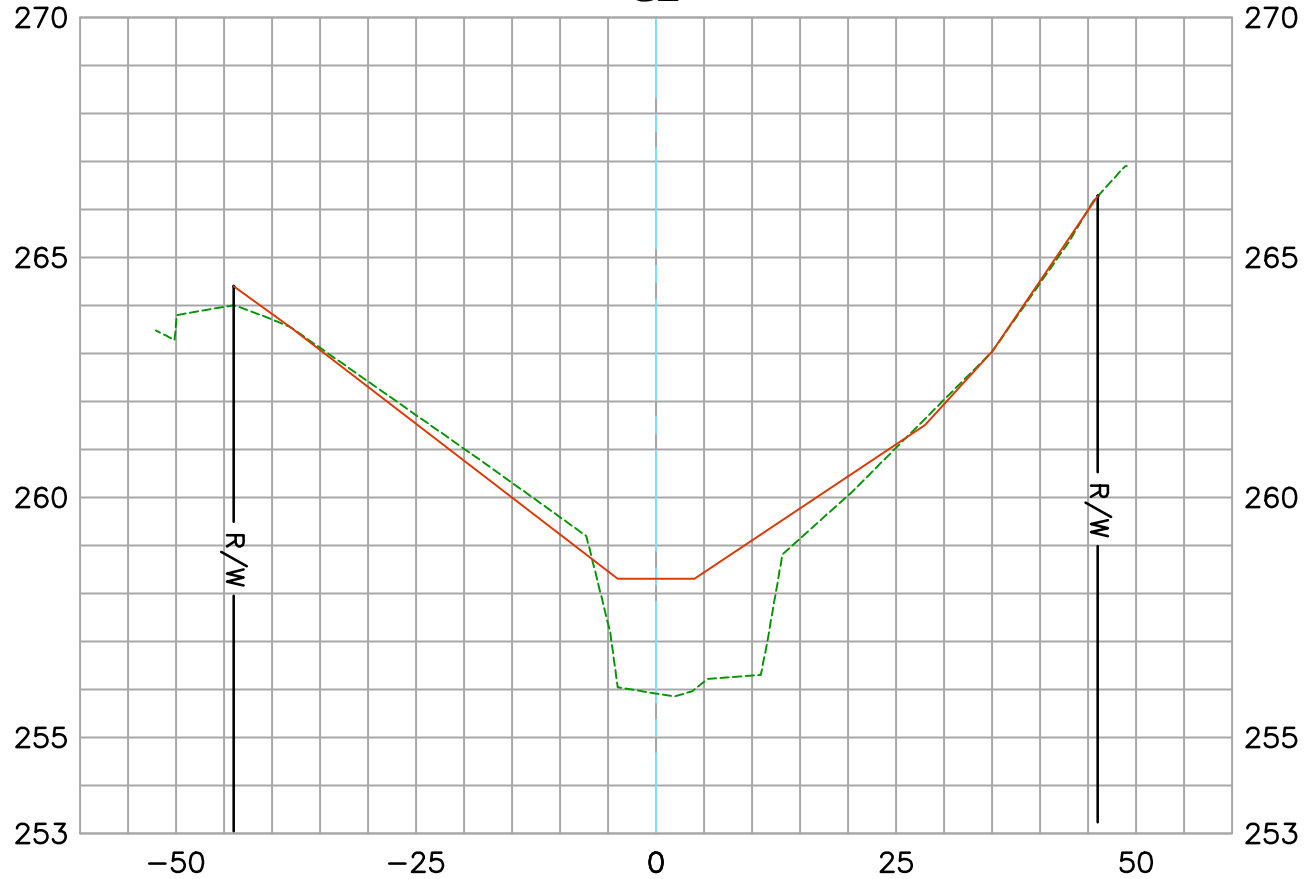
30+50.00

EXISTING CONDITION 03/18/2021  
RECORD DRAWINGS:  
F23-701-1, F23-701-2, & F23-701-3  
DATE PREPARED: 11/01/2021

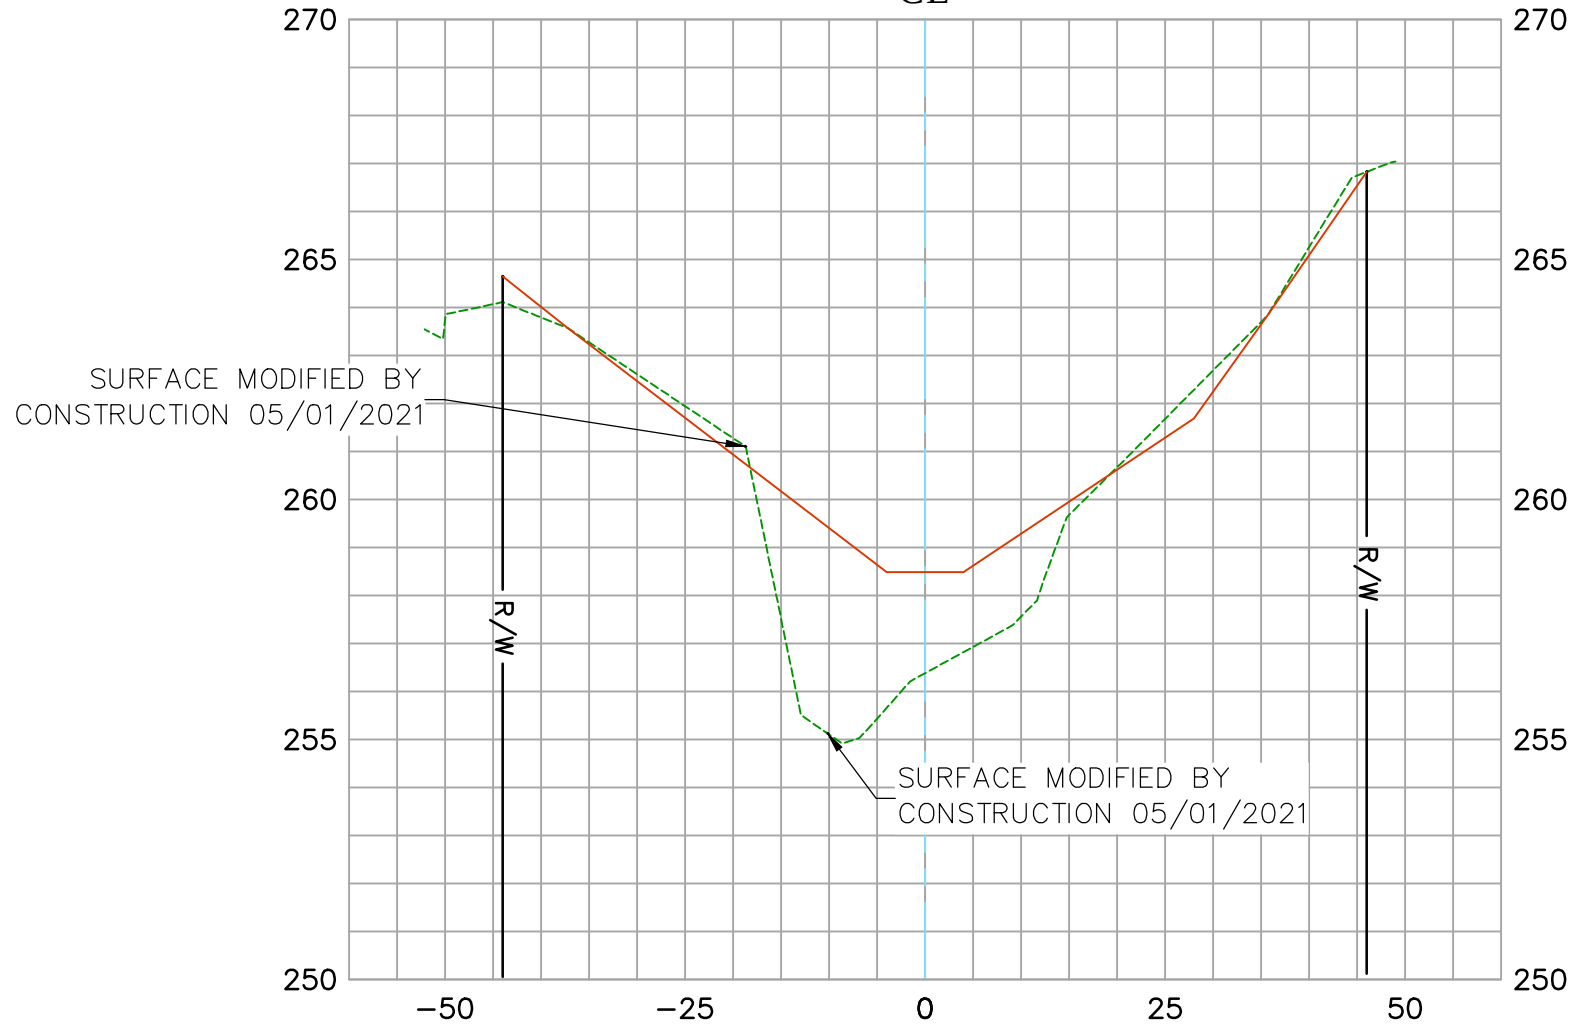
31+00.00

EXISTING CONDITION 03/18/2021  
RECORD DRAWINGS:  
F23-701-1, F23-701-2, & F23-701-3  
DATE PREPARED: 11/01/2021

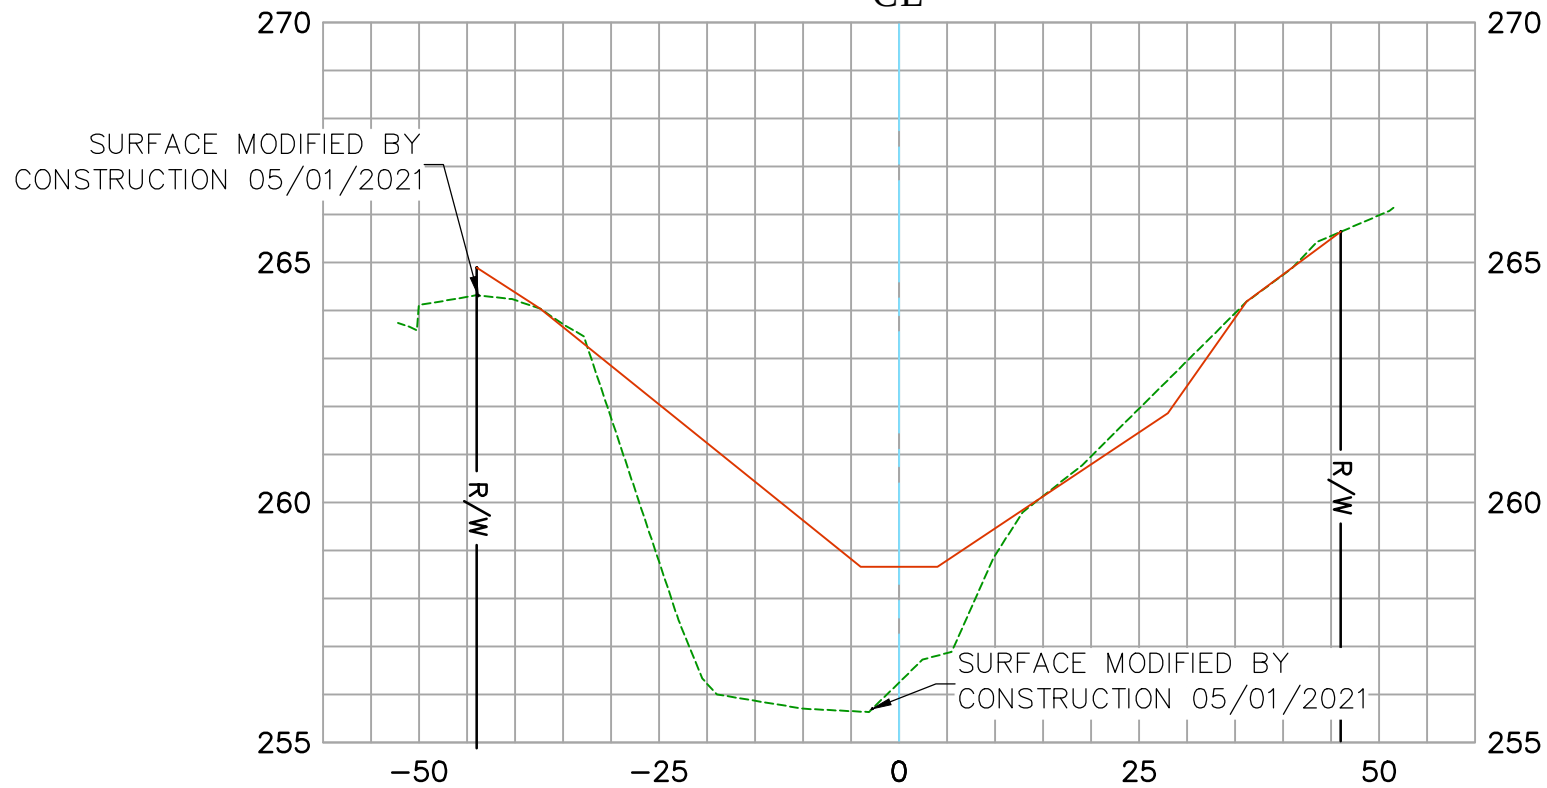
31+50.00

EXISTING CONDITION 03/18/2021  
RECORD DRAWINGS:  
F23-701-1, F23-701-2, & F23-701-3  
DATE PREPARED: 11/01/2021

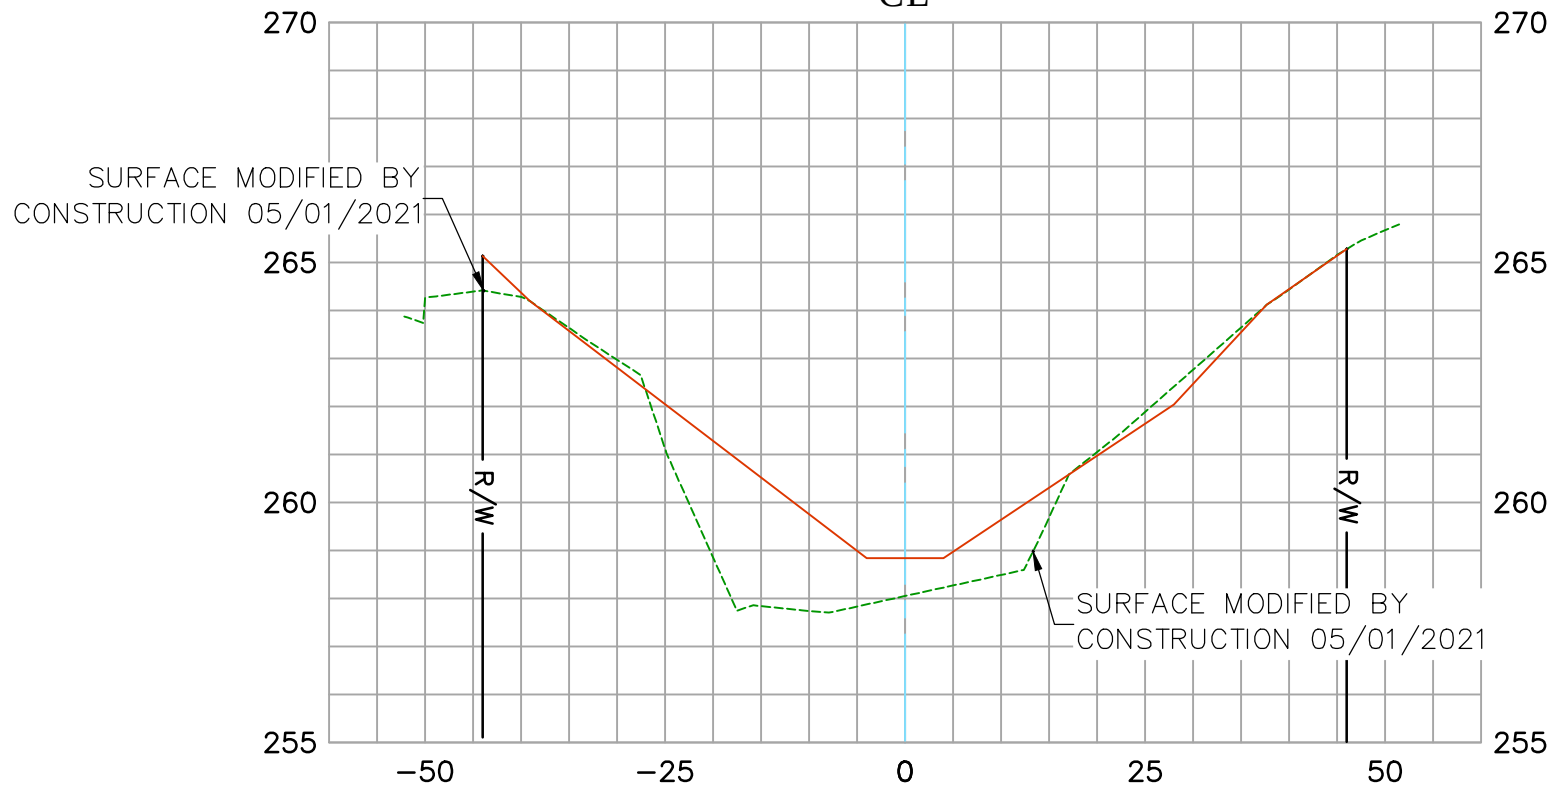
32+00.00

EXISTING CONDITION 03/18/2021  
RECORD DRAWINGS:  
F23-701-1, F23-701-2, & F23-701-3  
DATE PREPARED: 11/01/2021

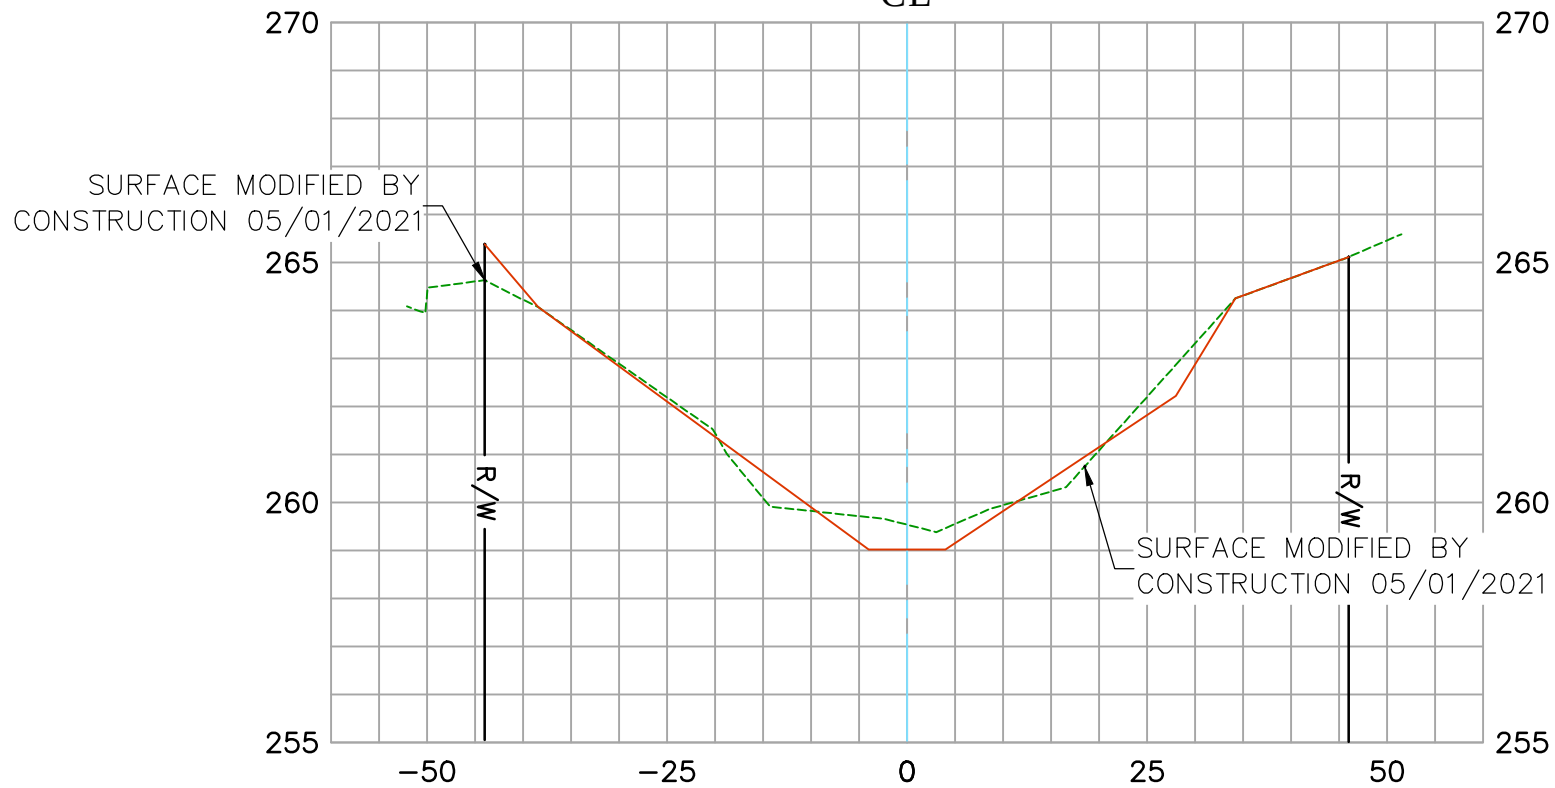
32+50.00

EXISTING CONDITION 03/18/2021  
RECORD DRAWINGS:  
F23-701-1, F23-701-2, & F23-701-3  
DATE PREPARED: 11/01/2021

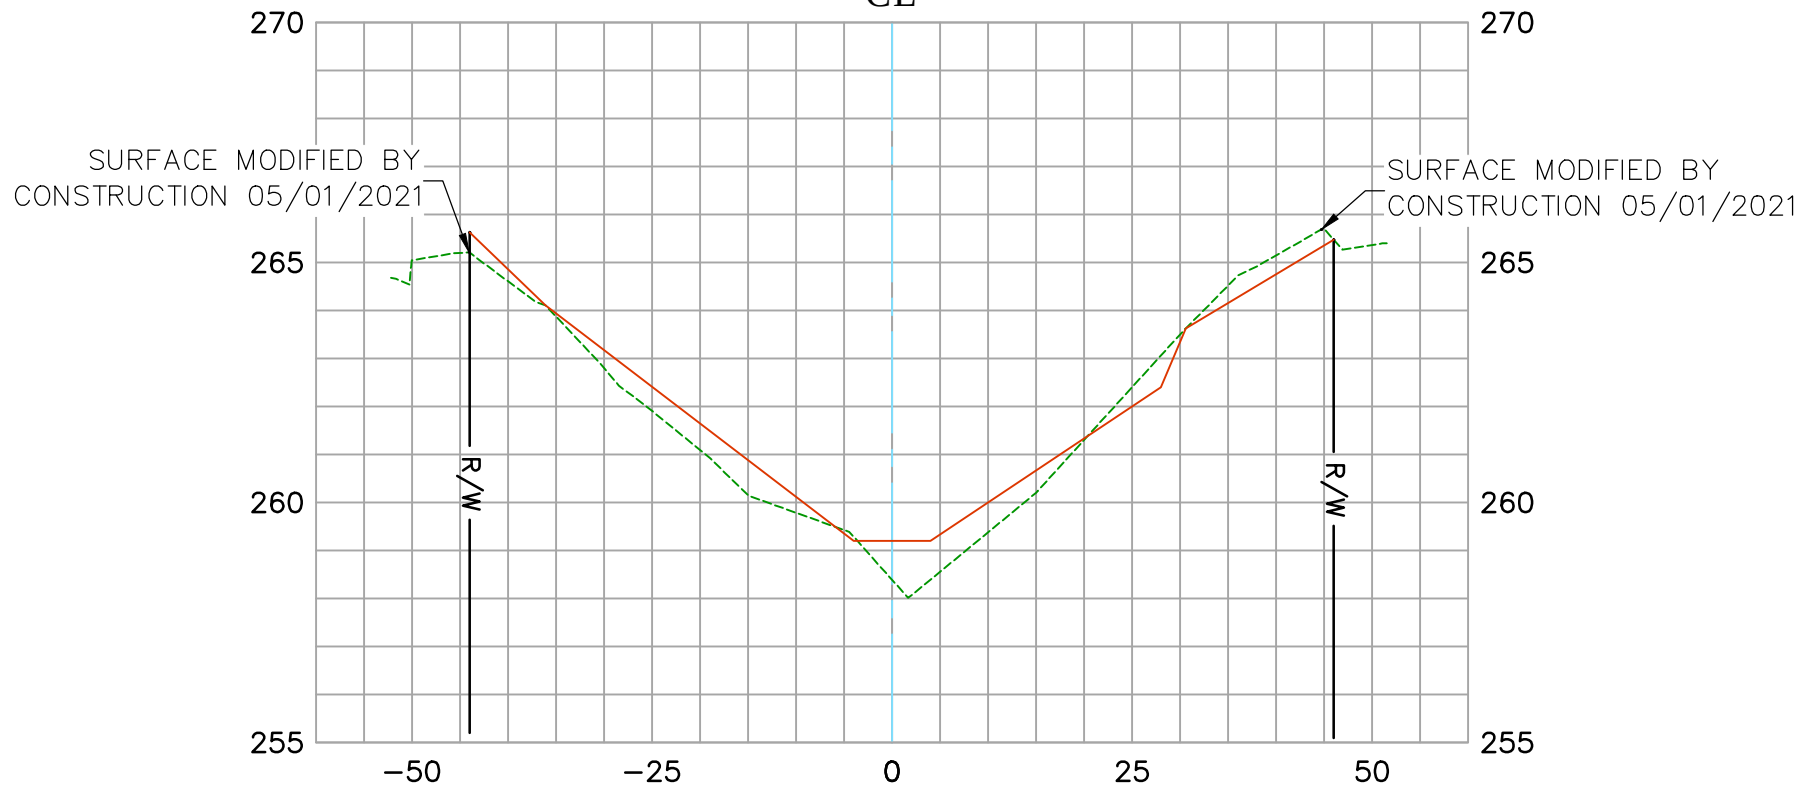
33+00.00

EXISTING CONDITION 03/18/2021  
RECORD DRAWINGS:  
F23-701-1, F23-701-2, & F23-701-3  
DATE PREPARED: 11/01/2021

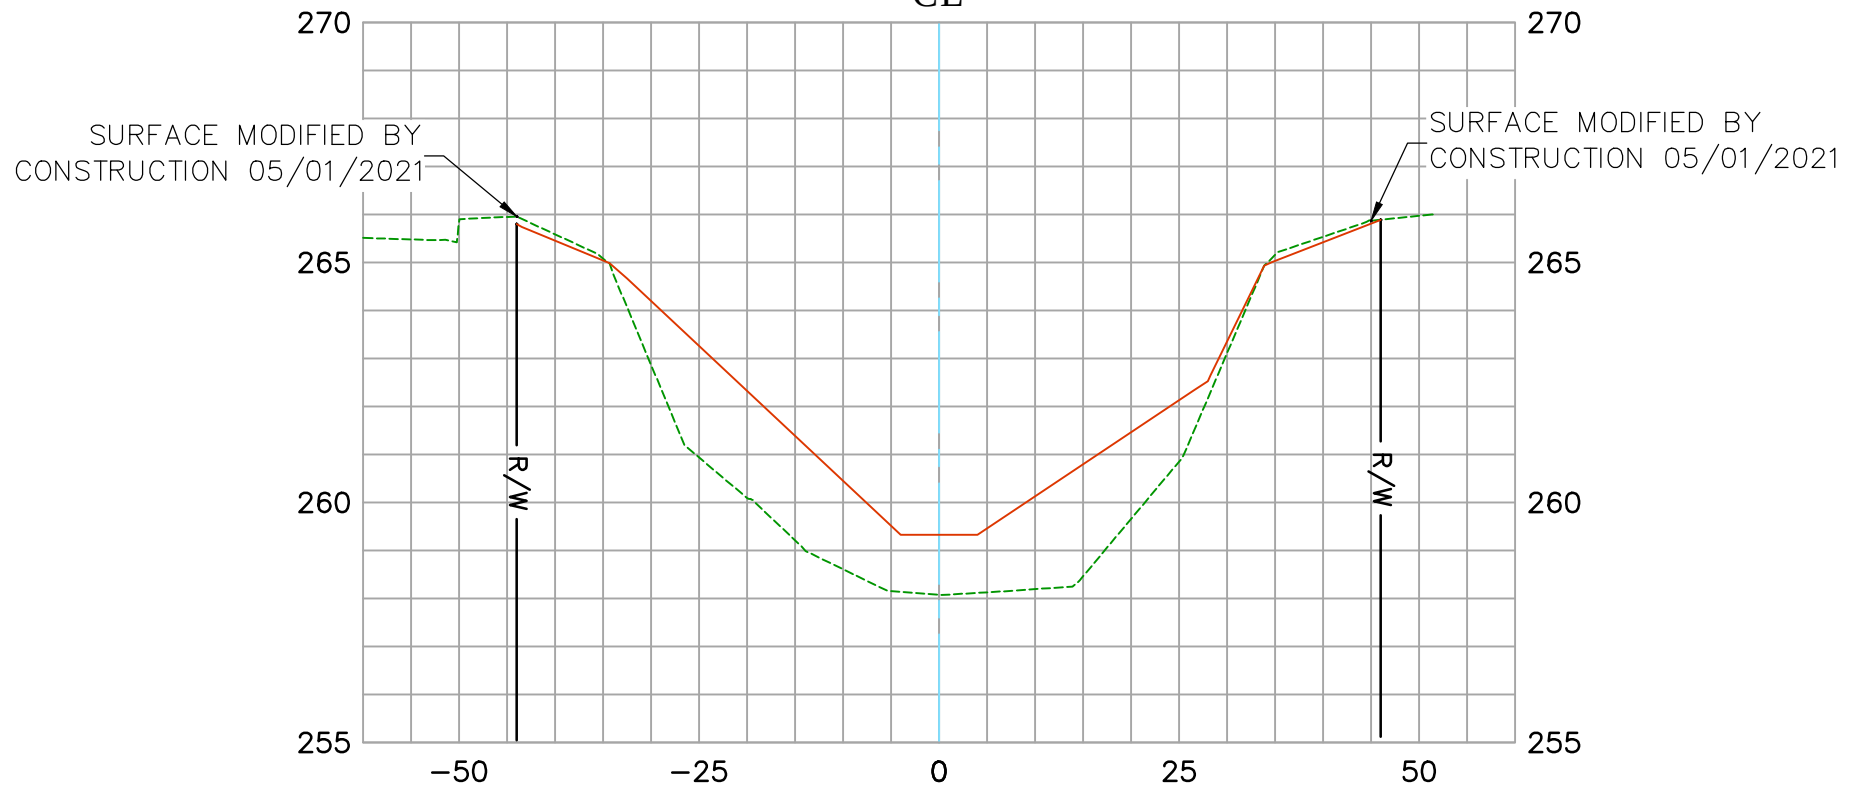
33+36.05

EXISTING CONDITION 03/18/2021  
RECORD DRAWINGS:  
F23-701-1, F23-701-2, & F23-701-3  
DATE PREPARED: 11/01/2021

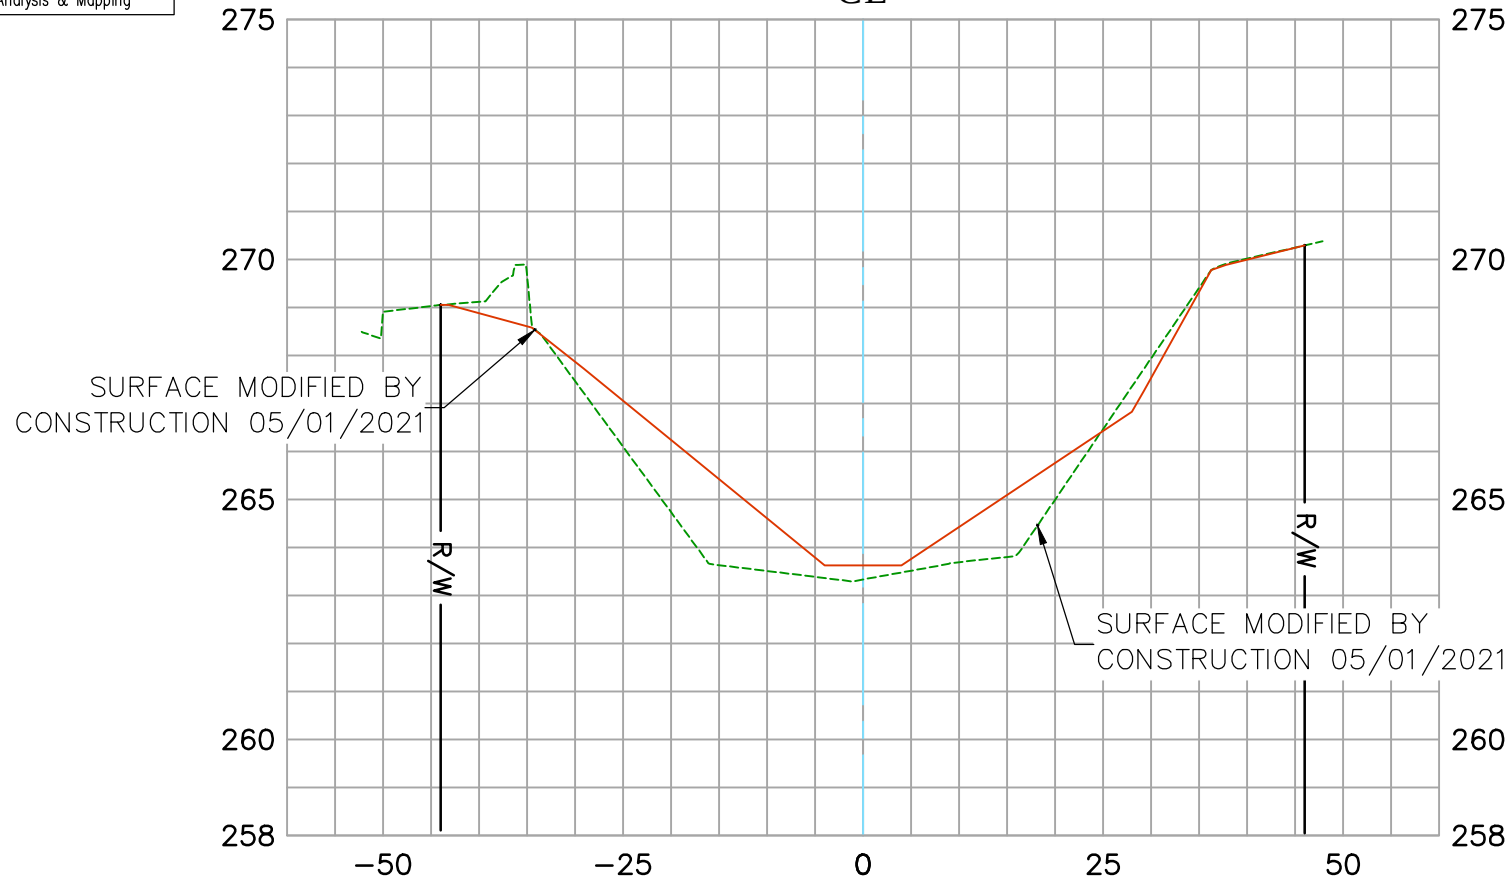
35+05.87

EXISTING CONDITION 03/18/2021  
RECORD DRAWINGS:  
F23-701-1, F23-701-2, & F23-701-3  
DATE PREPARED: 11/01/2021
