# OC PUBLIC WORKS DEPARTMENT

## CANADA CHANNEL

REHABILITATION

## PROJECT CROSS SECTIONS

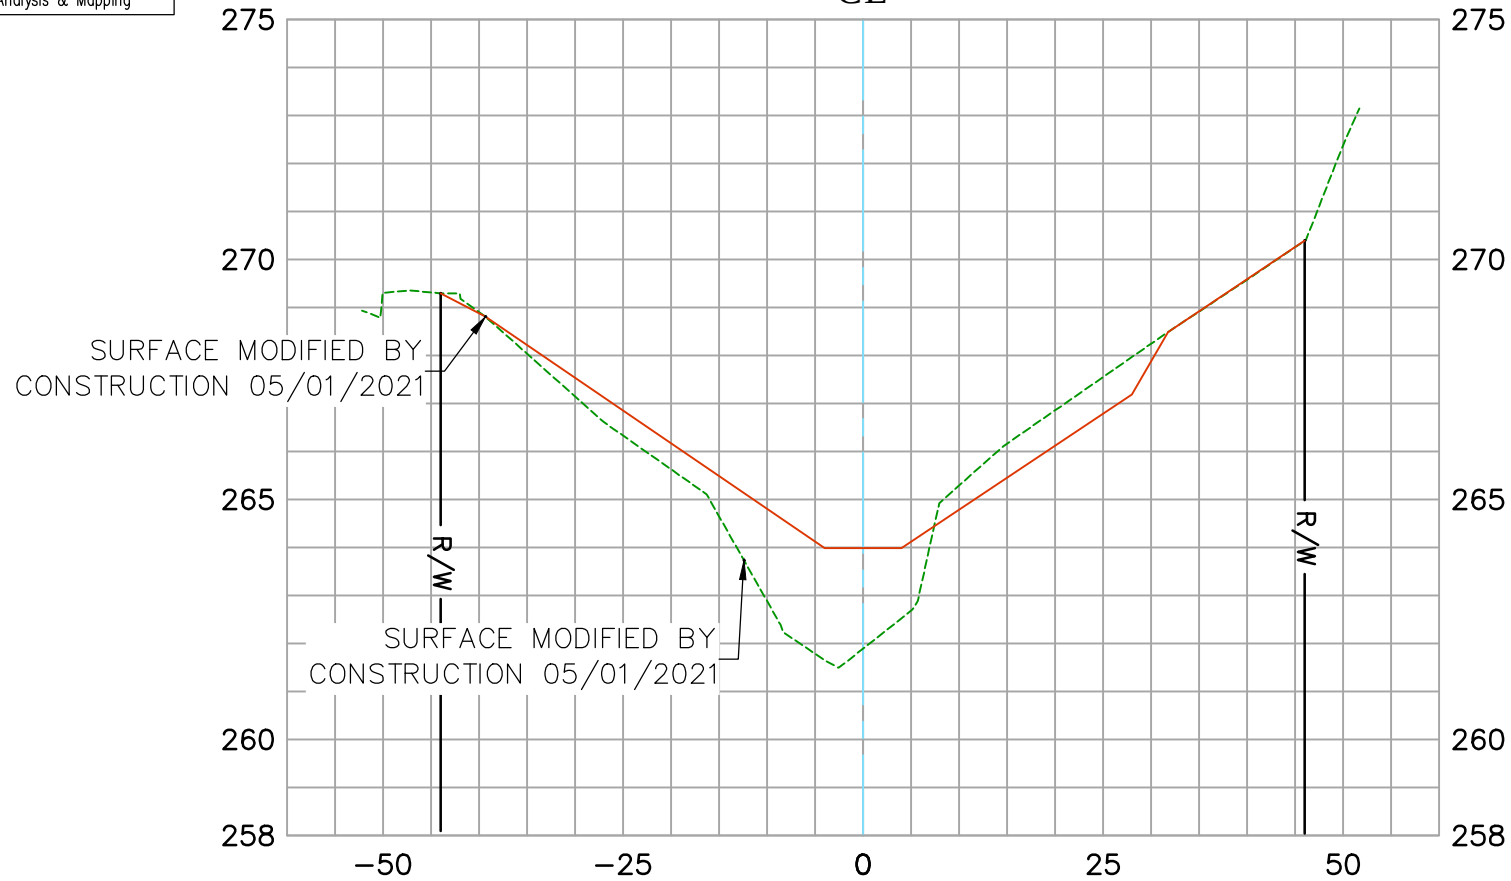
35+50.00

EXISTING CONDITION 03/18/2021  
RECORD DRAWINGS:  
F23-701-1, F23-701-2, & F23-701-3  
DATE PREPARED: 11/01/2021

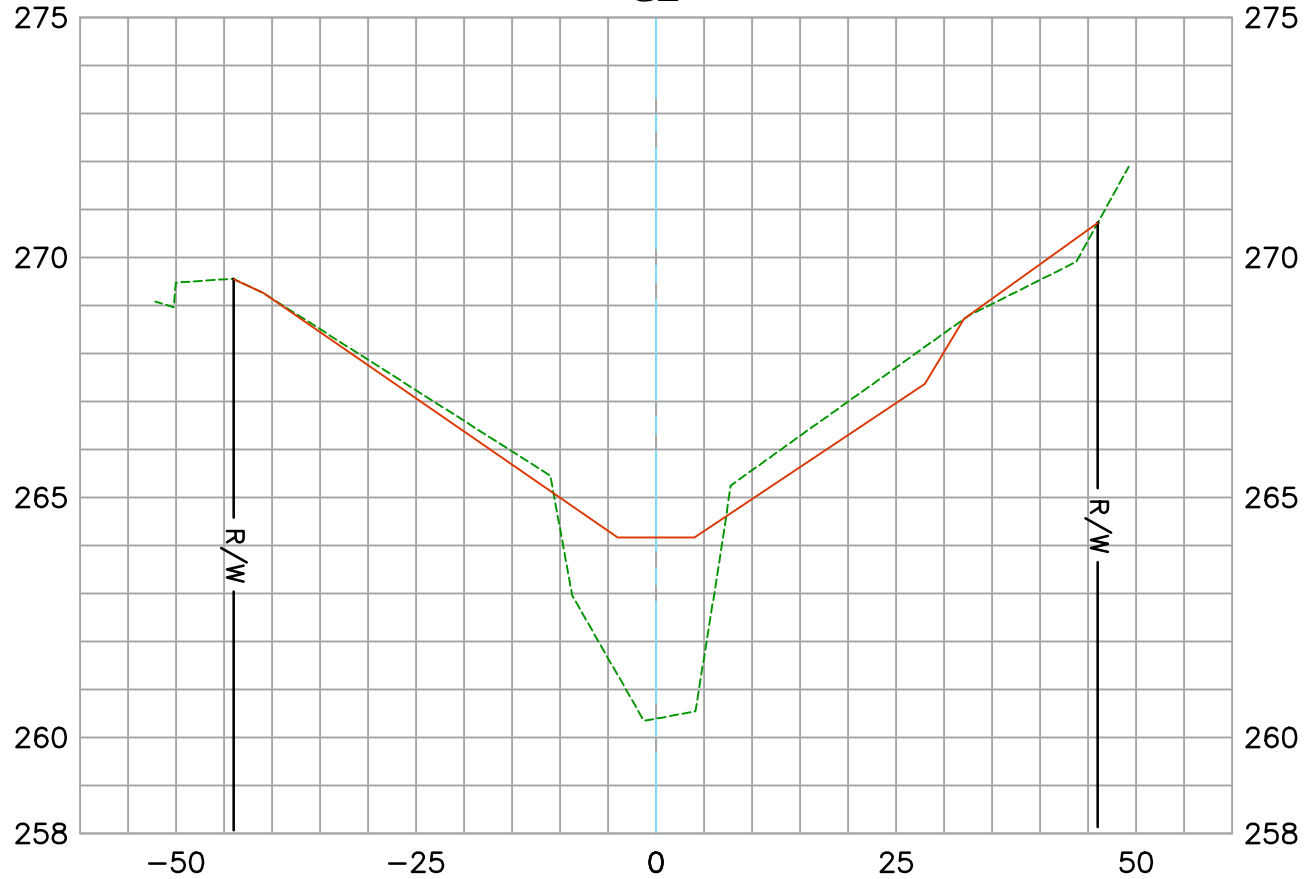
36+00.00

EXISTING CONDITION 03/18/2021  
RECORD DRAWINGS:  
F23-701-1, F23-701-2, & F23-701-3  
DATE PREPARED: 11/01/2021

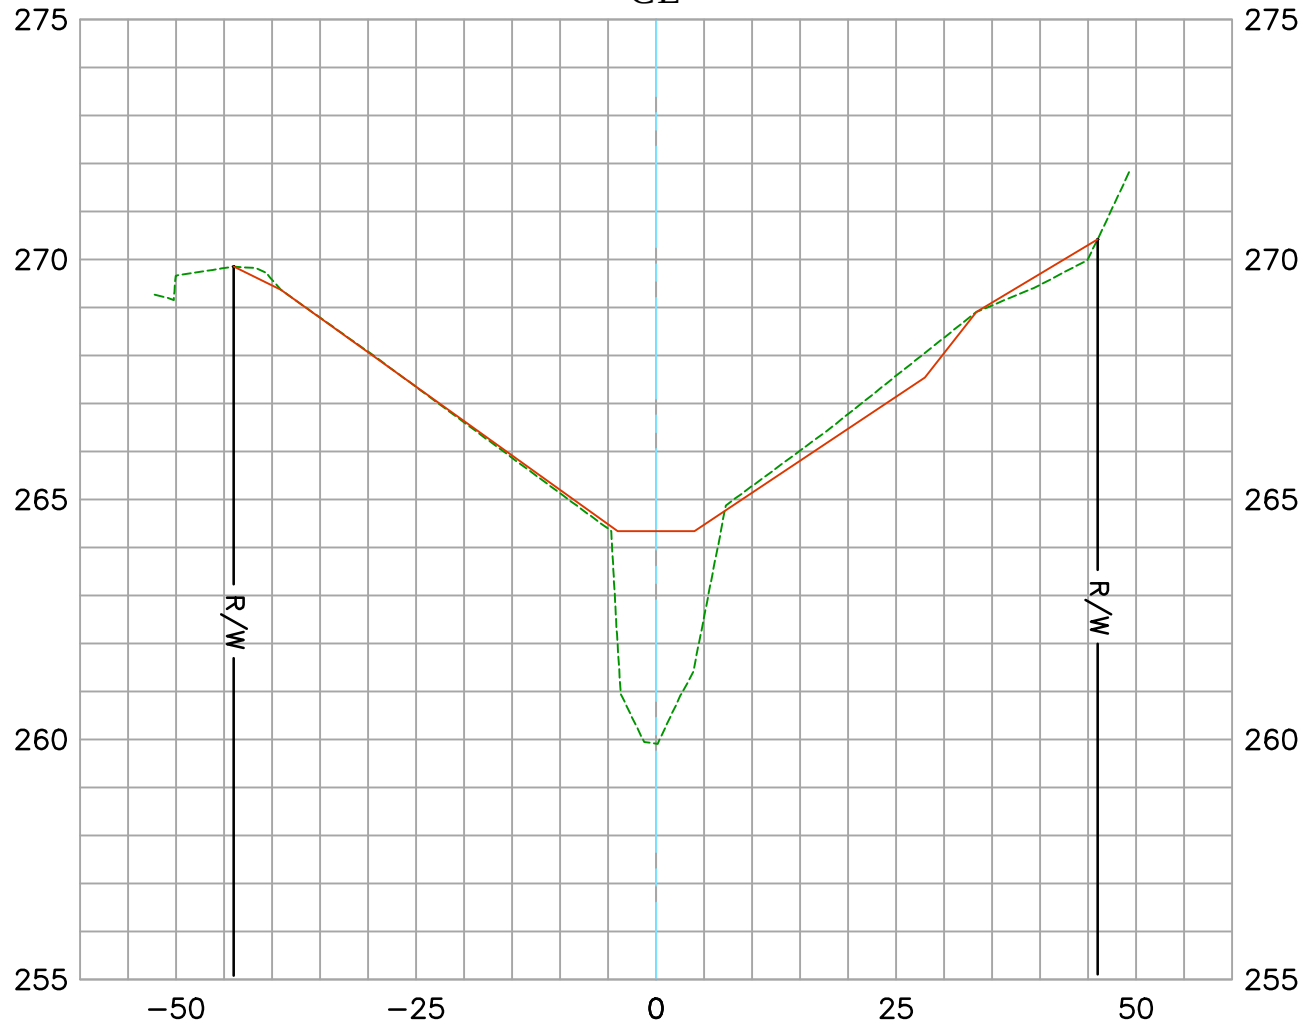
36+50.00

EXISTING CONDITION 03/18/2021  
RECORD DRAWINGS:  
F23-701-1, F23-701-2, & F23-701-3  
DATE PREPARED: 11/01/2021

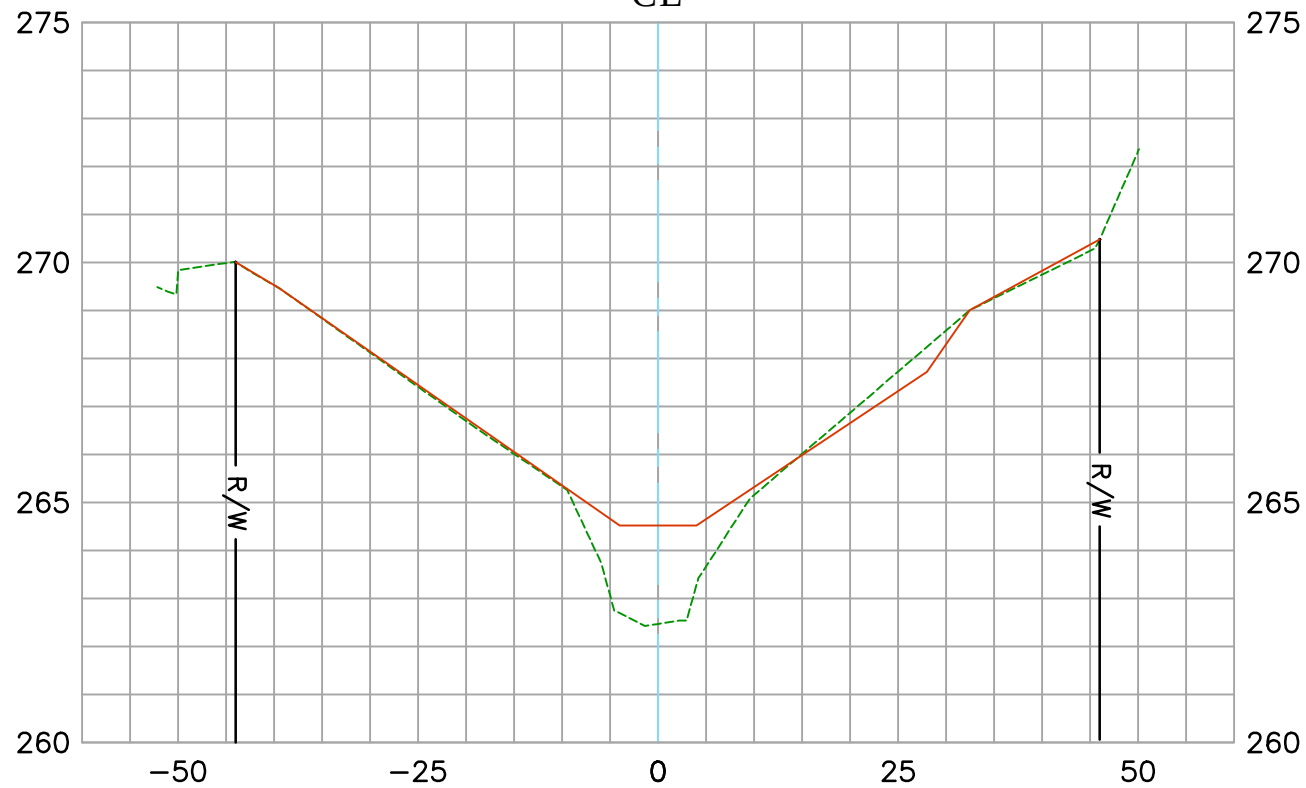
37+00.00

EXISTING CONDITION 03/18/2021  
RECORD DRAWINGS:  
F23-701-1, F23-701-2, & F23-701-3  
DATE PREPARED: 11/01/2021

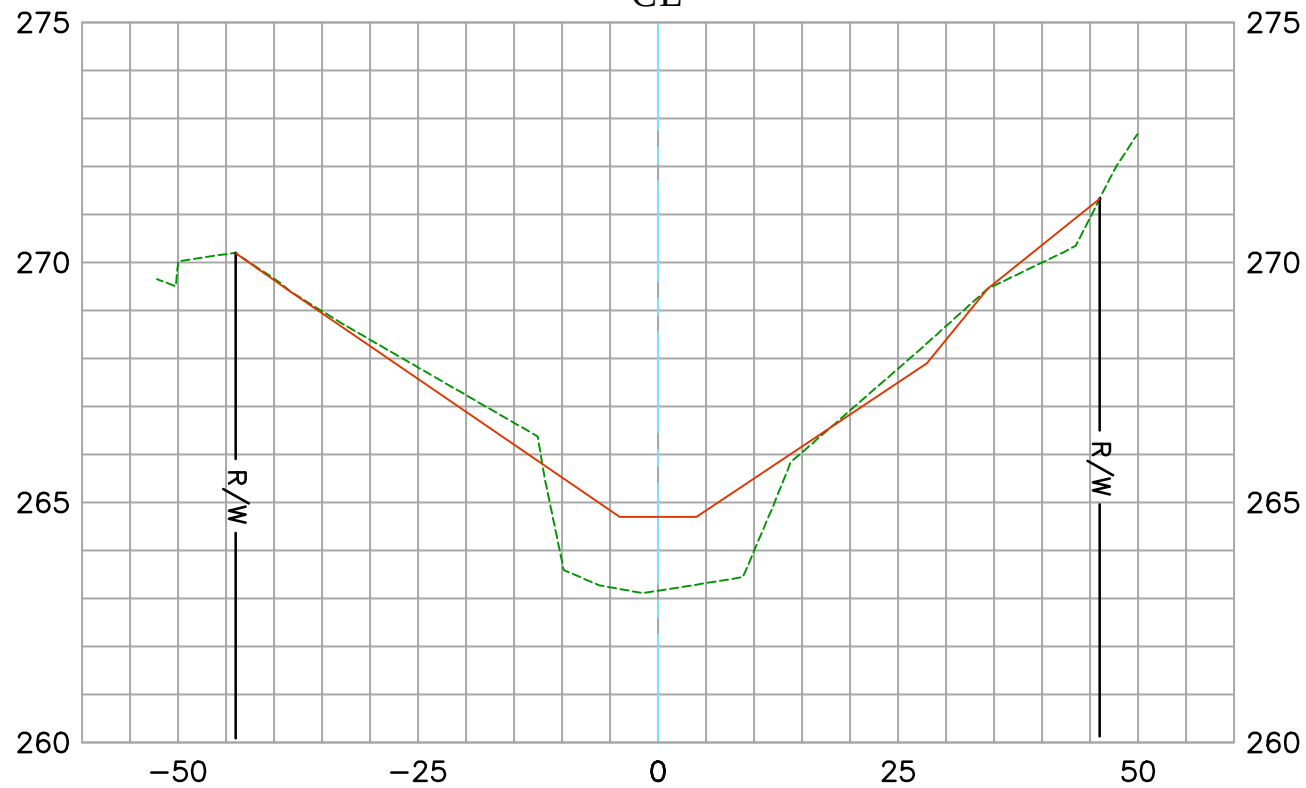
37+50.00

EXISTING CONDITION 03/18/2021  
RECORD DRAWINGS:  
F23-701-1, F23-701-2, & F23-701-3  
DATE PREPARED: 11/01/2021

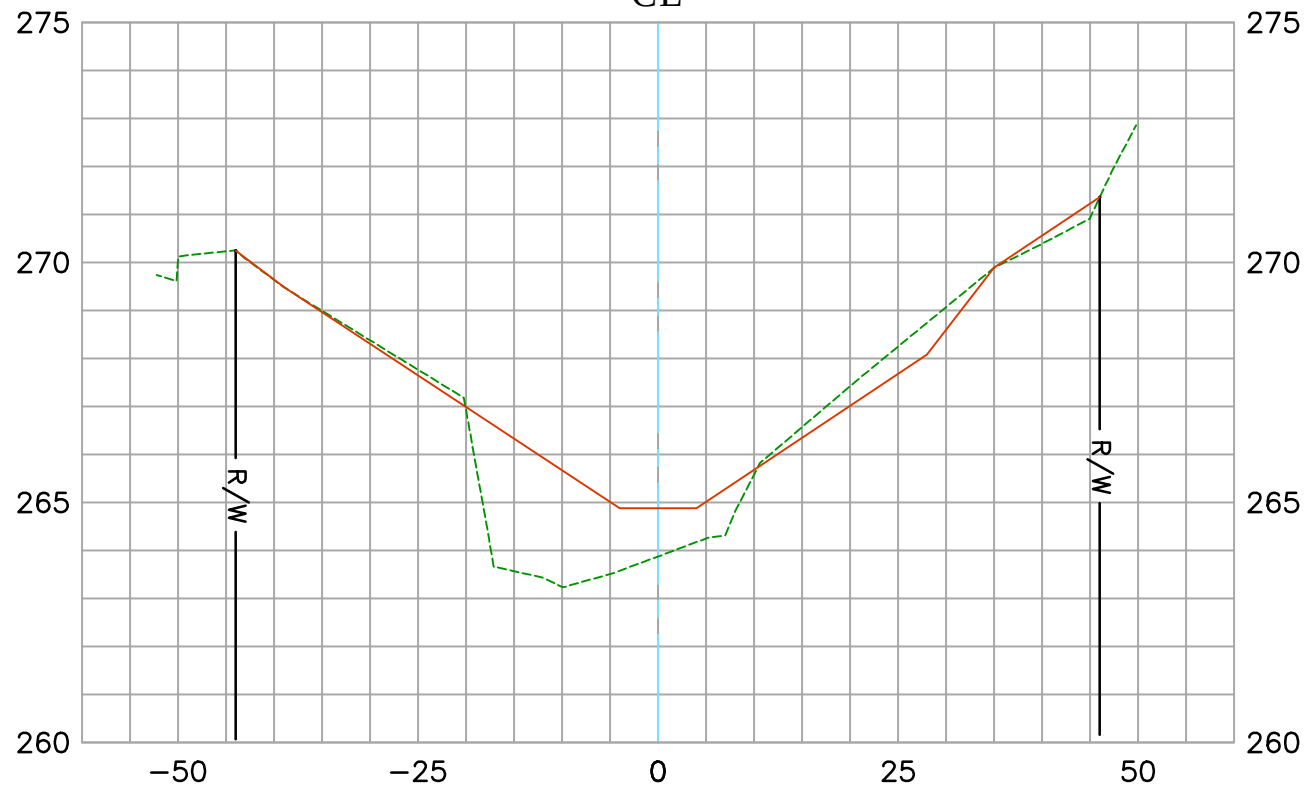
38+00.00

EXISTING CONDITION 03/18/2021  
RECORD DRAWINGS:  
F23-701-1, F23-701-2, & F23-701-3  
DATE PREPARED: 11/01/2021

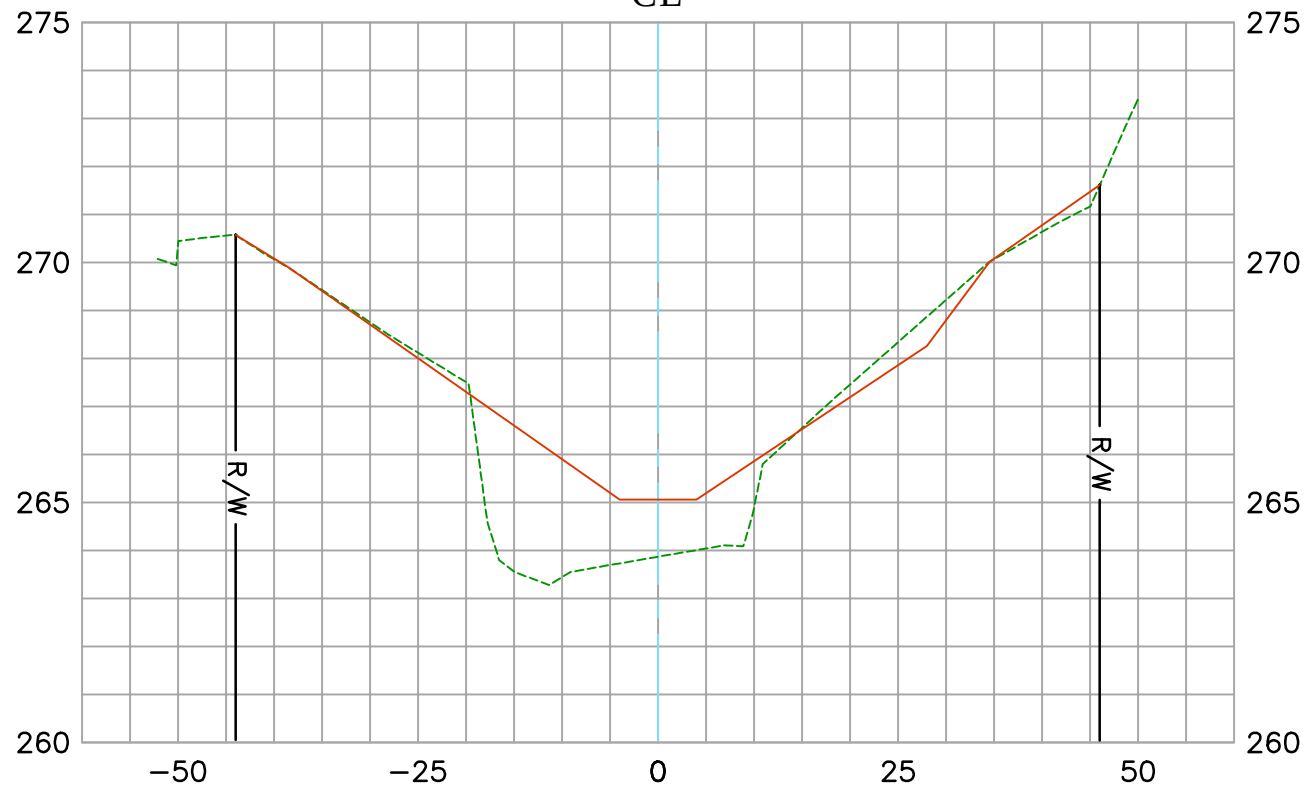
38+50.00

EXISTING CONDITION 03/18/2021  
RECORD DRAWINGS:  
F23-701-1, F23-701-2, & F23-701-3  
DATE PREPARED: 11/01/2021

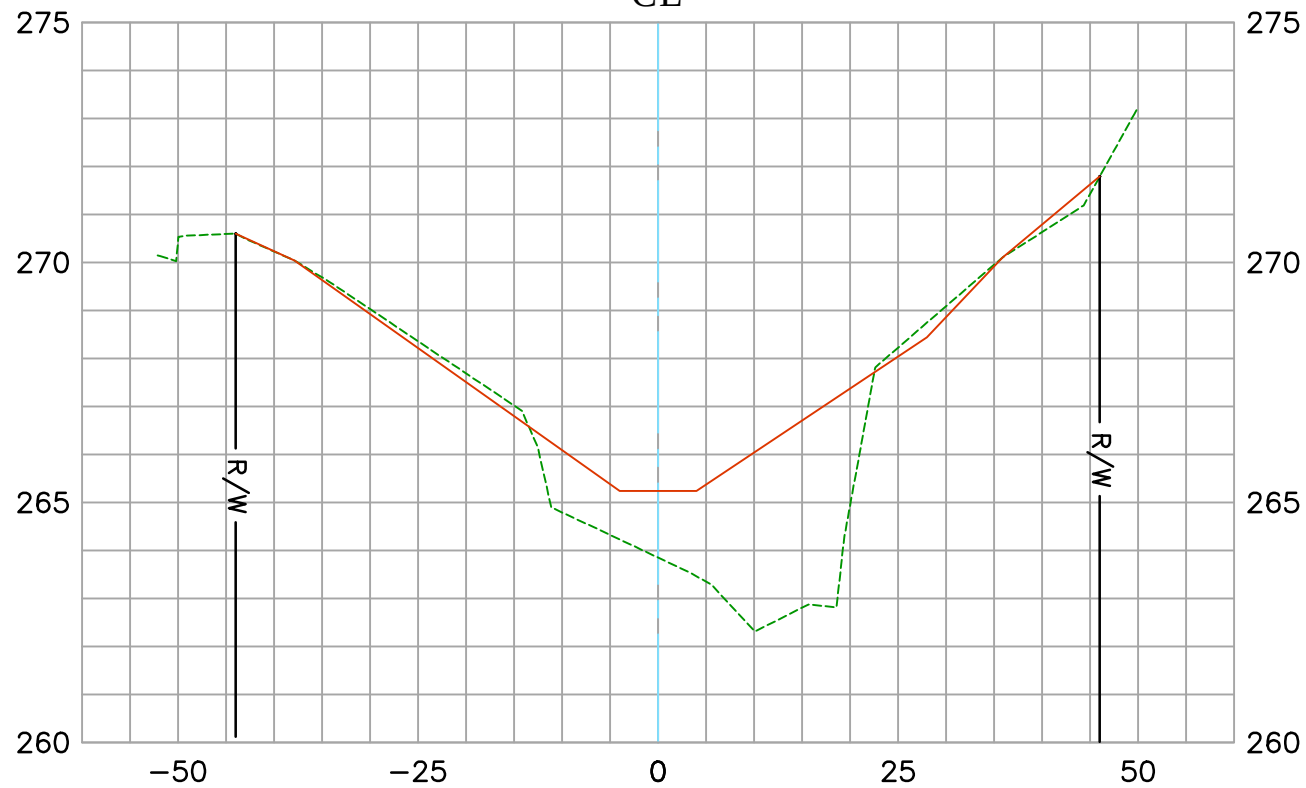
39+00.00

EXISTING CONDITION 03/18/2021  
RECORD DRAWINGS:  
F23-701-1, F23-701-2, & F23-701-3  
DATE PREPARED: 11/01/2021

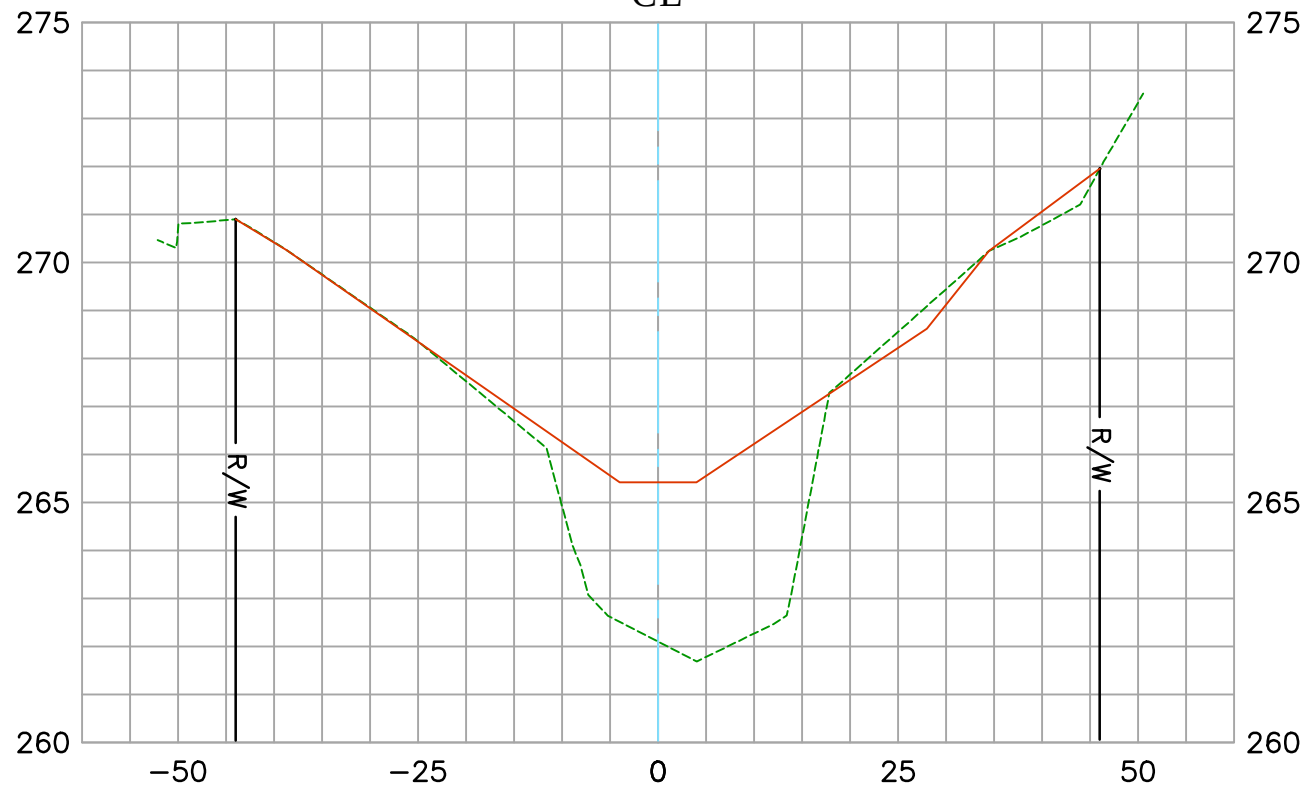
39+50.00

EXISTING CONDITION 03/18/2021  
RECORD DRAWINGS:  
F23-701-1, F23-701-2, & F23-701-3  
DATE PREPARED: 11/01/2021

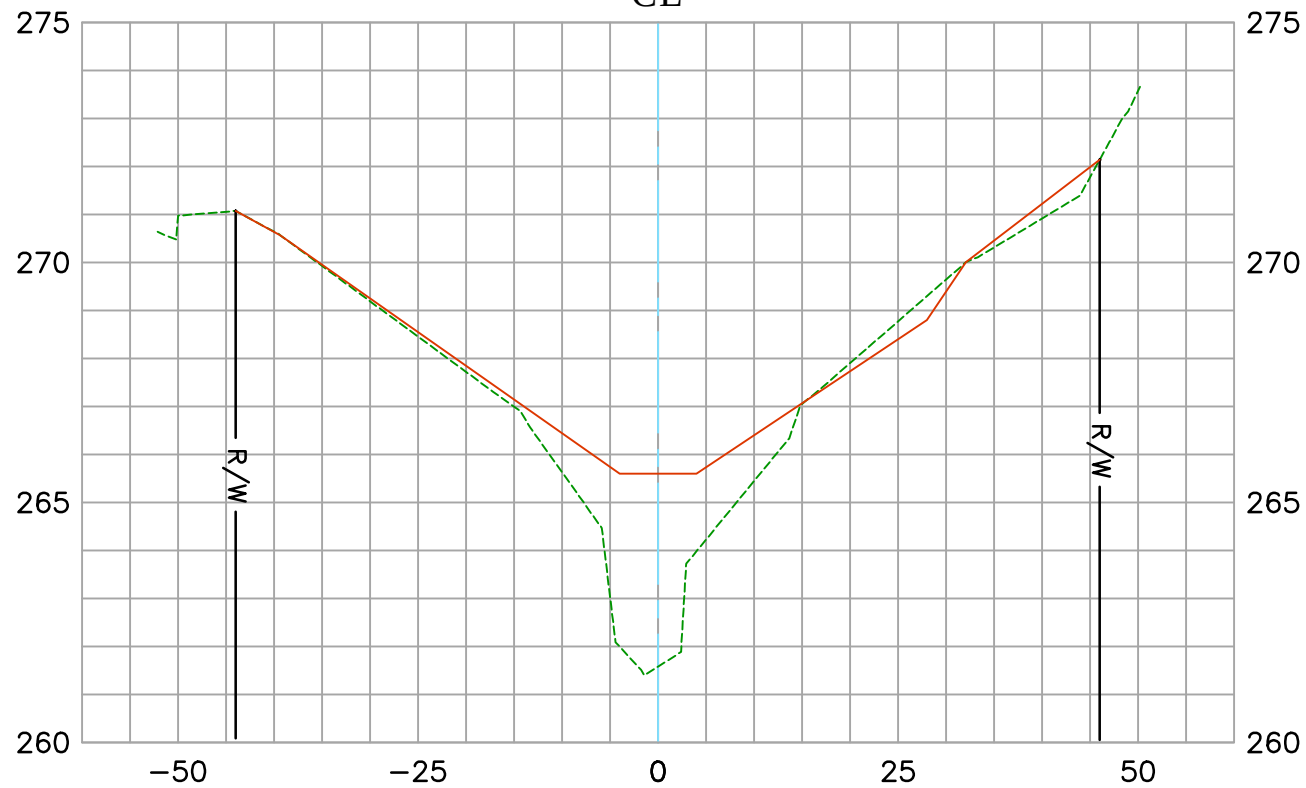
40+00.00

EXISTING CONDITION 03/18/2021  
RECORD DRAWINGS:  
F23-701-1, F23-701-2, & F23-701-3  
DATE PREPARED: 11/01/2021

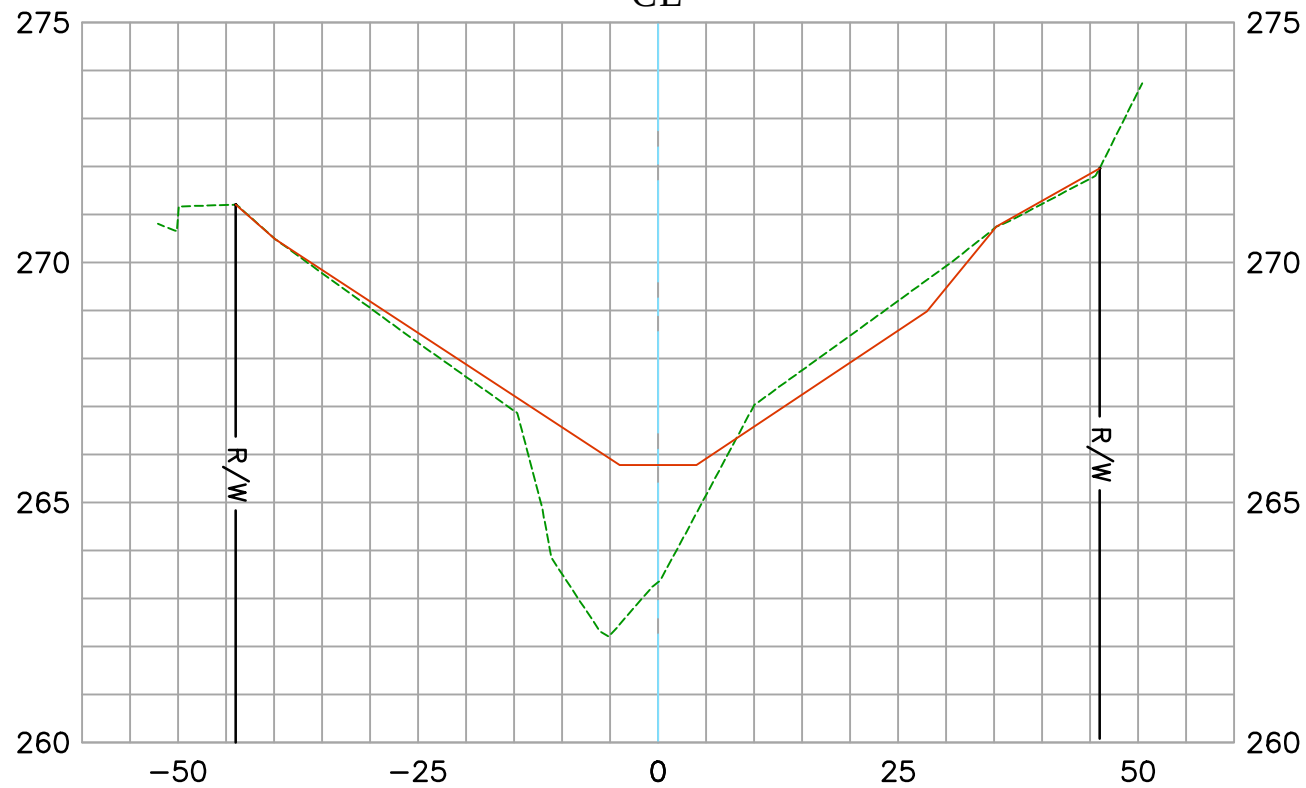
40+50.00

EXISTING CONDITION 03/18/2021  
RECORD DRAWINGS:  
F23-701-1, F23-701-2, & F23-701-3  
DATE PREPARED: 11/01/2021

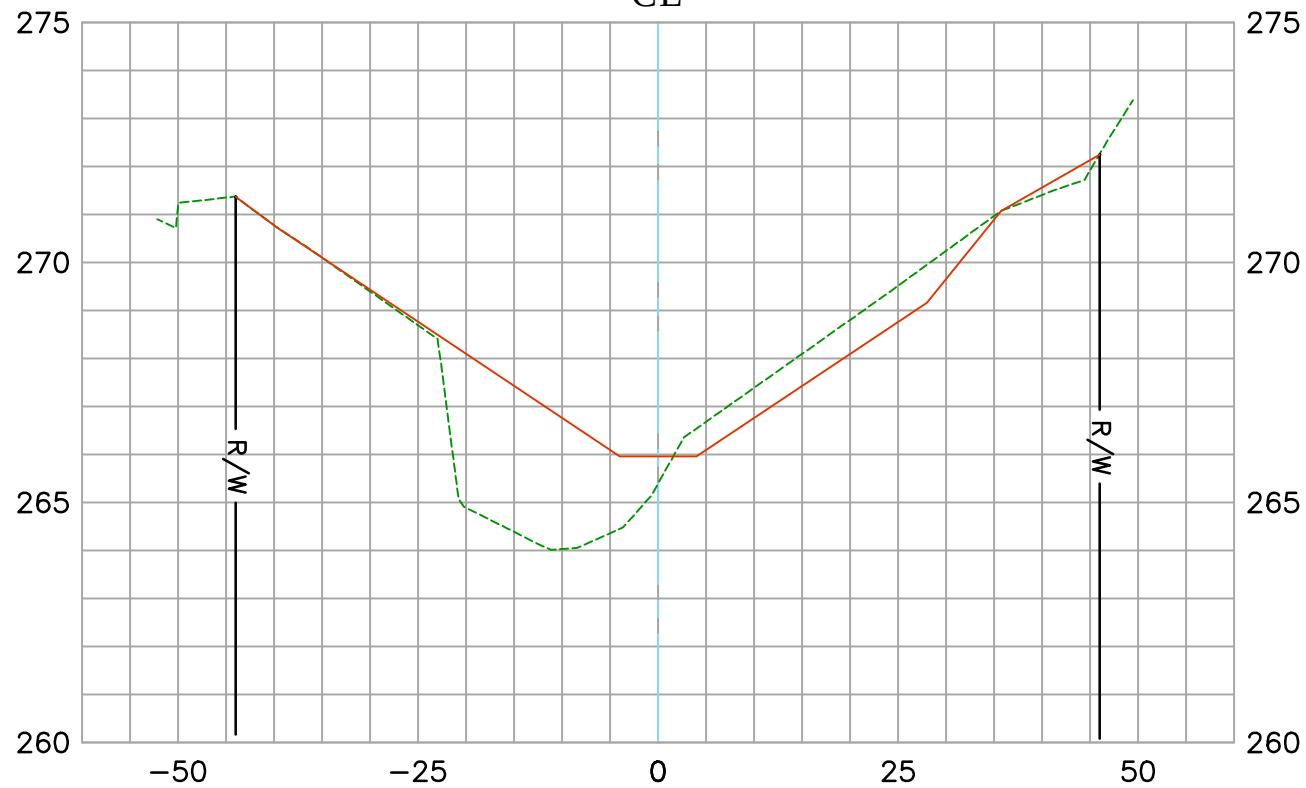
41+00.00

EXISTING CONDITION 03/18/2021  
RECORD DRAWINGS:  
F23-701-1, F23-701-2, & F23-701-3  
DATE PREPARED: 11/01/2021

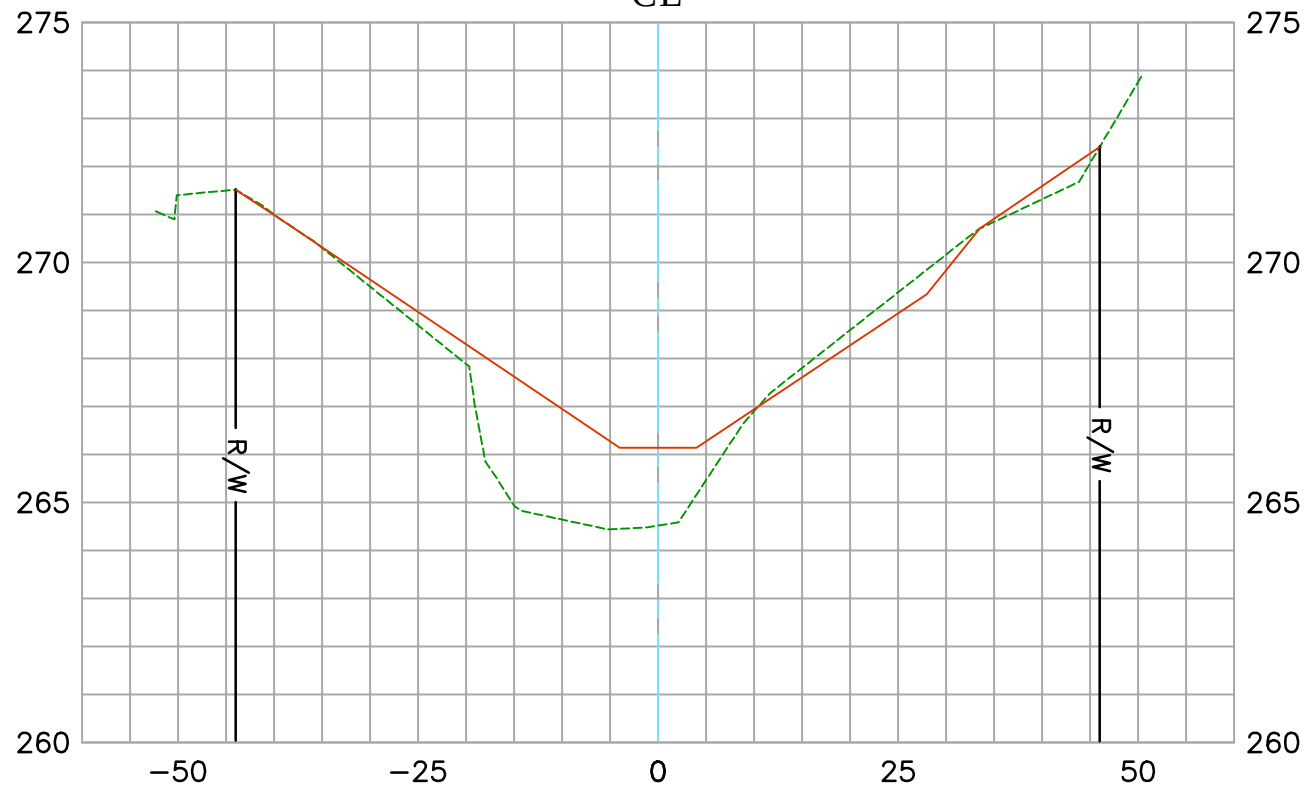
41+50.00

EXISTING CONDITION 03/18/2021  
RECORD DRAWINGS:  
F23-701-1, F23-701-2, & F23-701-3  
DATE PREPARED: 11/01/2021

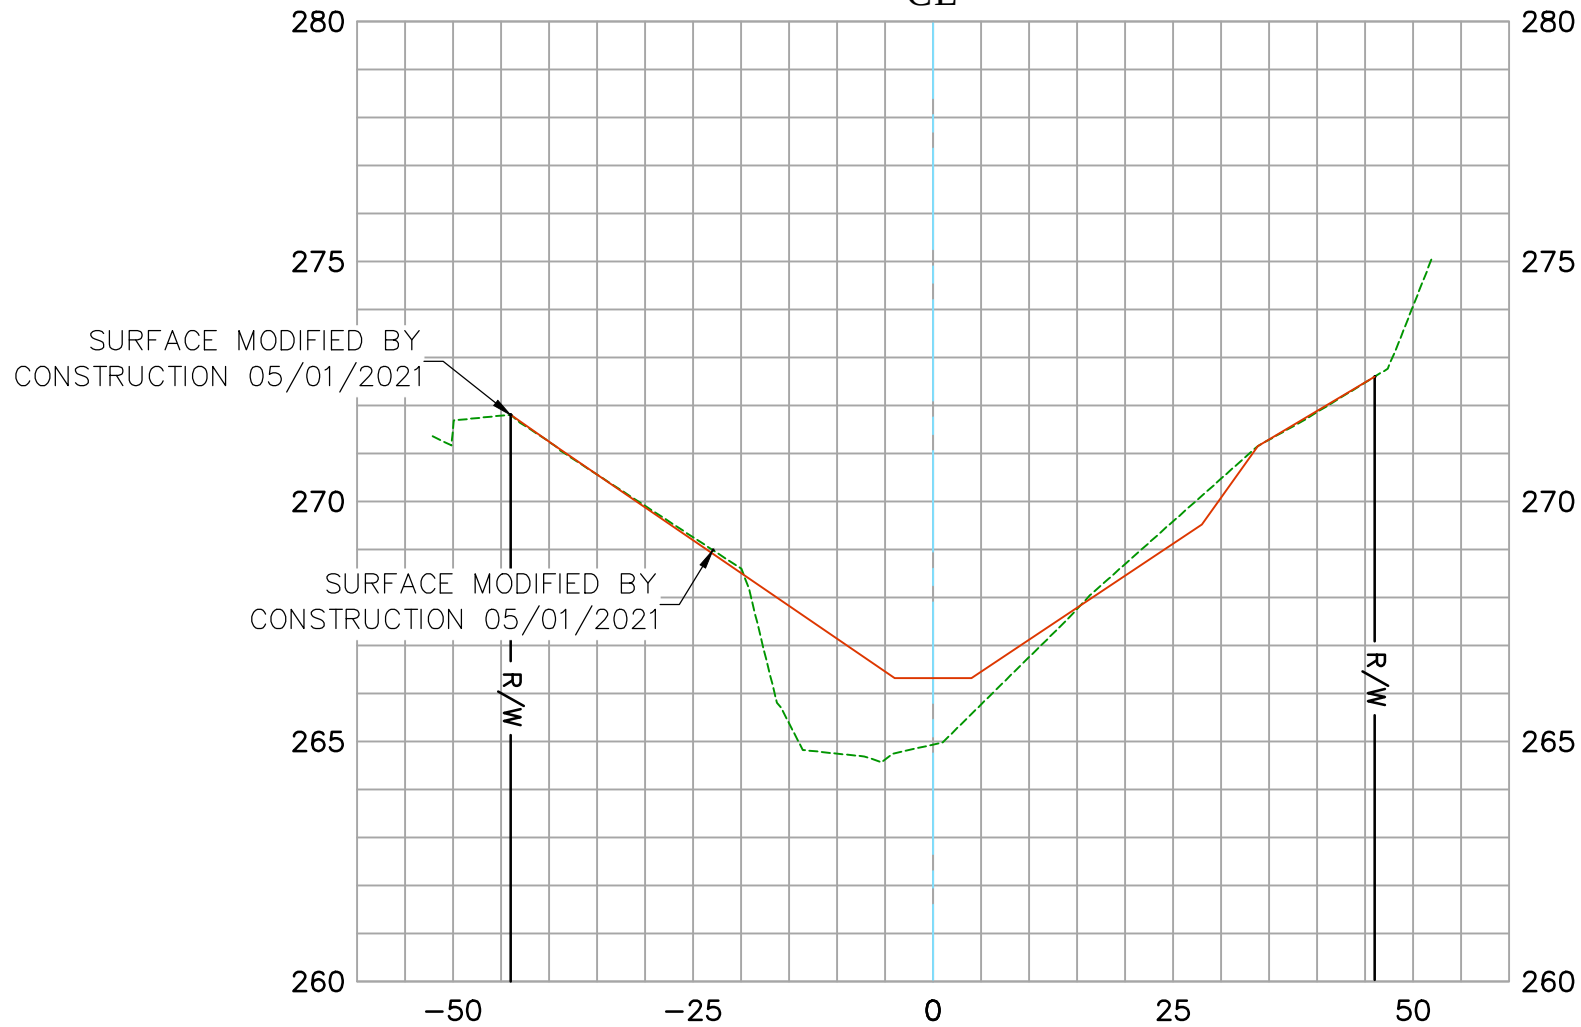
42+00.00

EXISTING CONDITION 03/18/2021  
RECORD DRAWINGS:  
F23-701-1, F23-701-2, & F23-701-3  
DATE PREPARED: 11/01/2021

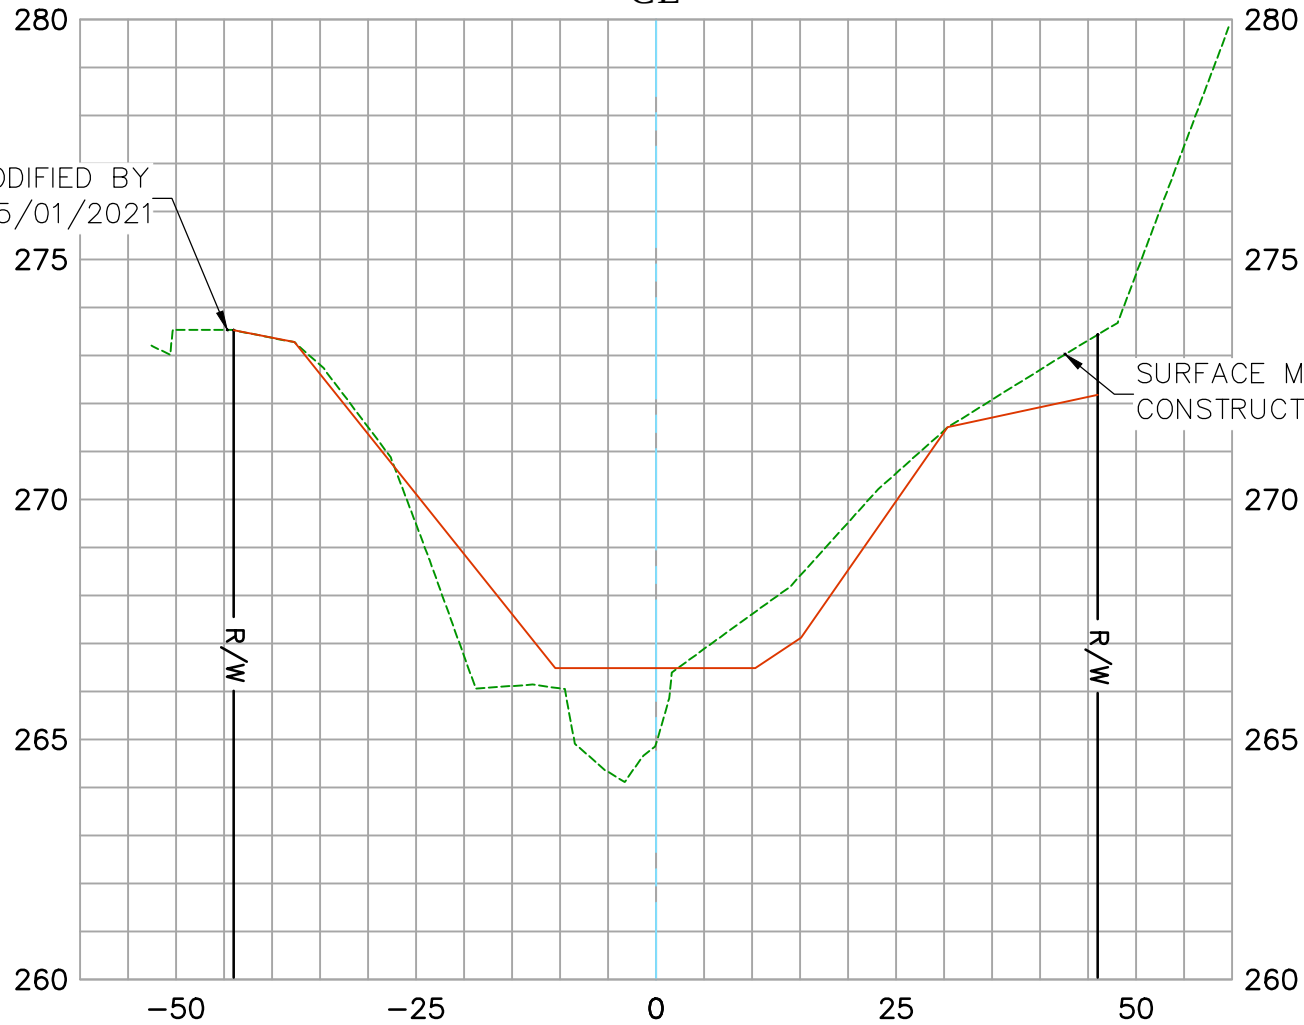
42+50.00

SURFACE MODIFIED BY  
CONSTRUCTION 05/01/2021

EXISTING CONDITION 03/18/2021  
RECORD DRAWINGS:  
F23-701-1, F23-701-2, & F23-701-3  
DATE PREPARED: 11/01/2021

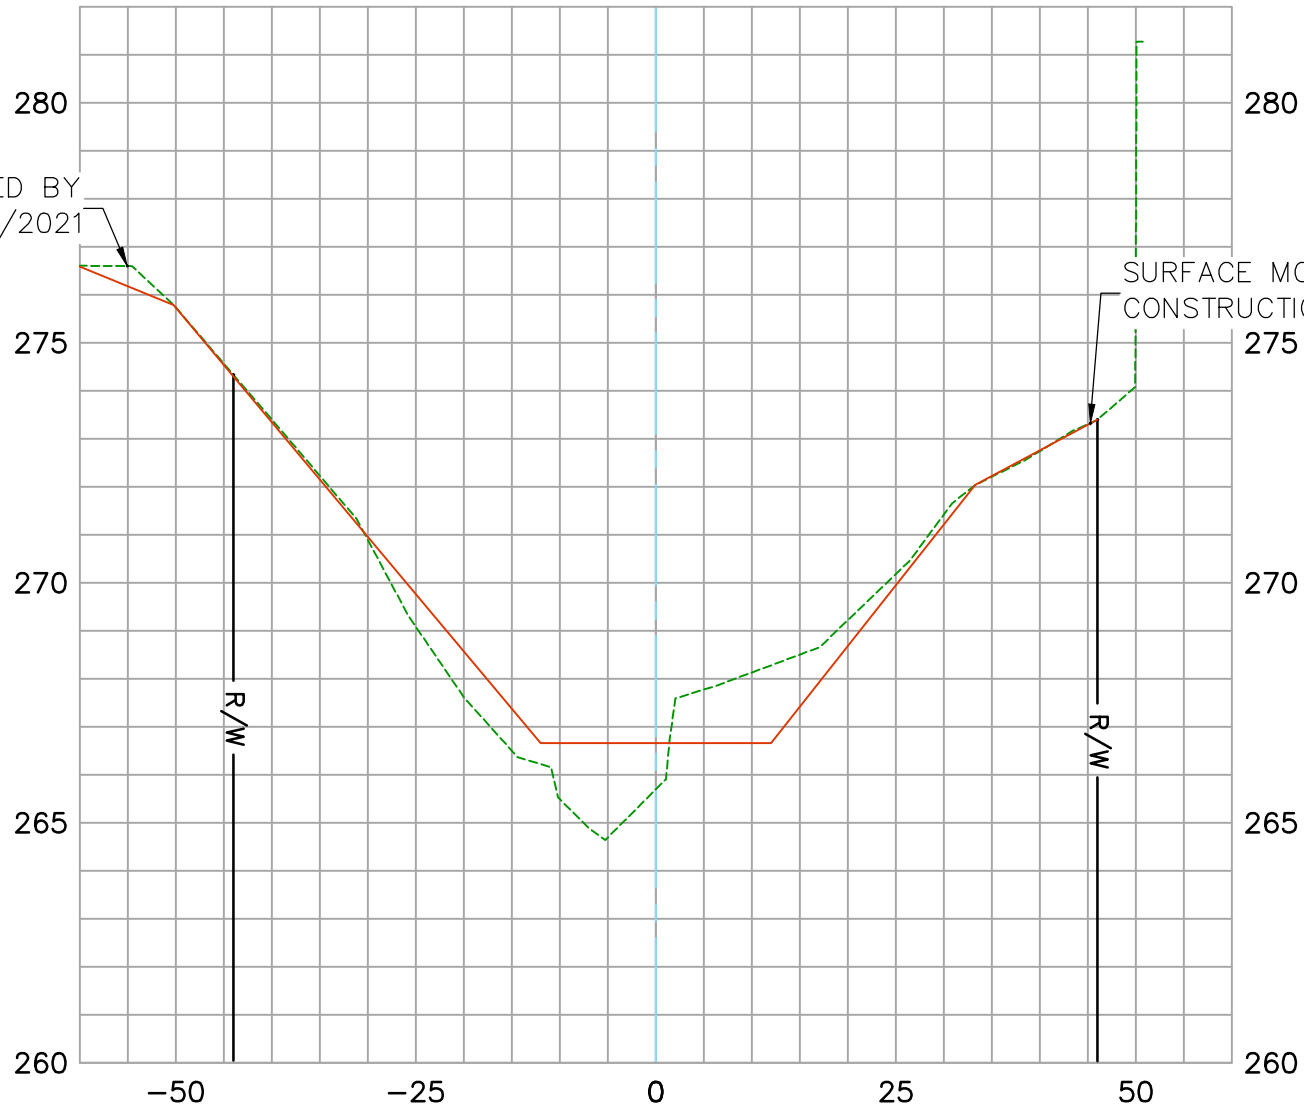
CAÑADA CHANNEL (F23)  
43+00.00  
CL

SURFACE MODIFIED BY  
CONSTRUCTION 05/01/2021

EXISTING CONDITION 03/18/2021  
RECORD DRAWINGS:  
F23-701-1, F23-701-2, & F23-701-3  
DATE PREPARED: 11/01/2021

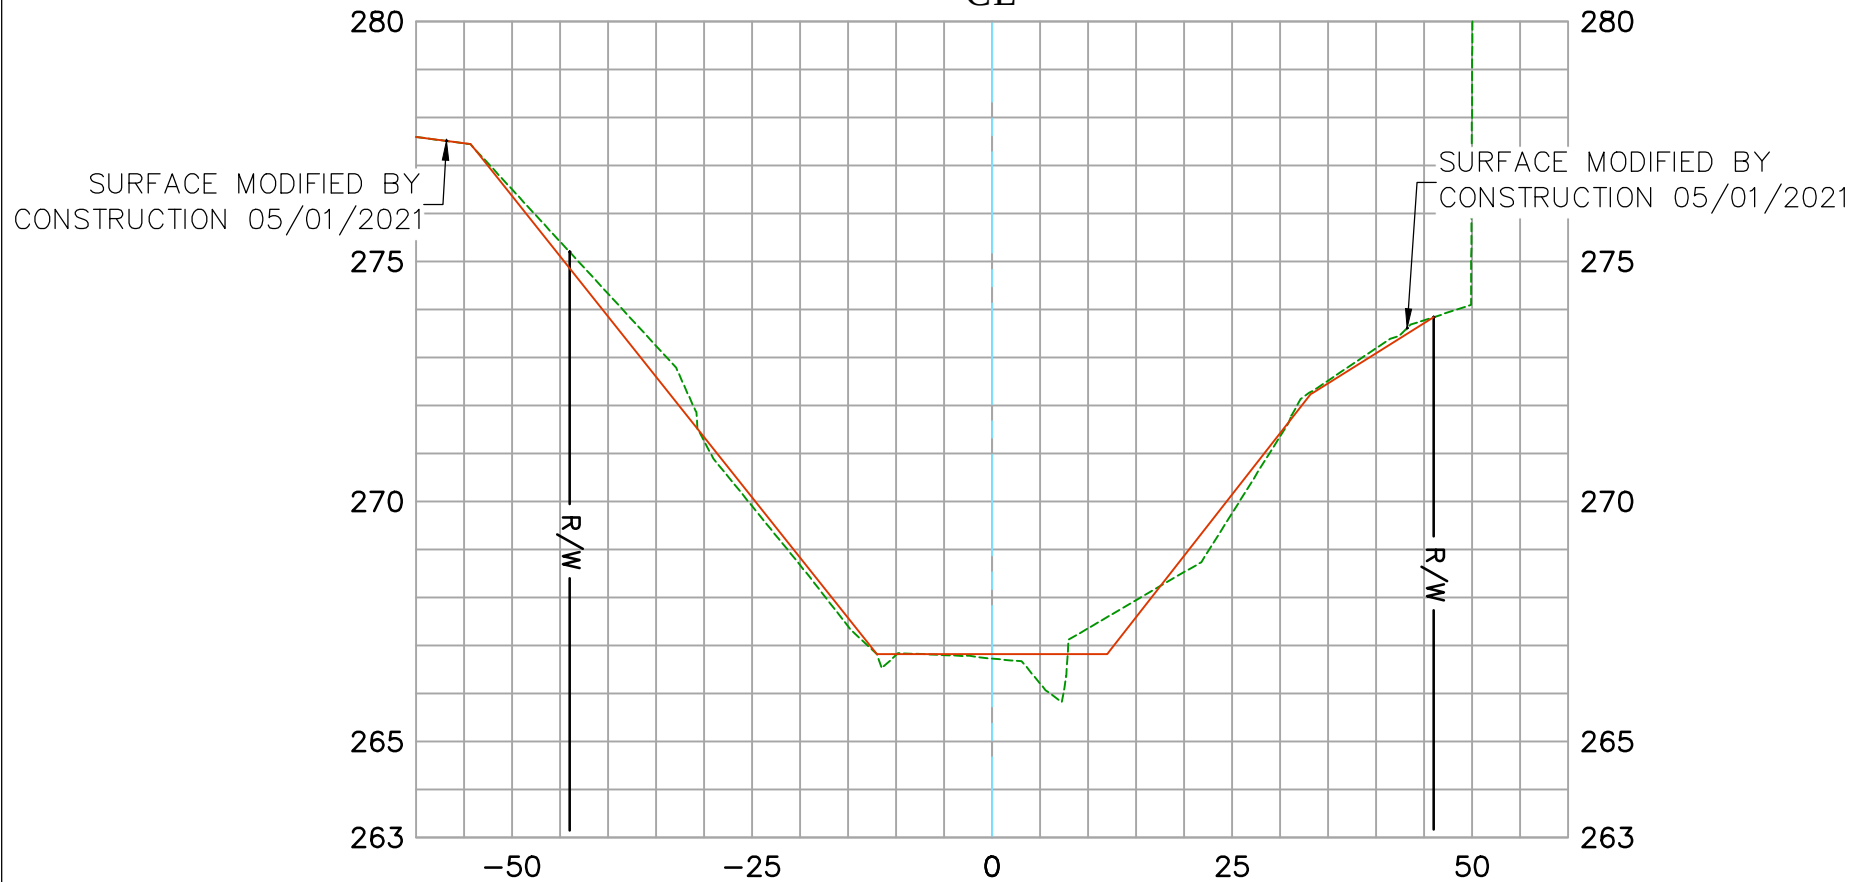
43+43.66

EXISTING CONDITION 03/18/2021  
RECORD DRAWINGS:  
F23-701-1, F23-701-2, & F23-701-3  
DATE PREPARED: 11/01/2021
