Agua Chinon Retarding Basin

Monitoring Survey

Aqua Chinon Retarding Basin (F18B01) Monitoring Survey

10/1/2018

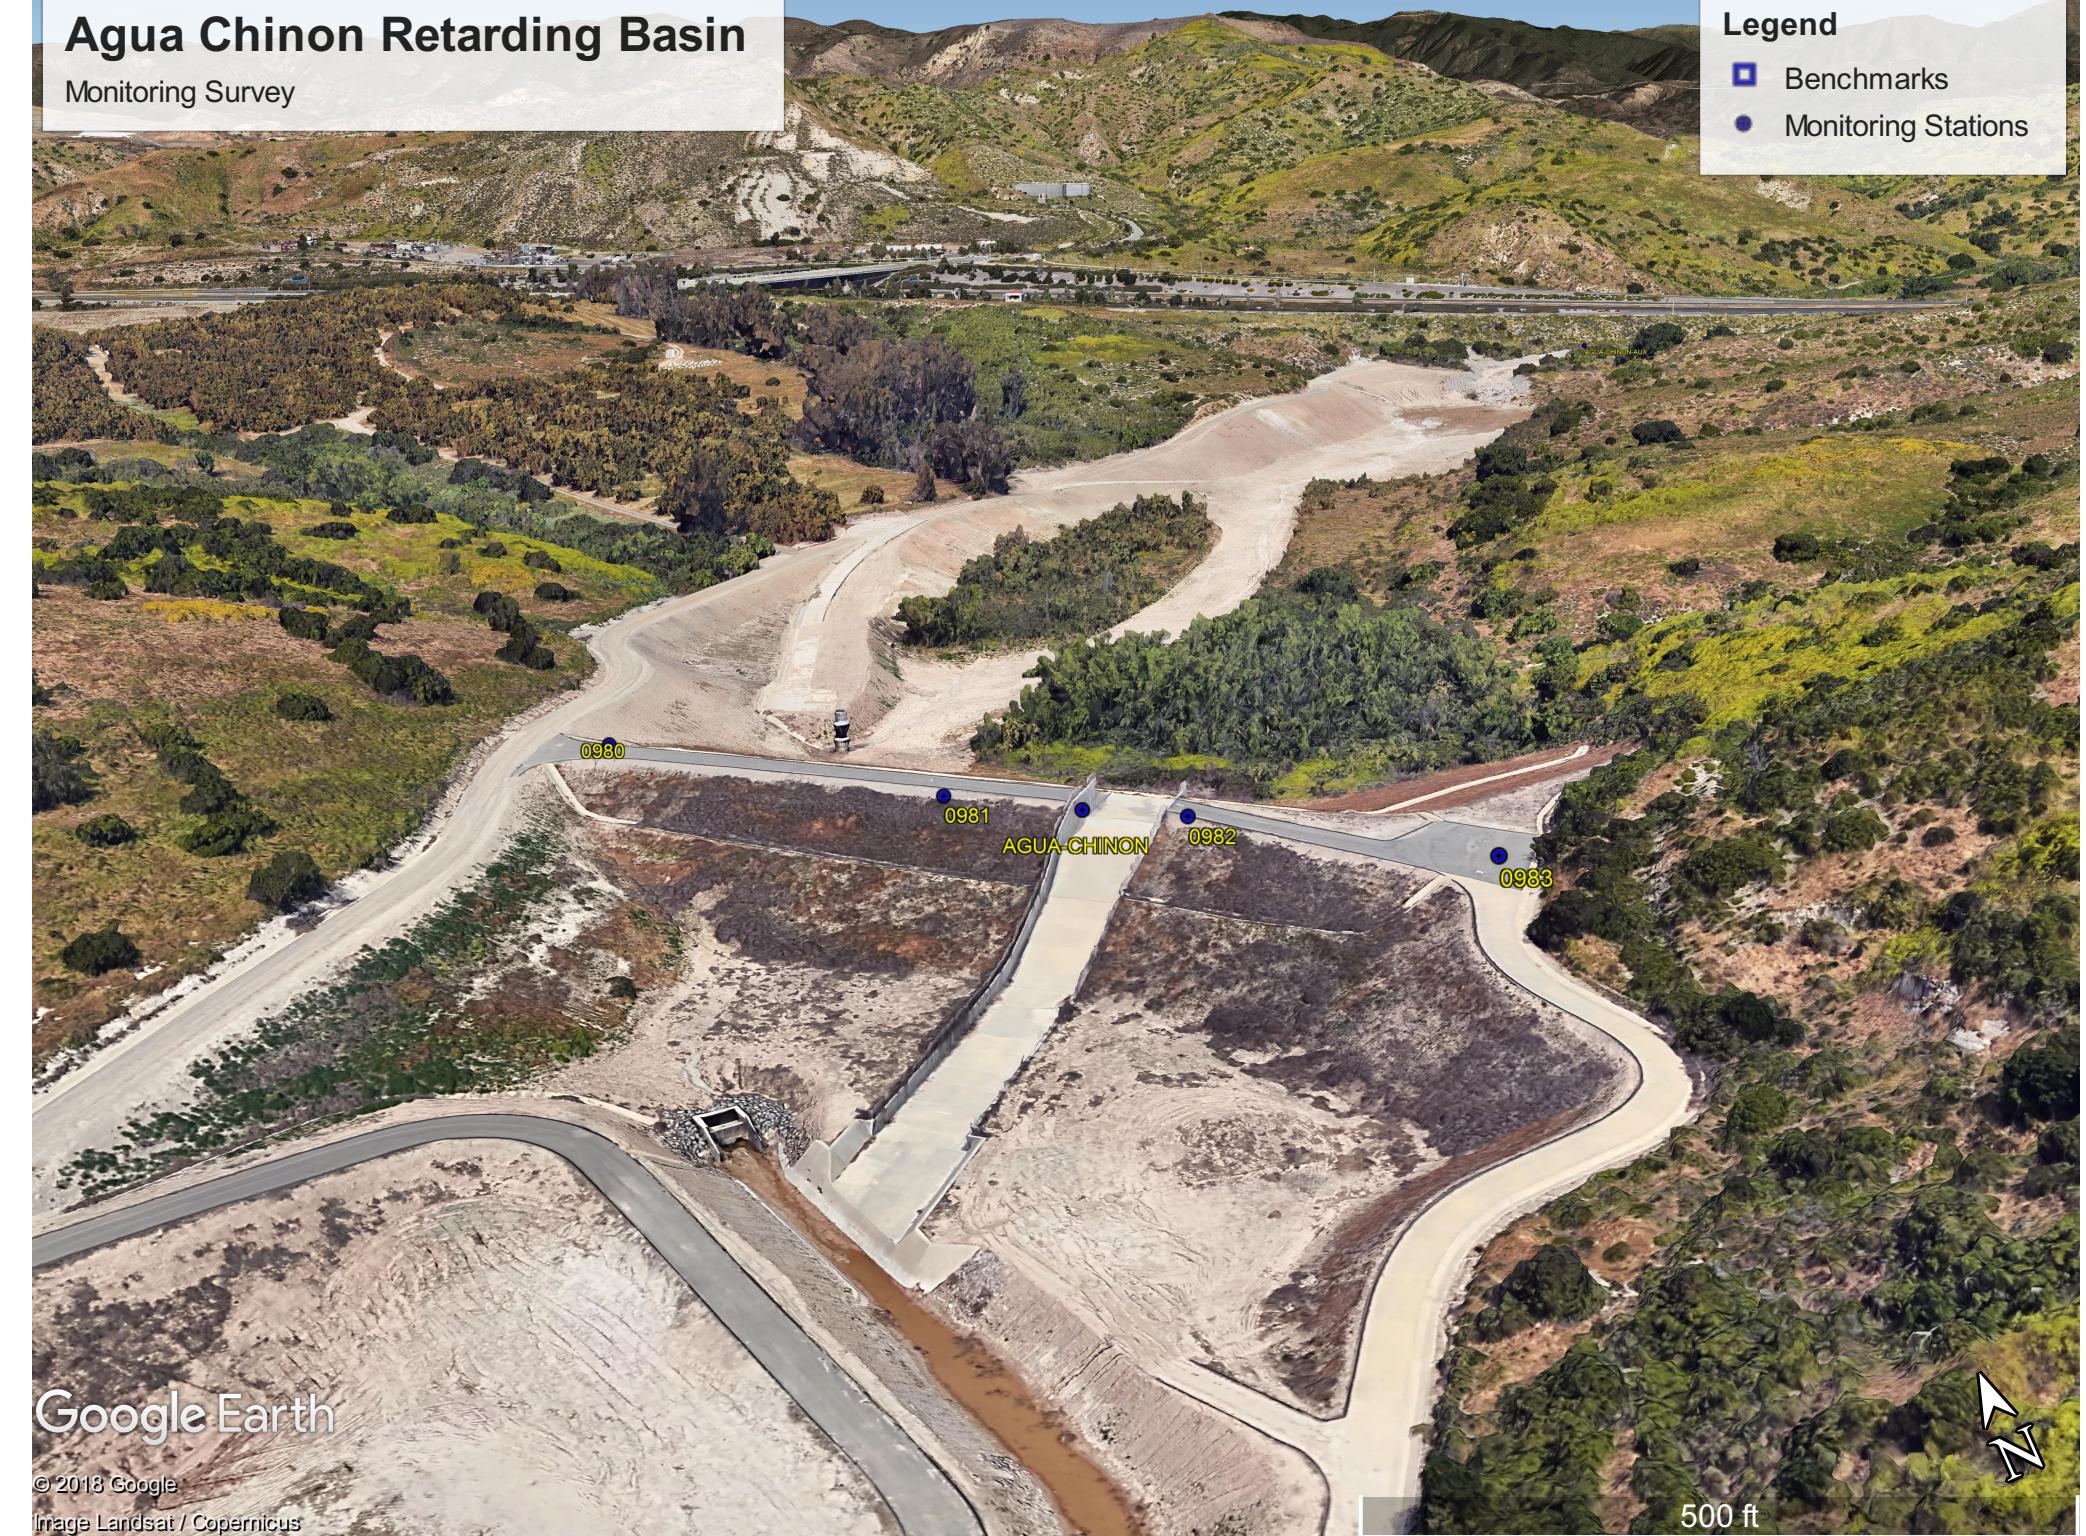
Legend

- Benchmarks
- Monitoring Stations

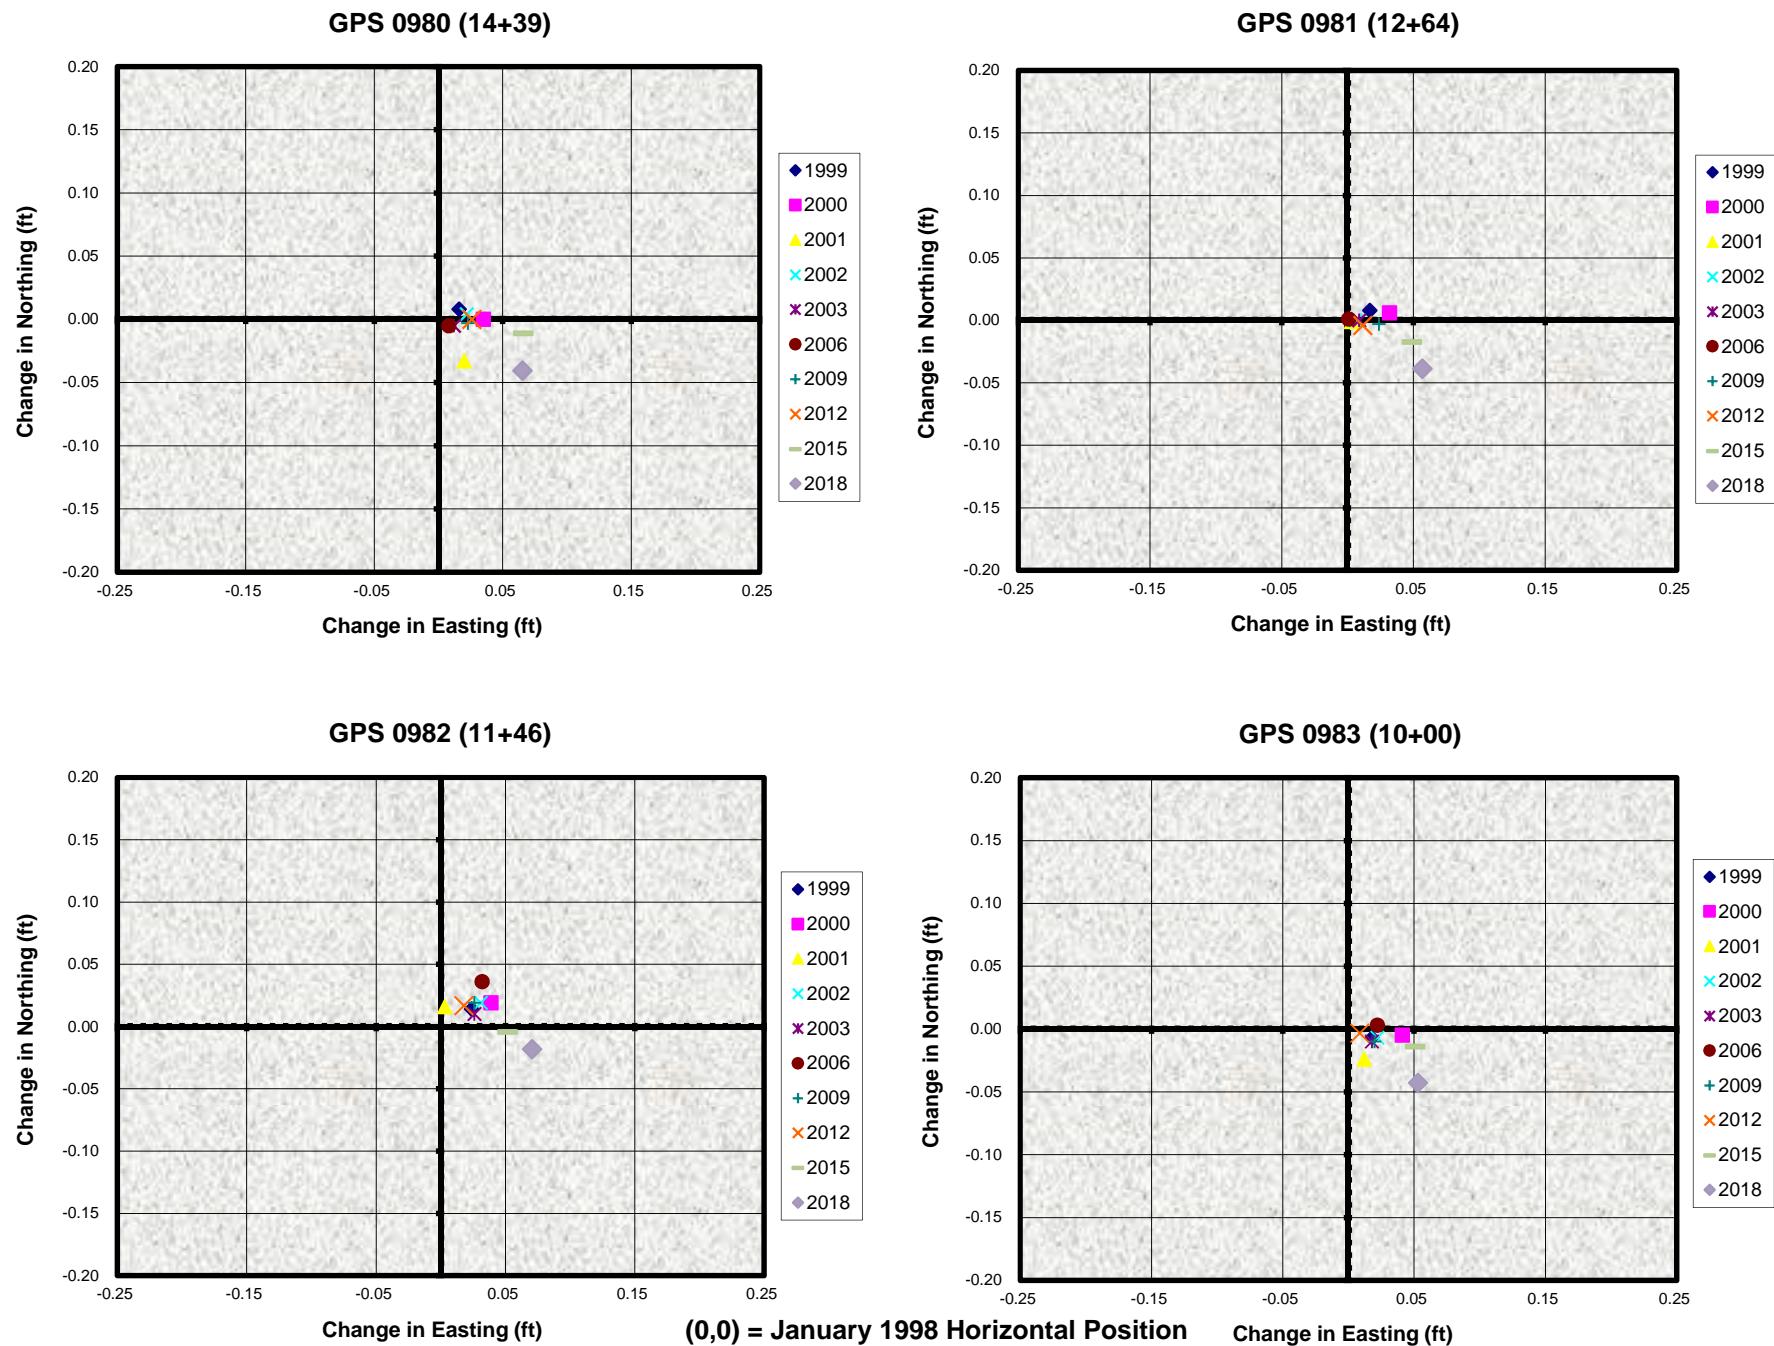
Agua Chinon Dam - (Horizontal) Horizontal Movement from 1998 Initial Survey

Four monuments were three-dimensionally positioned utilizing GPS Static survey techniques. Because of the layout of the monuments, horizontal comparisons will be shown as differences in the northing and easting, instead of the station and offset method.

2018 All monuments show slight southeast shift which may be due to land deformation between basin and OEOC.

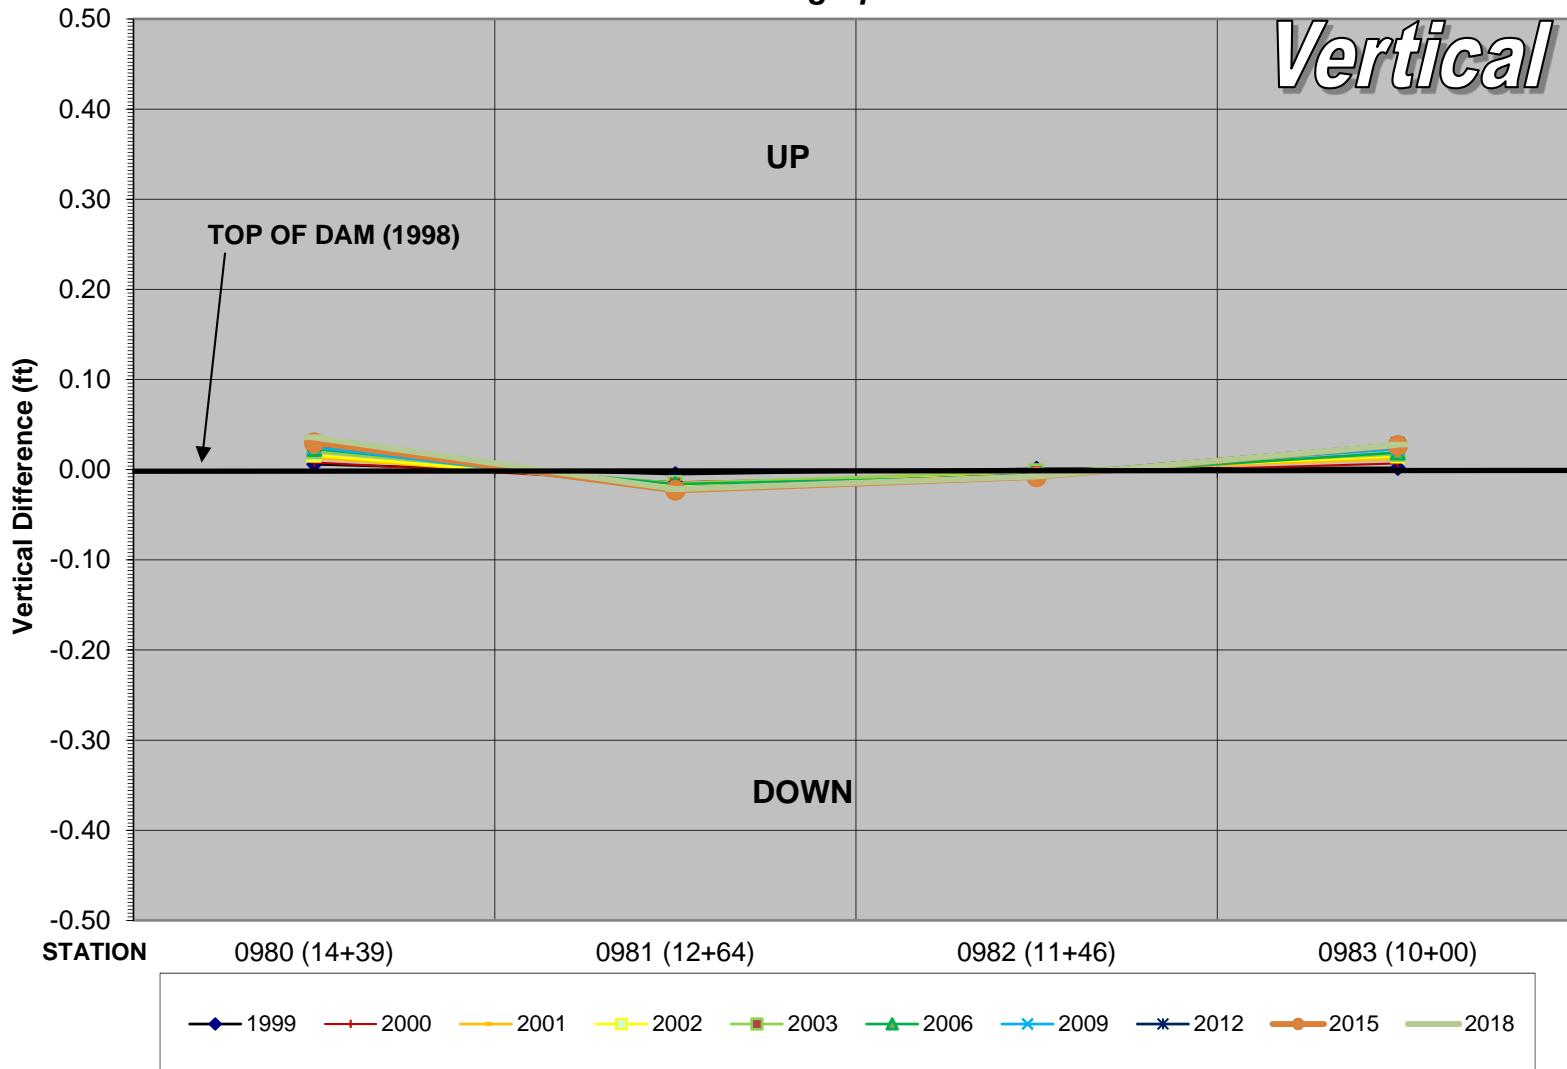
Agua Chinon Dam
Vertical Movement (Orthometric Height Difference from 1998 Elevations)
Profile View - Looking Upstream

Vertical differences are calculated comparing the elevation to the "1998 survey" elevation.
