# Cove Road - Crib Wall

Monitoring Survey

## **Cove Road - Crib Wall Monitoring Survey**

This crib-type retaining wall was built in 1985 after the top of the bluff located under Cannons Restaurant failed during heavy rains in the winter of 1980-1981.

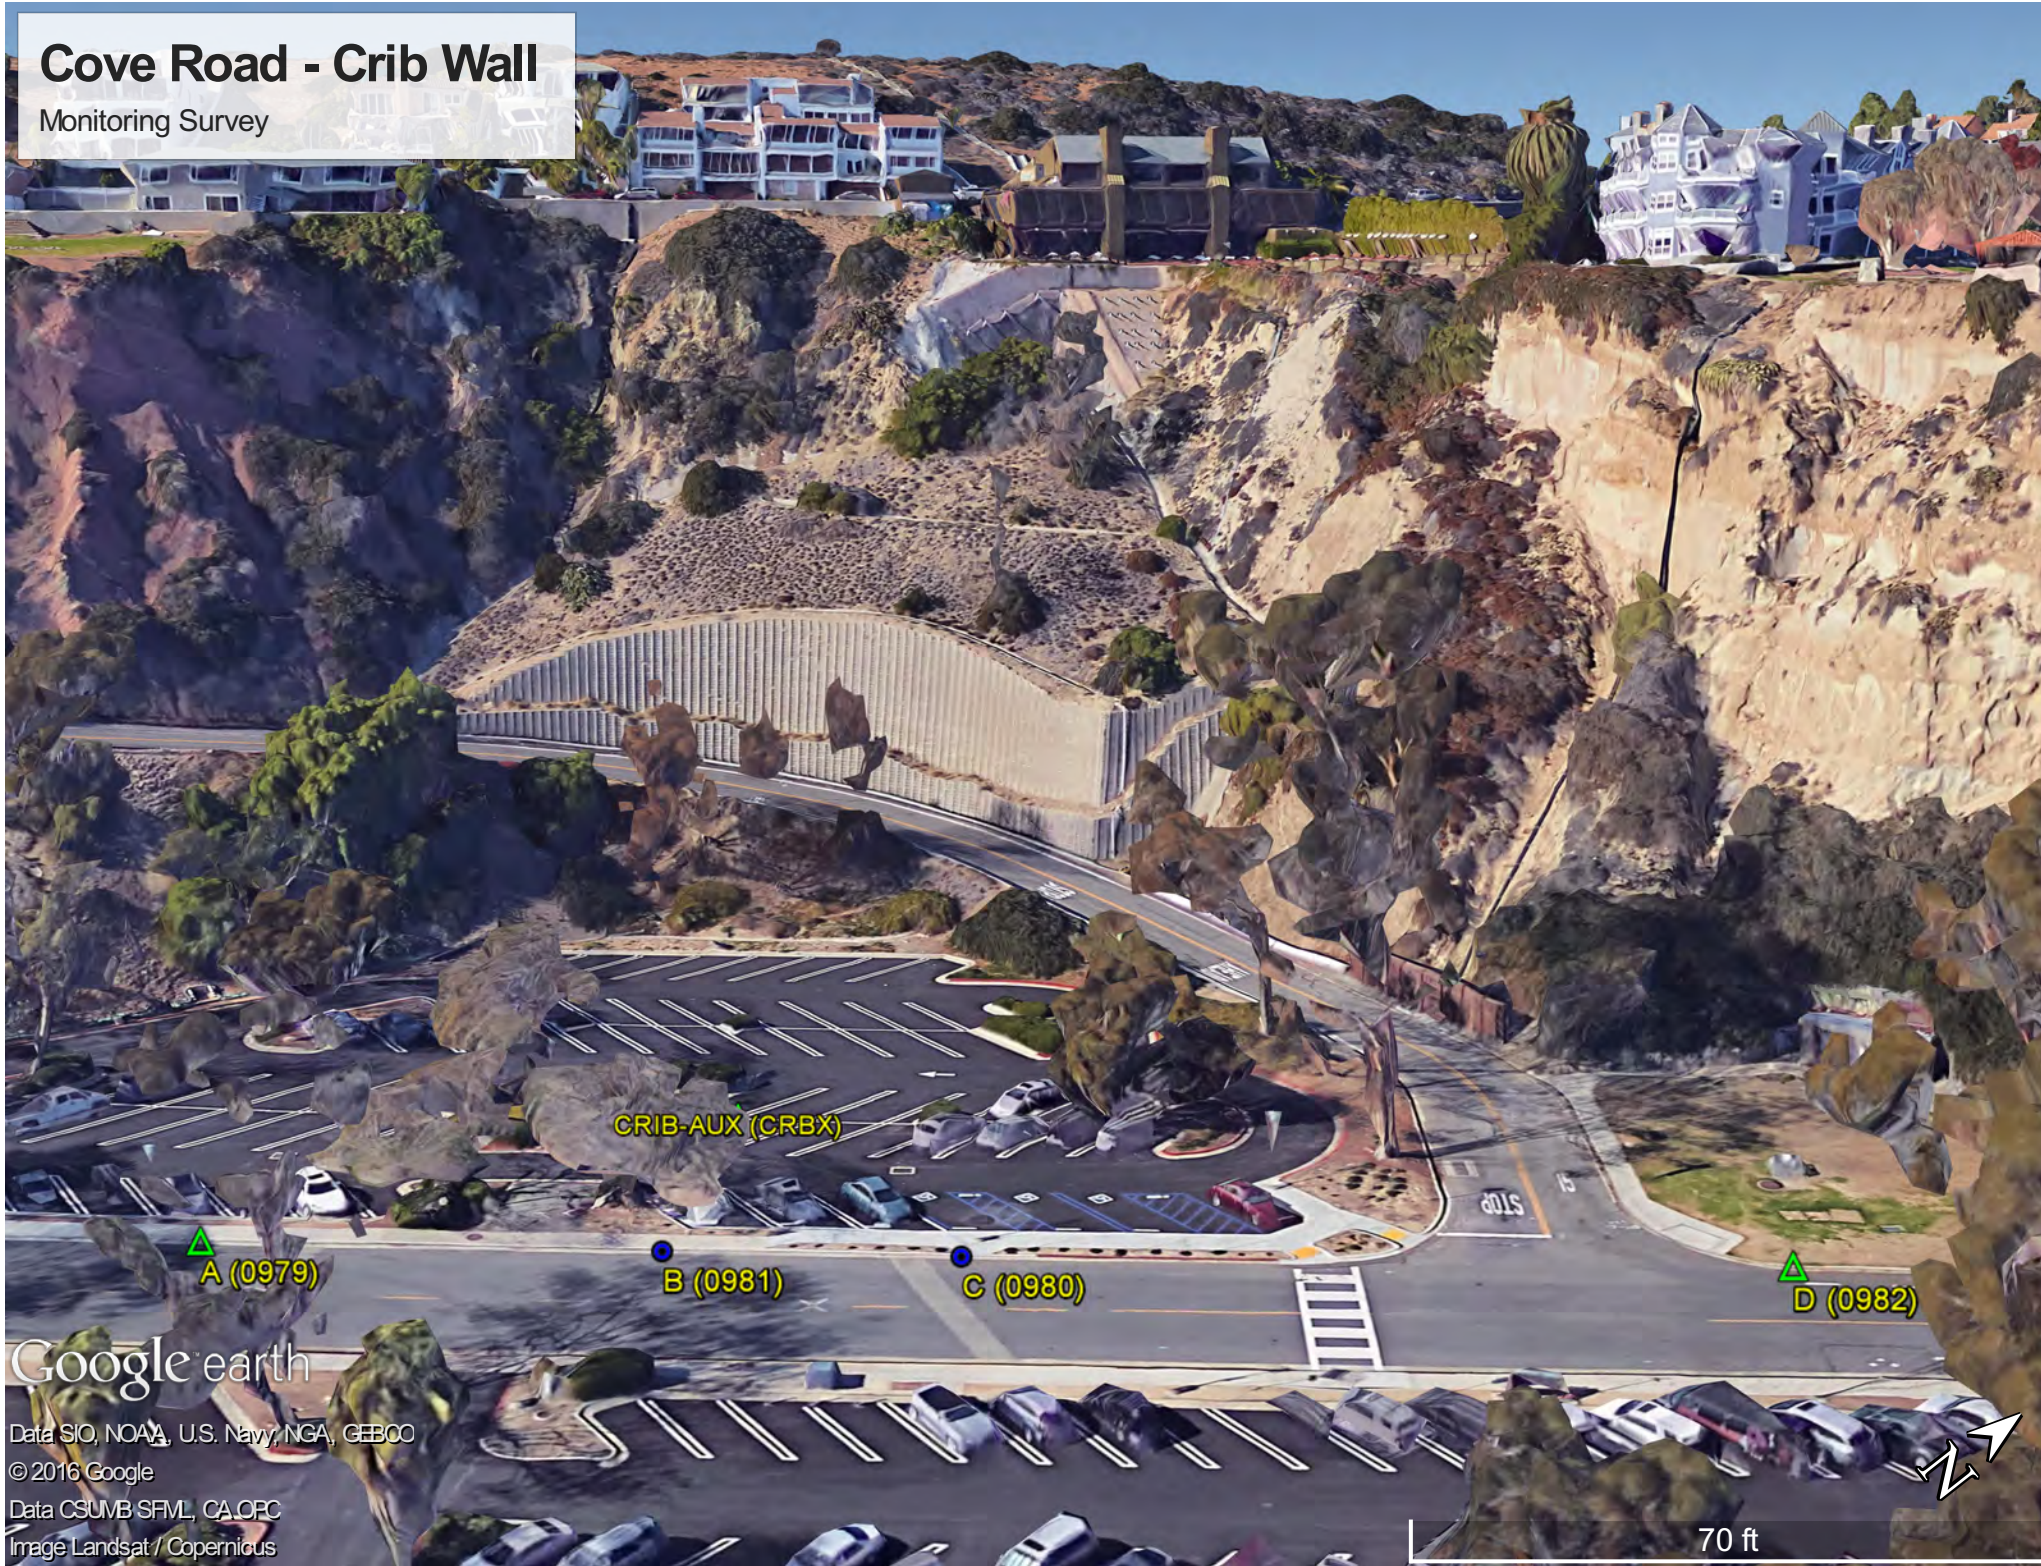
21 mini-prisms were set into the Crib Wall for monitoring targets July, 1997.

See following sheet for procedures and chart details.

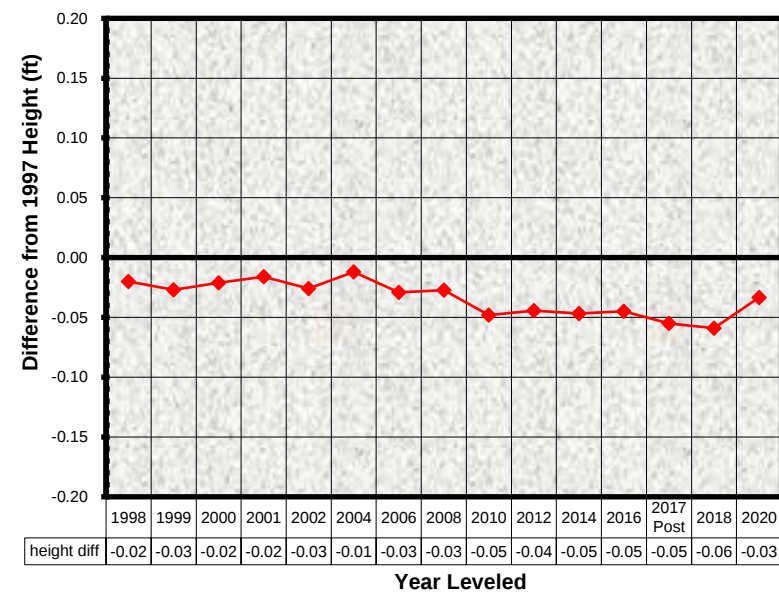
## Station # 20 - Vertical

Each chart contains movement (change in northing, easting, elevation) from each survey relative to the 1997 base survey for each station. All data is shown in U.S. Survey Feet.

**Aug 2017:** (Post-Construction) Survey was performed to monitor the wall during the Erosion Repair and Drain Modification project. Targets 17, 19, 20, and 21 show questionable movement.
