**GPS #:** **4513R1**

City / Location: Rancho Santa Margarita

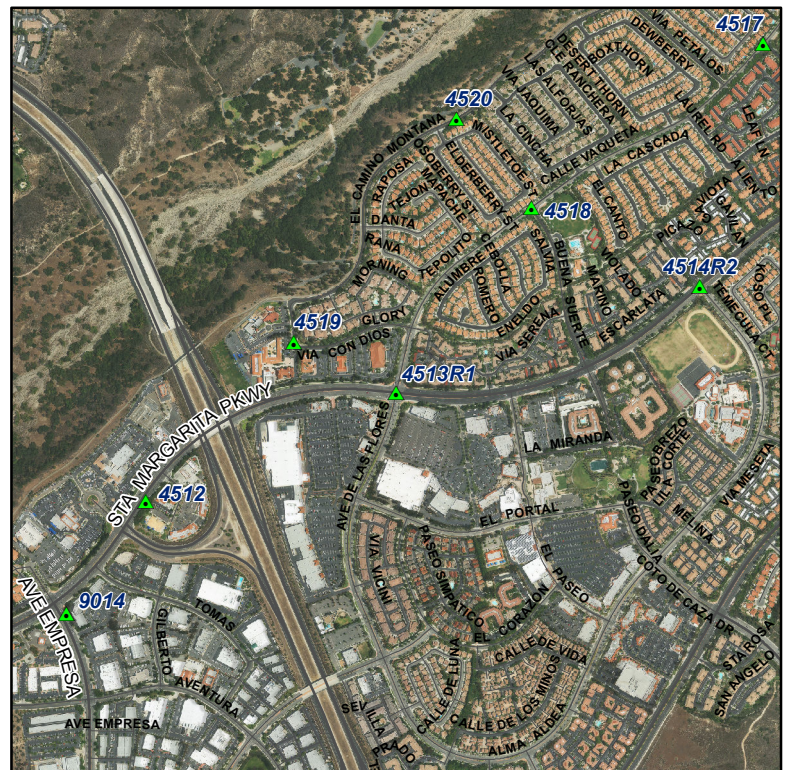
FD MAG NAIL AND WASHER STAMPED "LS 6970"  
PER CR 2007-2167 ORIGINAL MONUMENT BEING;  
PUNCHED SPIKE AND BRASS WASHER STAMPED  
"LS 3246" FLUSH IN A.C. SURFACE, AT THE  
CENTERLINE INTERSECTION OF SANTA MARGARITA  
PKWY. AND AVENIDA DE LAS FLORES.
