**GPS #:** 4529

City / Location: Rancho Santa Margarita

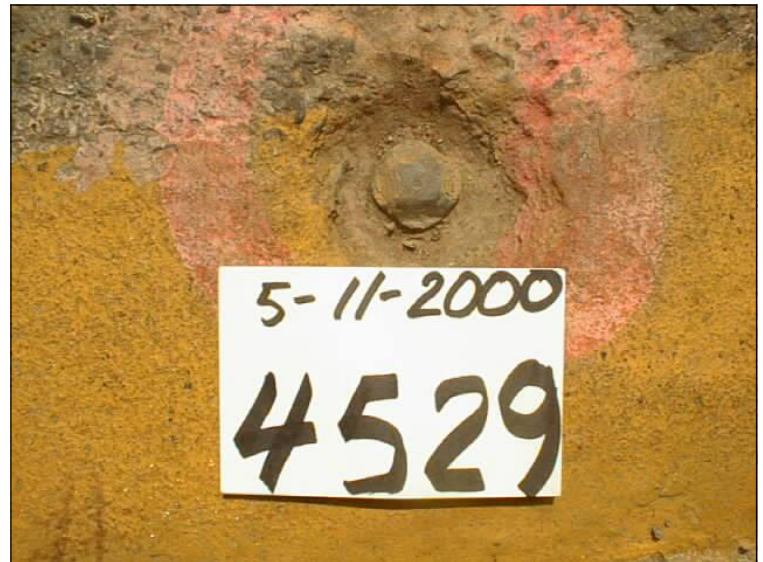
FD PUNCHED ROUND HEAD SPIKE FLUSH IN A.C. SURFACE, AT THE APPARENT CENTERLINE E.C. OF ESPERANZA, 70'+/- N'LY FROM ITS TERMINUS.
