*OC Survey Section*

**Subsidence and Deformation  
Monitoring Studies  
2013**

Prepared by  
THE  
GEODETIC CONTROL UNIT

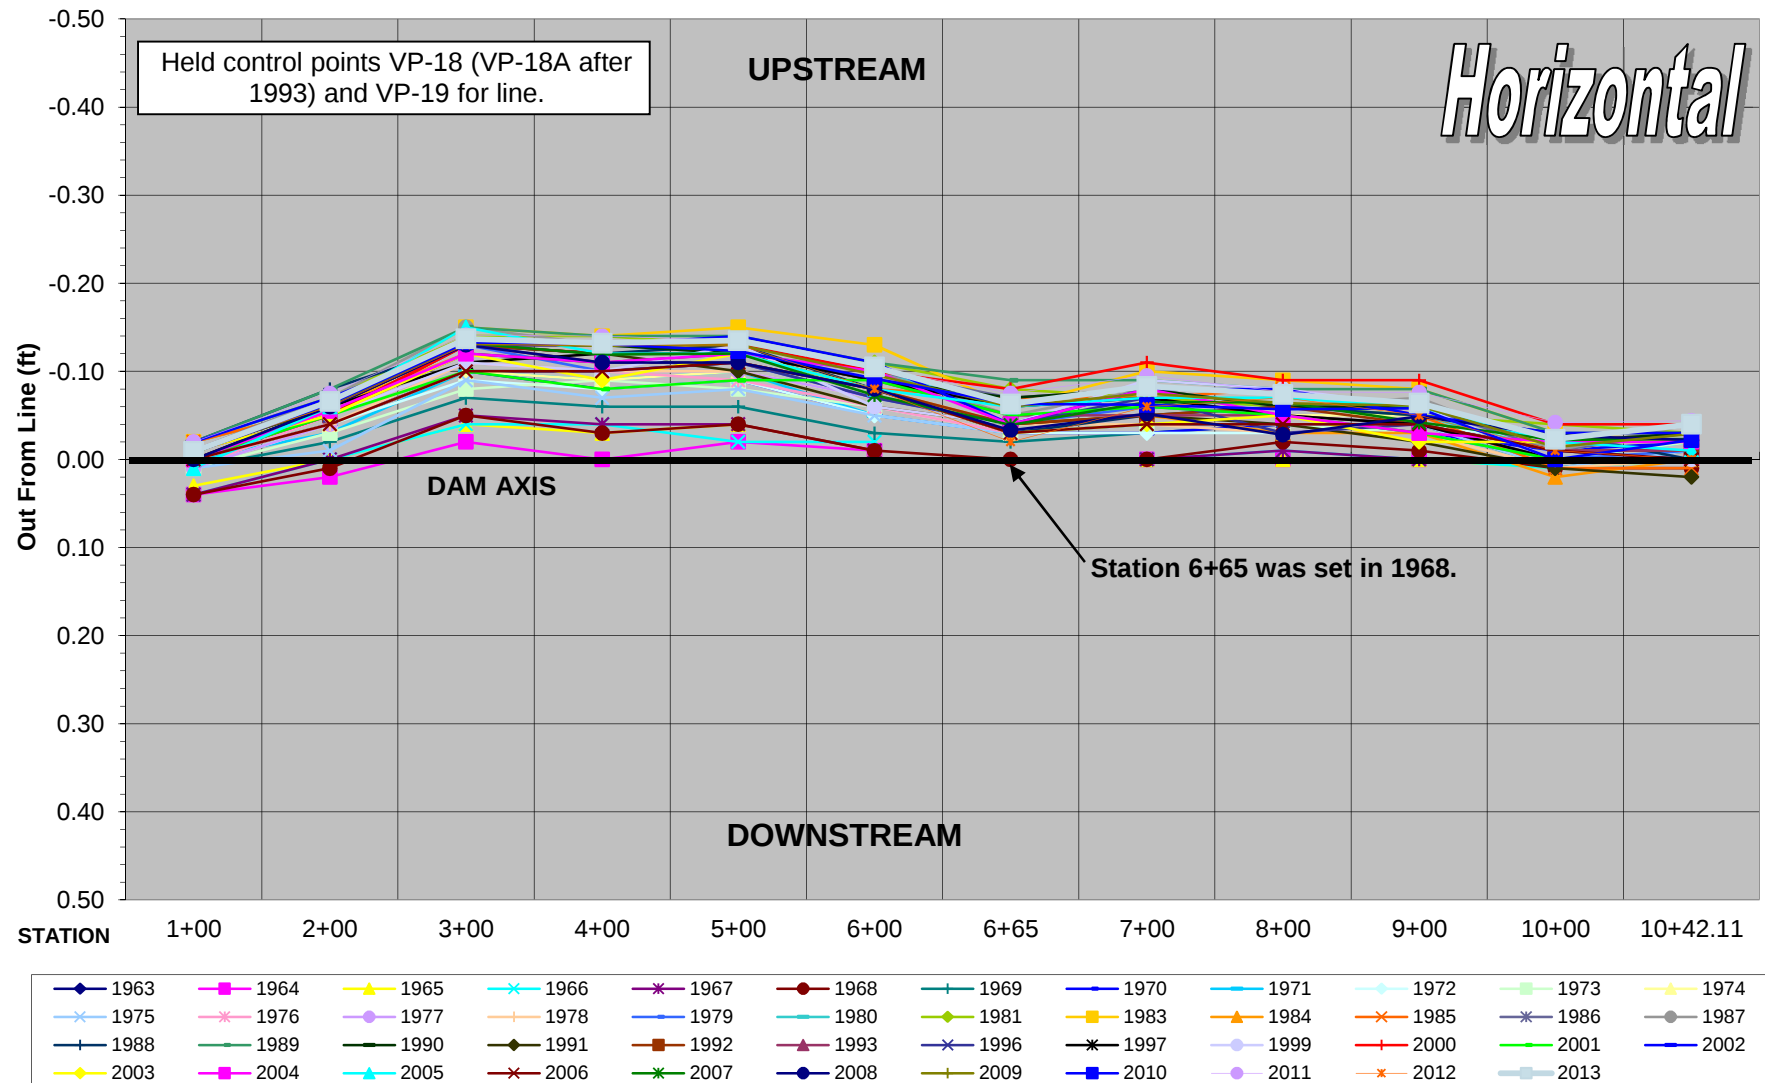
## Horizontal Movement Perpendicular to Dam Axis (Out From Line) - Plan View

Control points "VP-18" ("VP-18A" after 1993) and "VP-19" are held for ***Out From Line*** and along line calculations.

Positive numbers represent monitored stations to the right of line (downstream), negative numbers represent monitored stations to the left of line (upstream).

**1963-1973** Gradual subsidence measured due to settling of dam. Upstream horizontal movement measured, mostly concentrated around stations 3+00 thru 5+00.

**1974-1977** Upstream horizontal movement and subsidence still measured. Rates are Gradually slowing.

**1978-1988** Subsidence continues at a very slow rate. Horizontal appears stable.

**1989-2000** Vertical subsidence has discontinued. Horizontal appears stable.

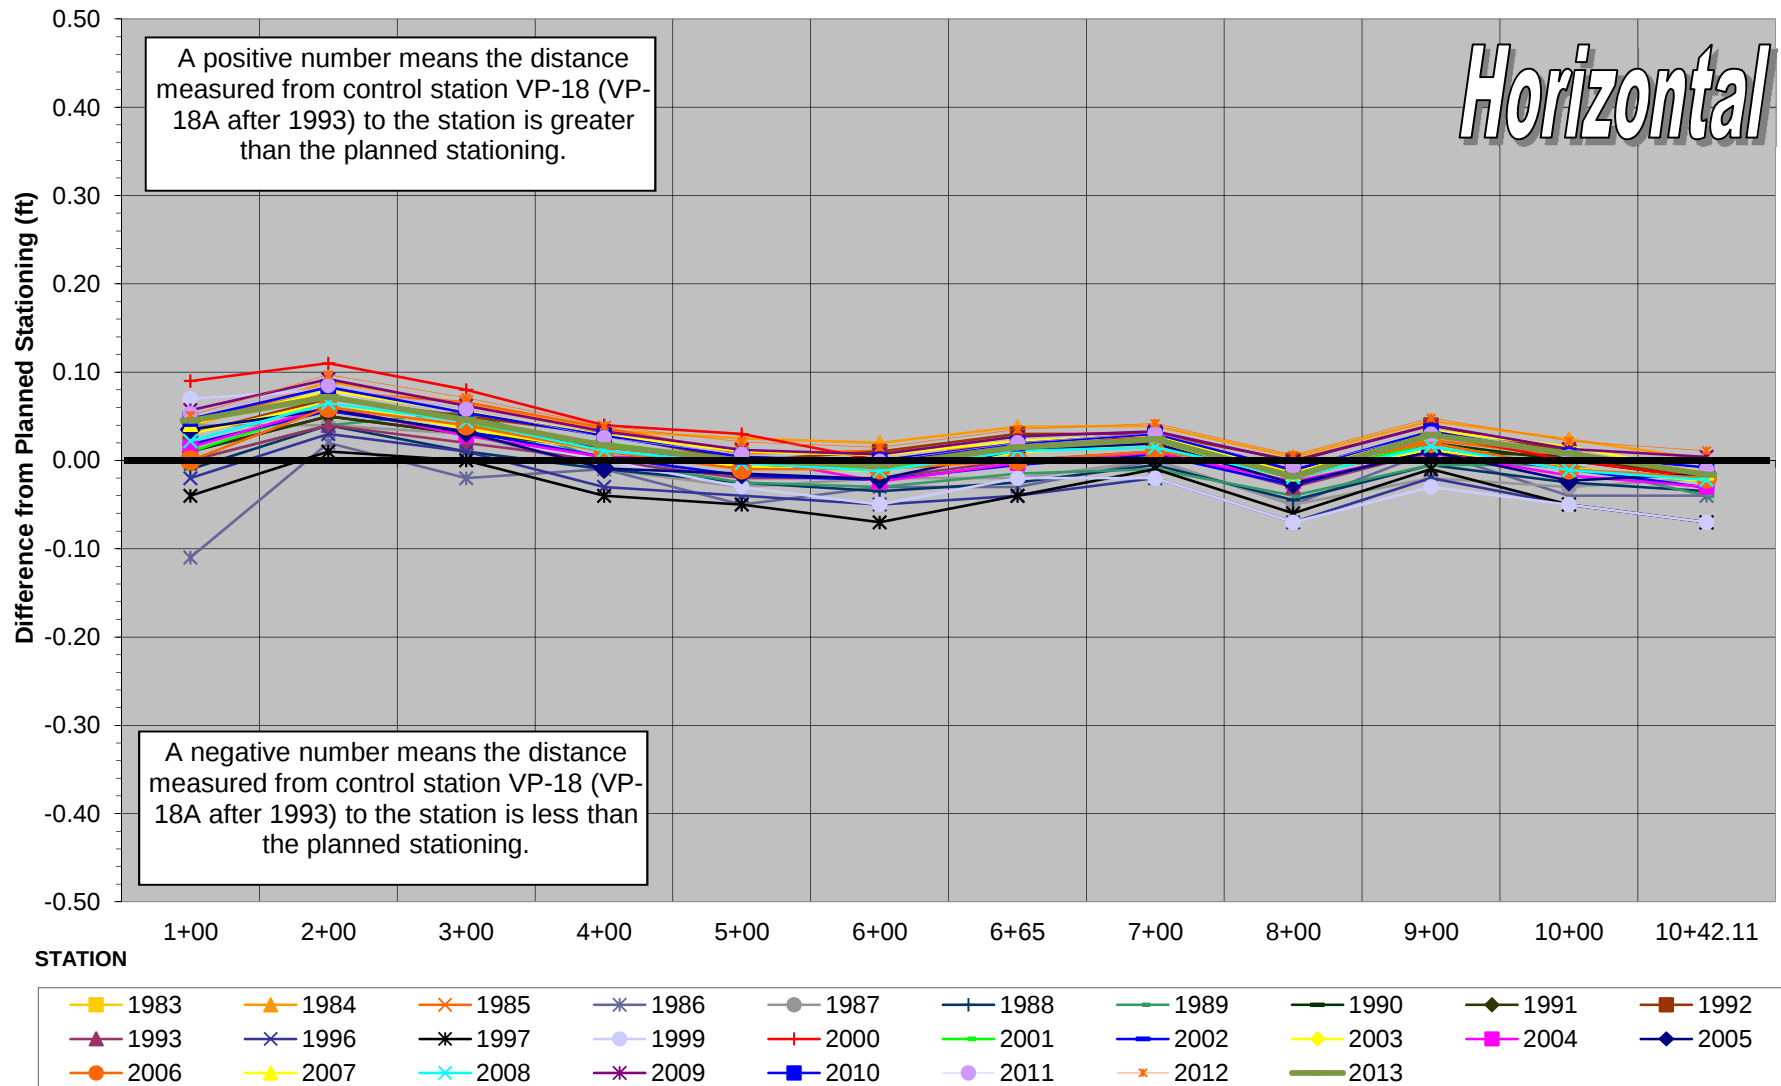
# Villa Park (Main) Dam Horizontal Movement Along Dam Axis (Difference from Planned Stationing)

Control points "VP-18" ("VP-18A" after 1993) are held for stationing calculations.

Positive numbers mean that the distances measured to each station are greater than planned stationing, negative number means less than planned stationing.

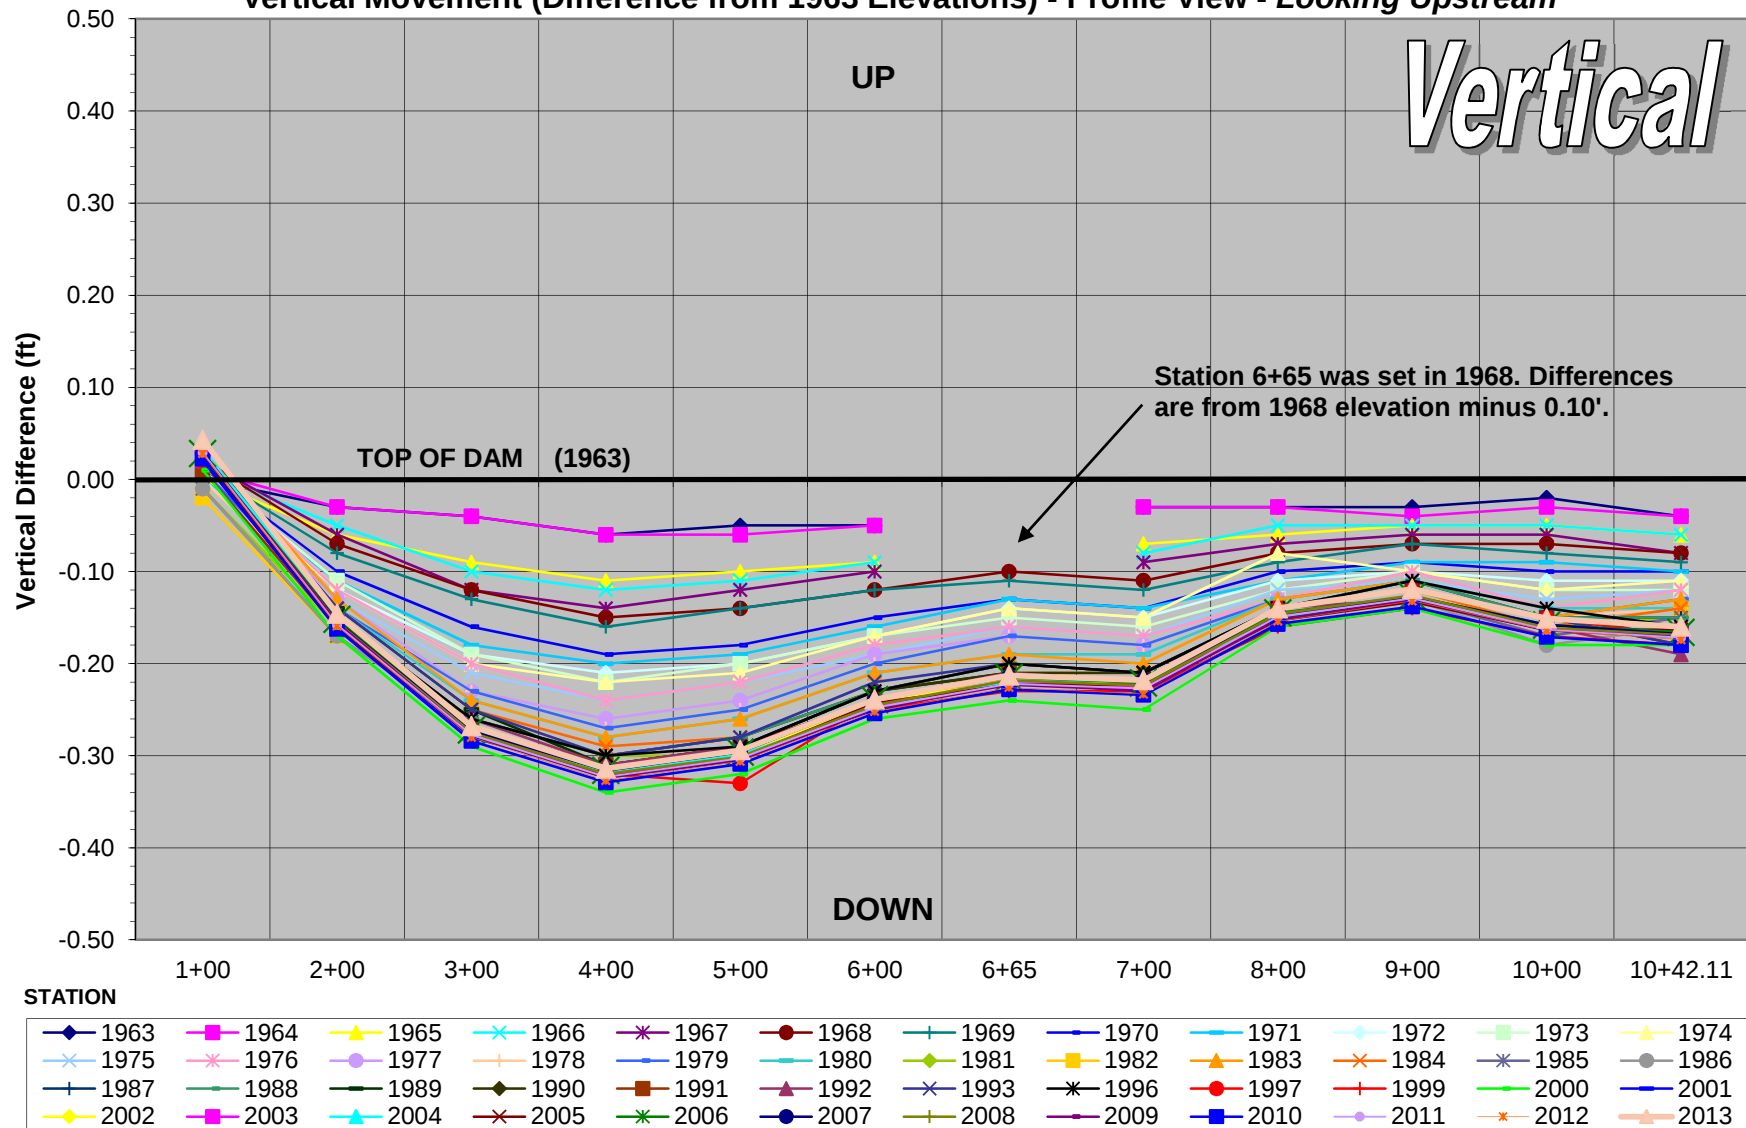
## Vertical Movement (Difference from 1963 Elevations) - Profile View - Looking Upstream

Vertical differences are calculated comparing the elevation to the "1963 survey" elevation.

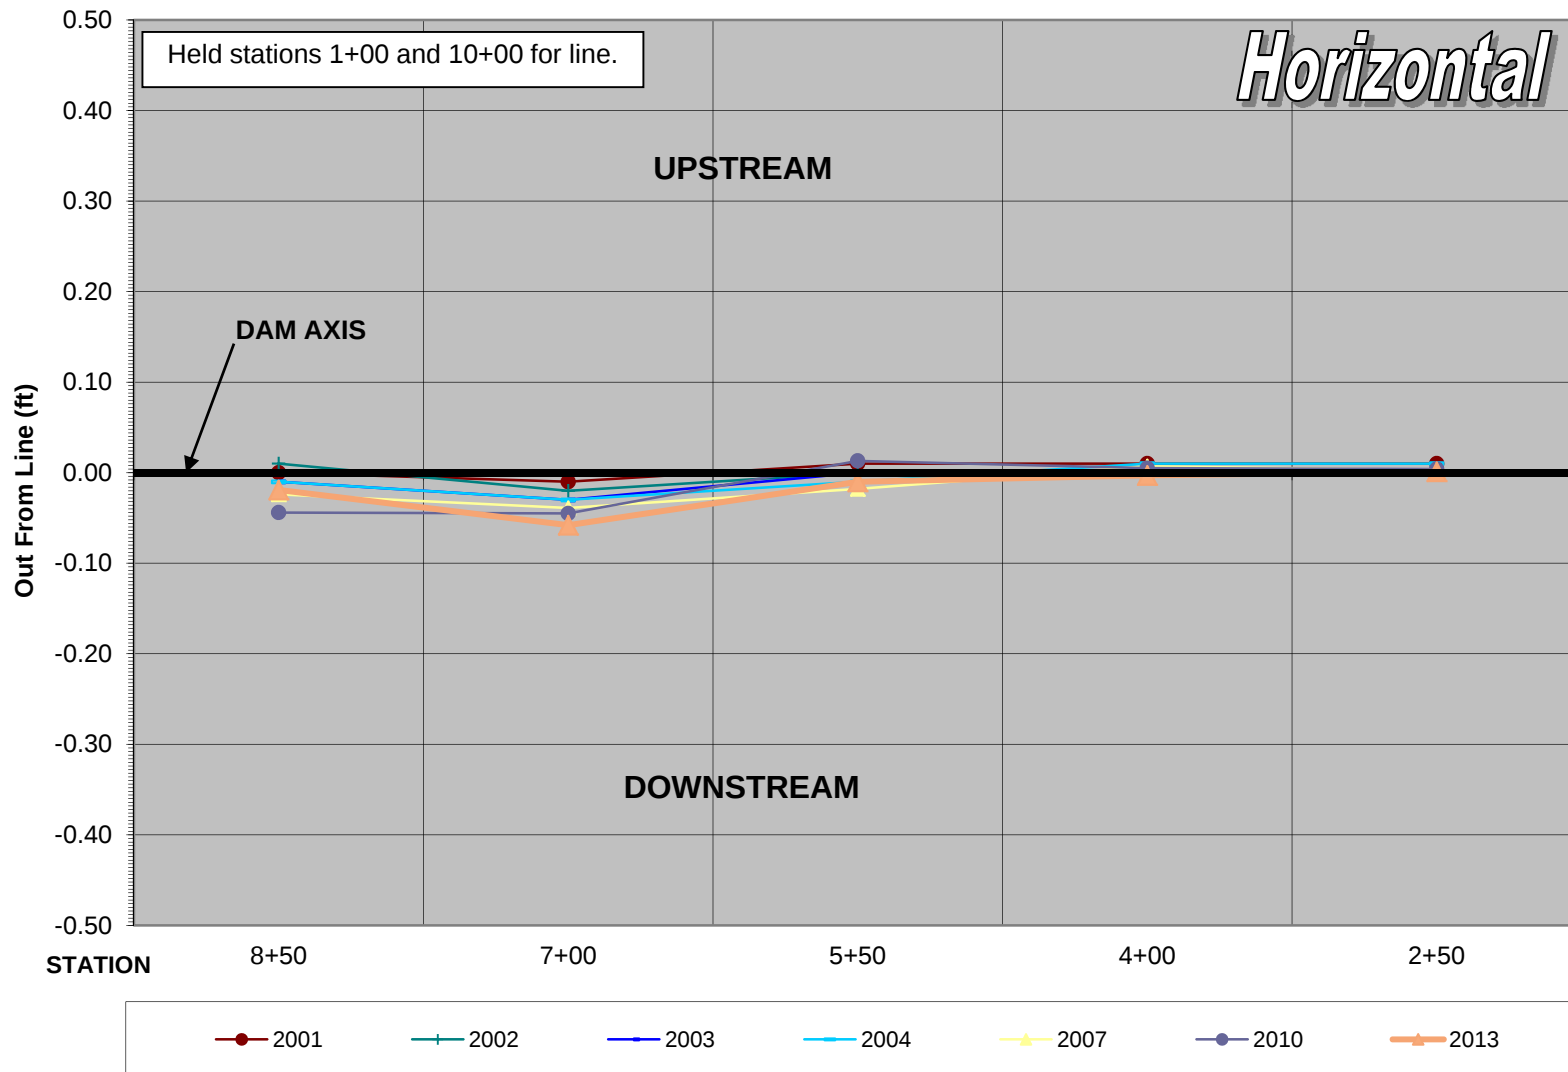
Ochard Estates Retarding Basin  
Horizontal Movement Perpendicular to Dam Axis (Out From Line) - Plan View

| <b>2013</b> | Station 7+00 shows slight horizontal movement downstream. Stations 7+00 and 8+00 show continual vertical settling. |

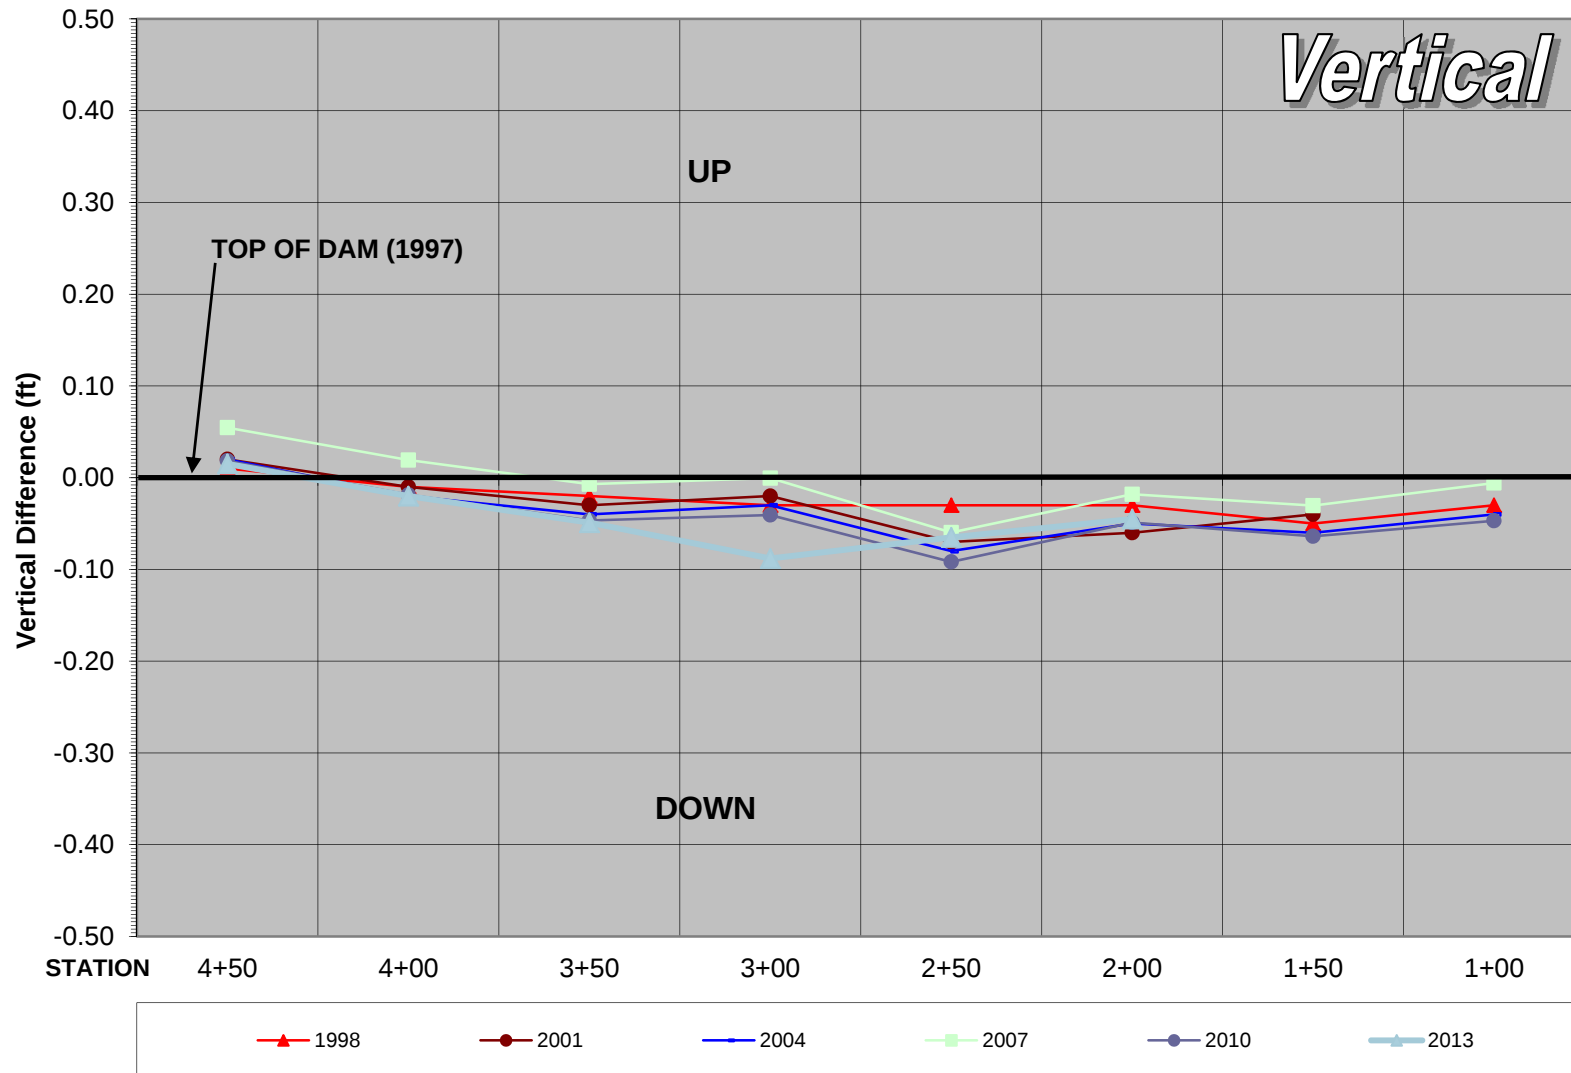
East Hicks Canyon Dam  
Vertical Movement (Difference from 1997 Elevations) - Profile View - *Looking Upstream*

| <b>2013</b> | All well lids are missing and well monuments appear to have been disturbed from heavy equipment scrapping the asphalt surface. Monuments appear stable horizontally but 3+00 has sank 0.05'. |

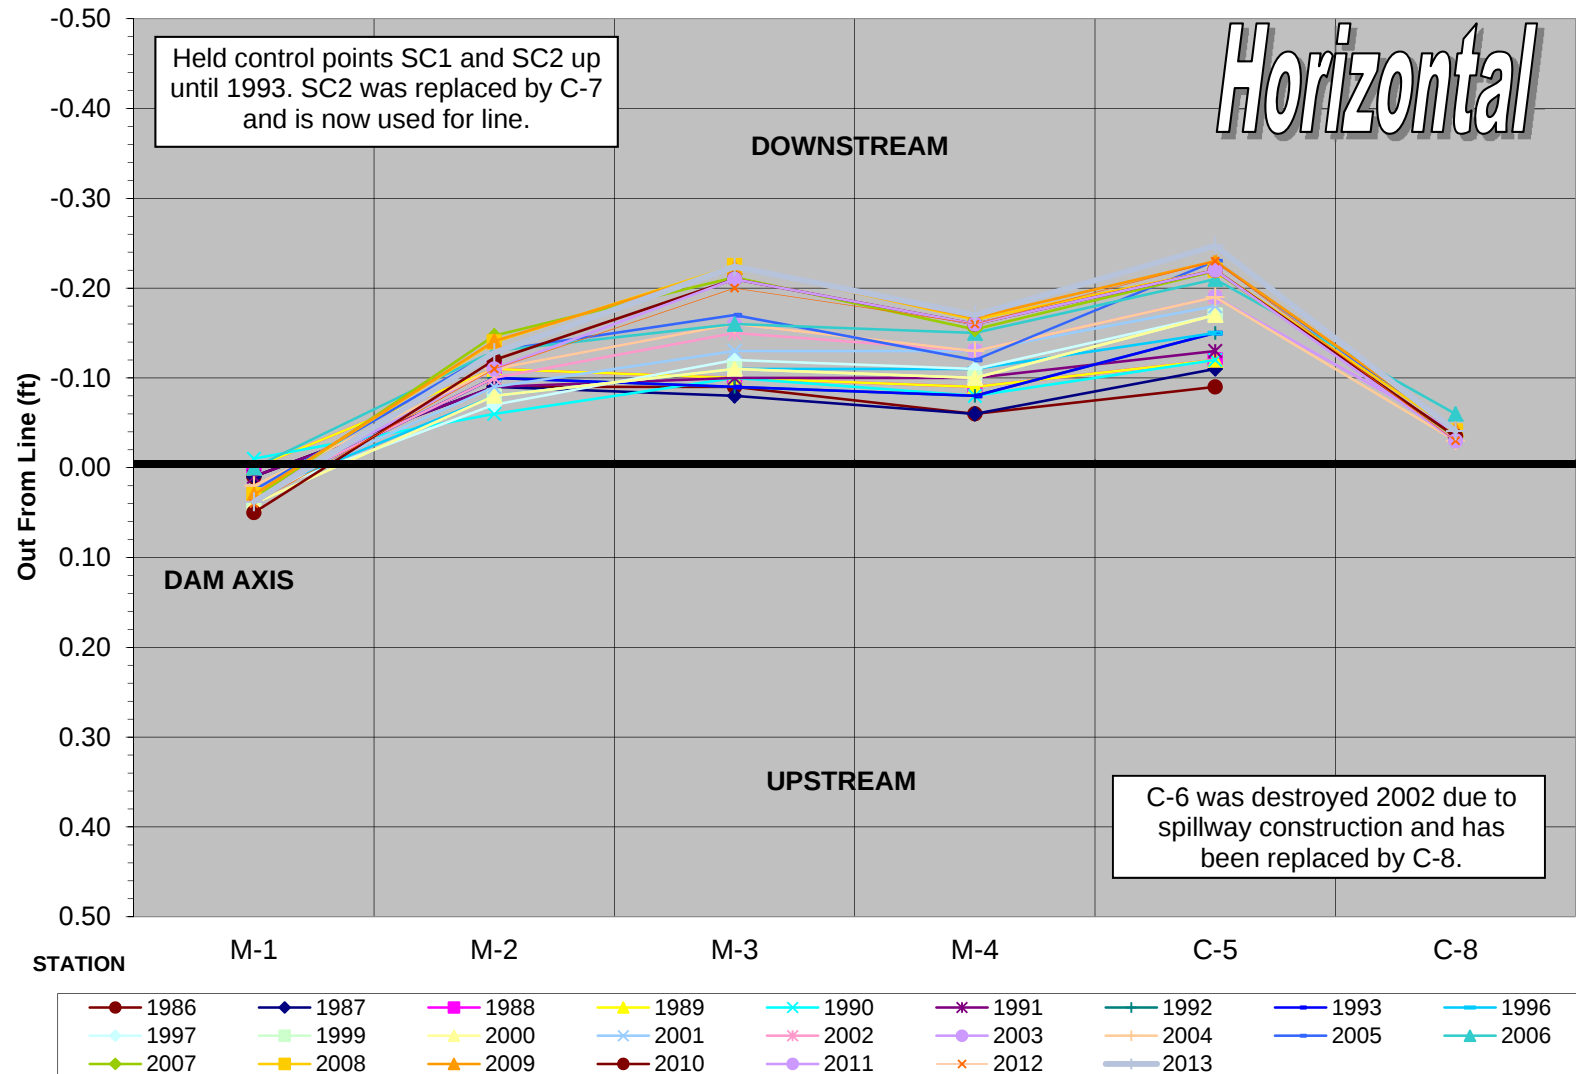
## Horizontal Movement Perpendicular to Dam Axis (Out From Line) Plan View

Control points "SC-1" and "SC-2" are held for ***Out From Line*** calculations until 1993. In 1993, "SC-2" was found disturbed and replaced by "C-7" for line. Negative numbers represent stations right of line (downstream), positive numbers represent stations left of line (upstream).

- 1981-1990** Downstream horizontal movement measured on all stations located on top of dam. Vertical uplift is found on all stations.
- 1990-2000** Downstream horizontal movement continues with the greatest amount at station C-5. Vertical uplift also continues with the greatest amount at both end stations, M-1 and C-7.

- 2001** Same horizontal and vertical trends continue
- 2002** Same horizontal trend continues. Vertical appears stable. C-6 was destroyed due to spillway construction and has been replaced by C-8.

- 2003** Same horizontal trend continues. Vertical appears stable.
- 2004** No significant movement found.
- 2005** C-5 shows downstream horizontal movement. Vertical uplift also continues with the greatest amount at both end stations, M-1 and C-7.

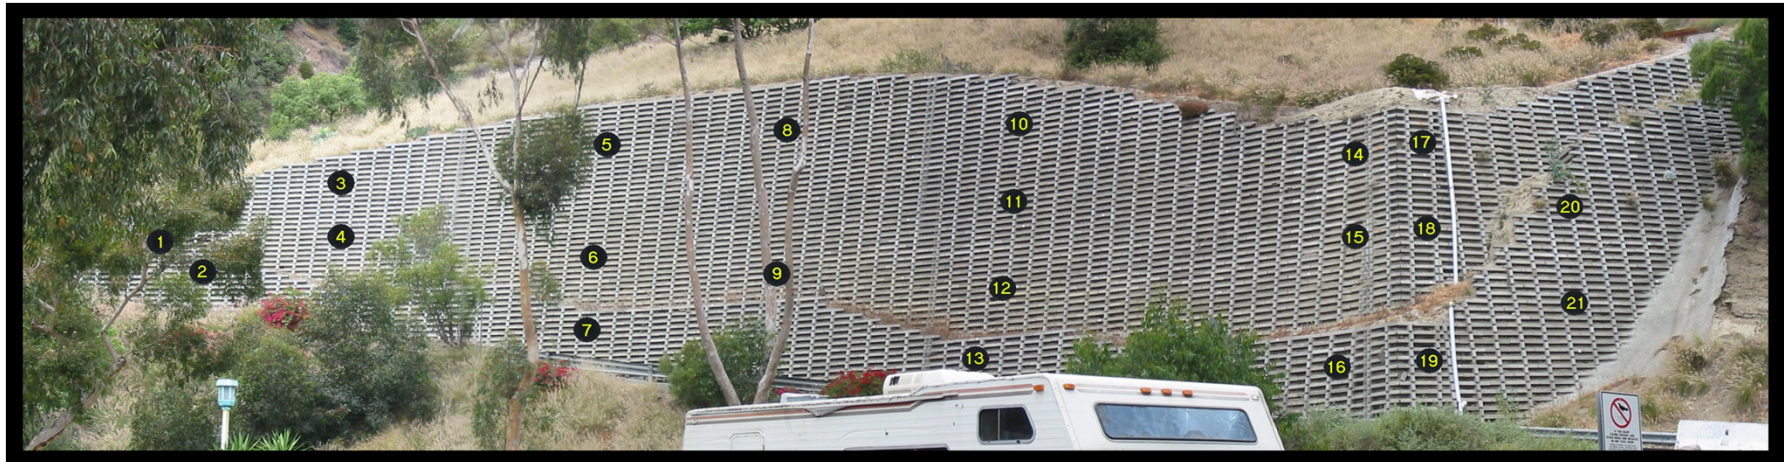
### TARGET LOCATIONS

21 mini-prisms were set into the Crib Wall for monitoring targets July, 1997.
