Subsidence and Deformation Monitoring Studies 2014

OC Survey
Geodetic Unit

Dam Monitoring Survey Reports

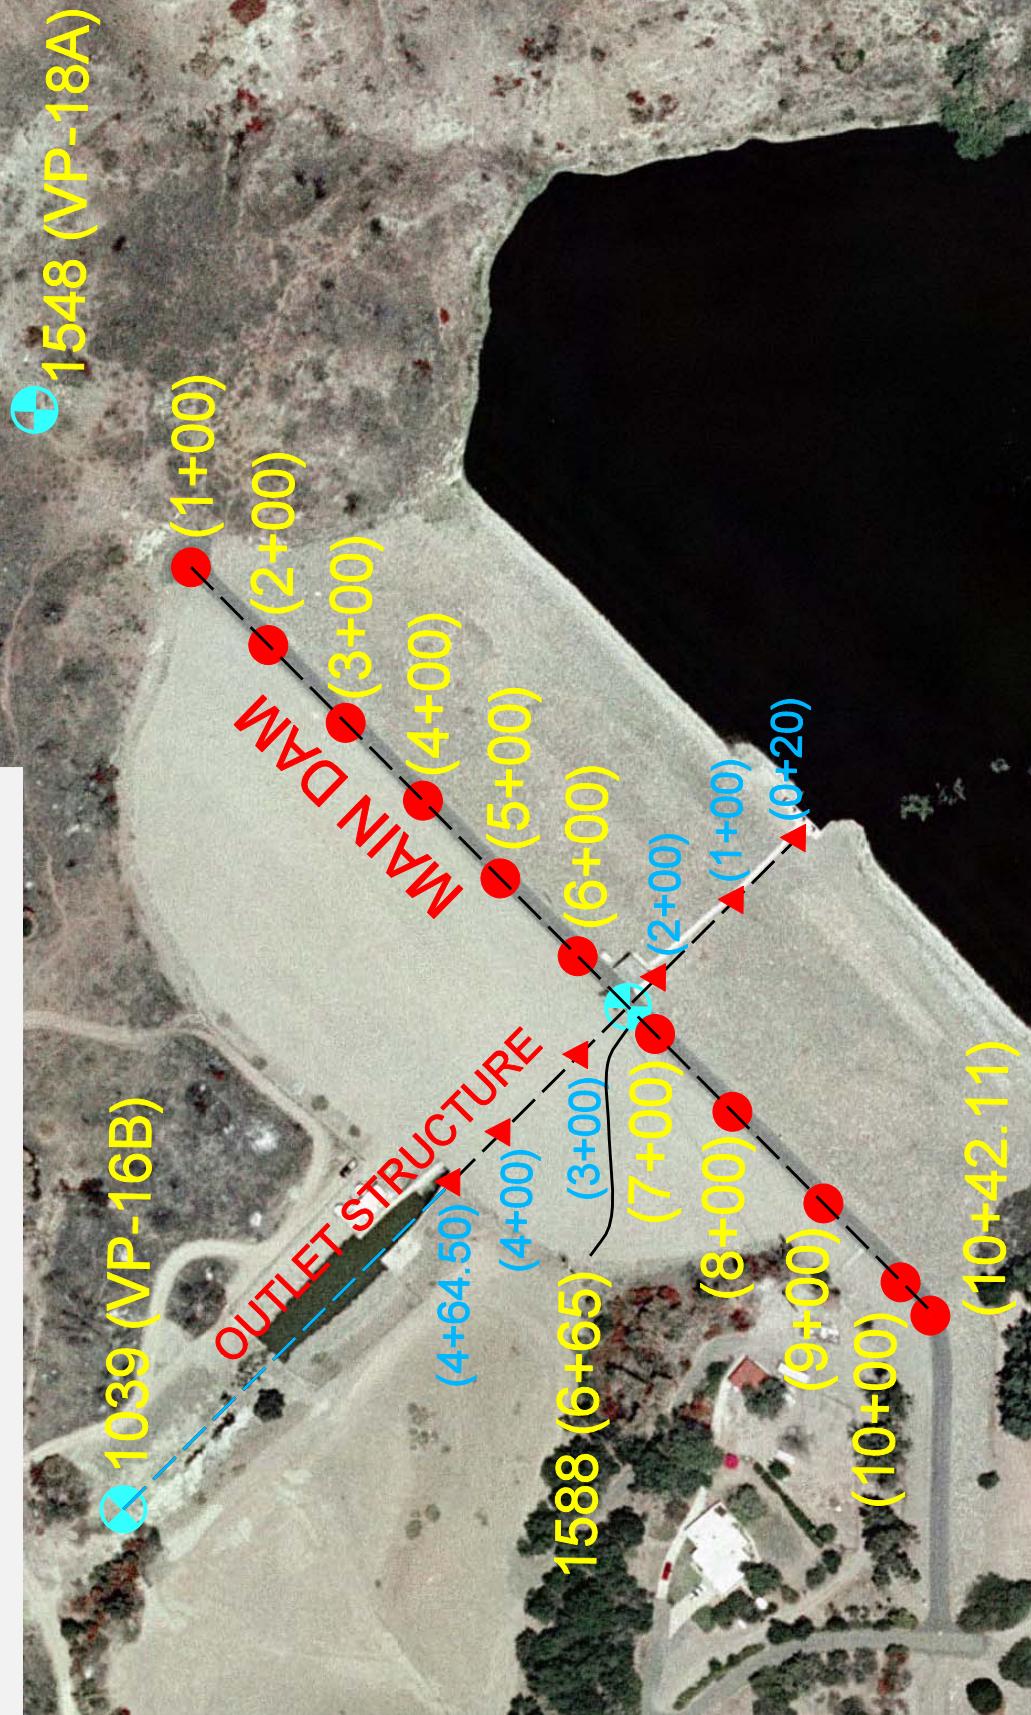
Villa Park (Outlet) Dam

● = GPS
● = CONVENTIONAL
▲ = CONVENTIONAL (TUNNEL MON.)

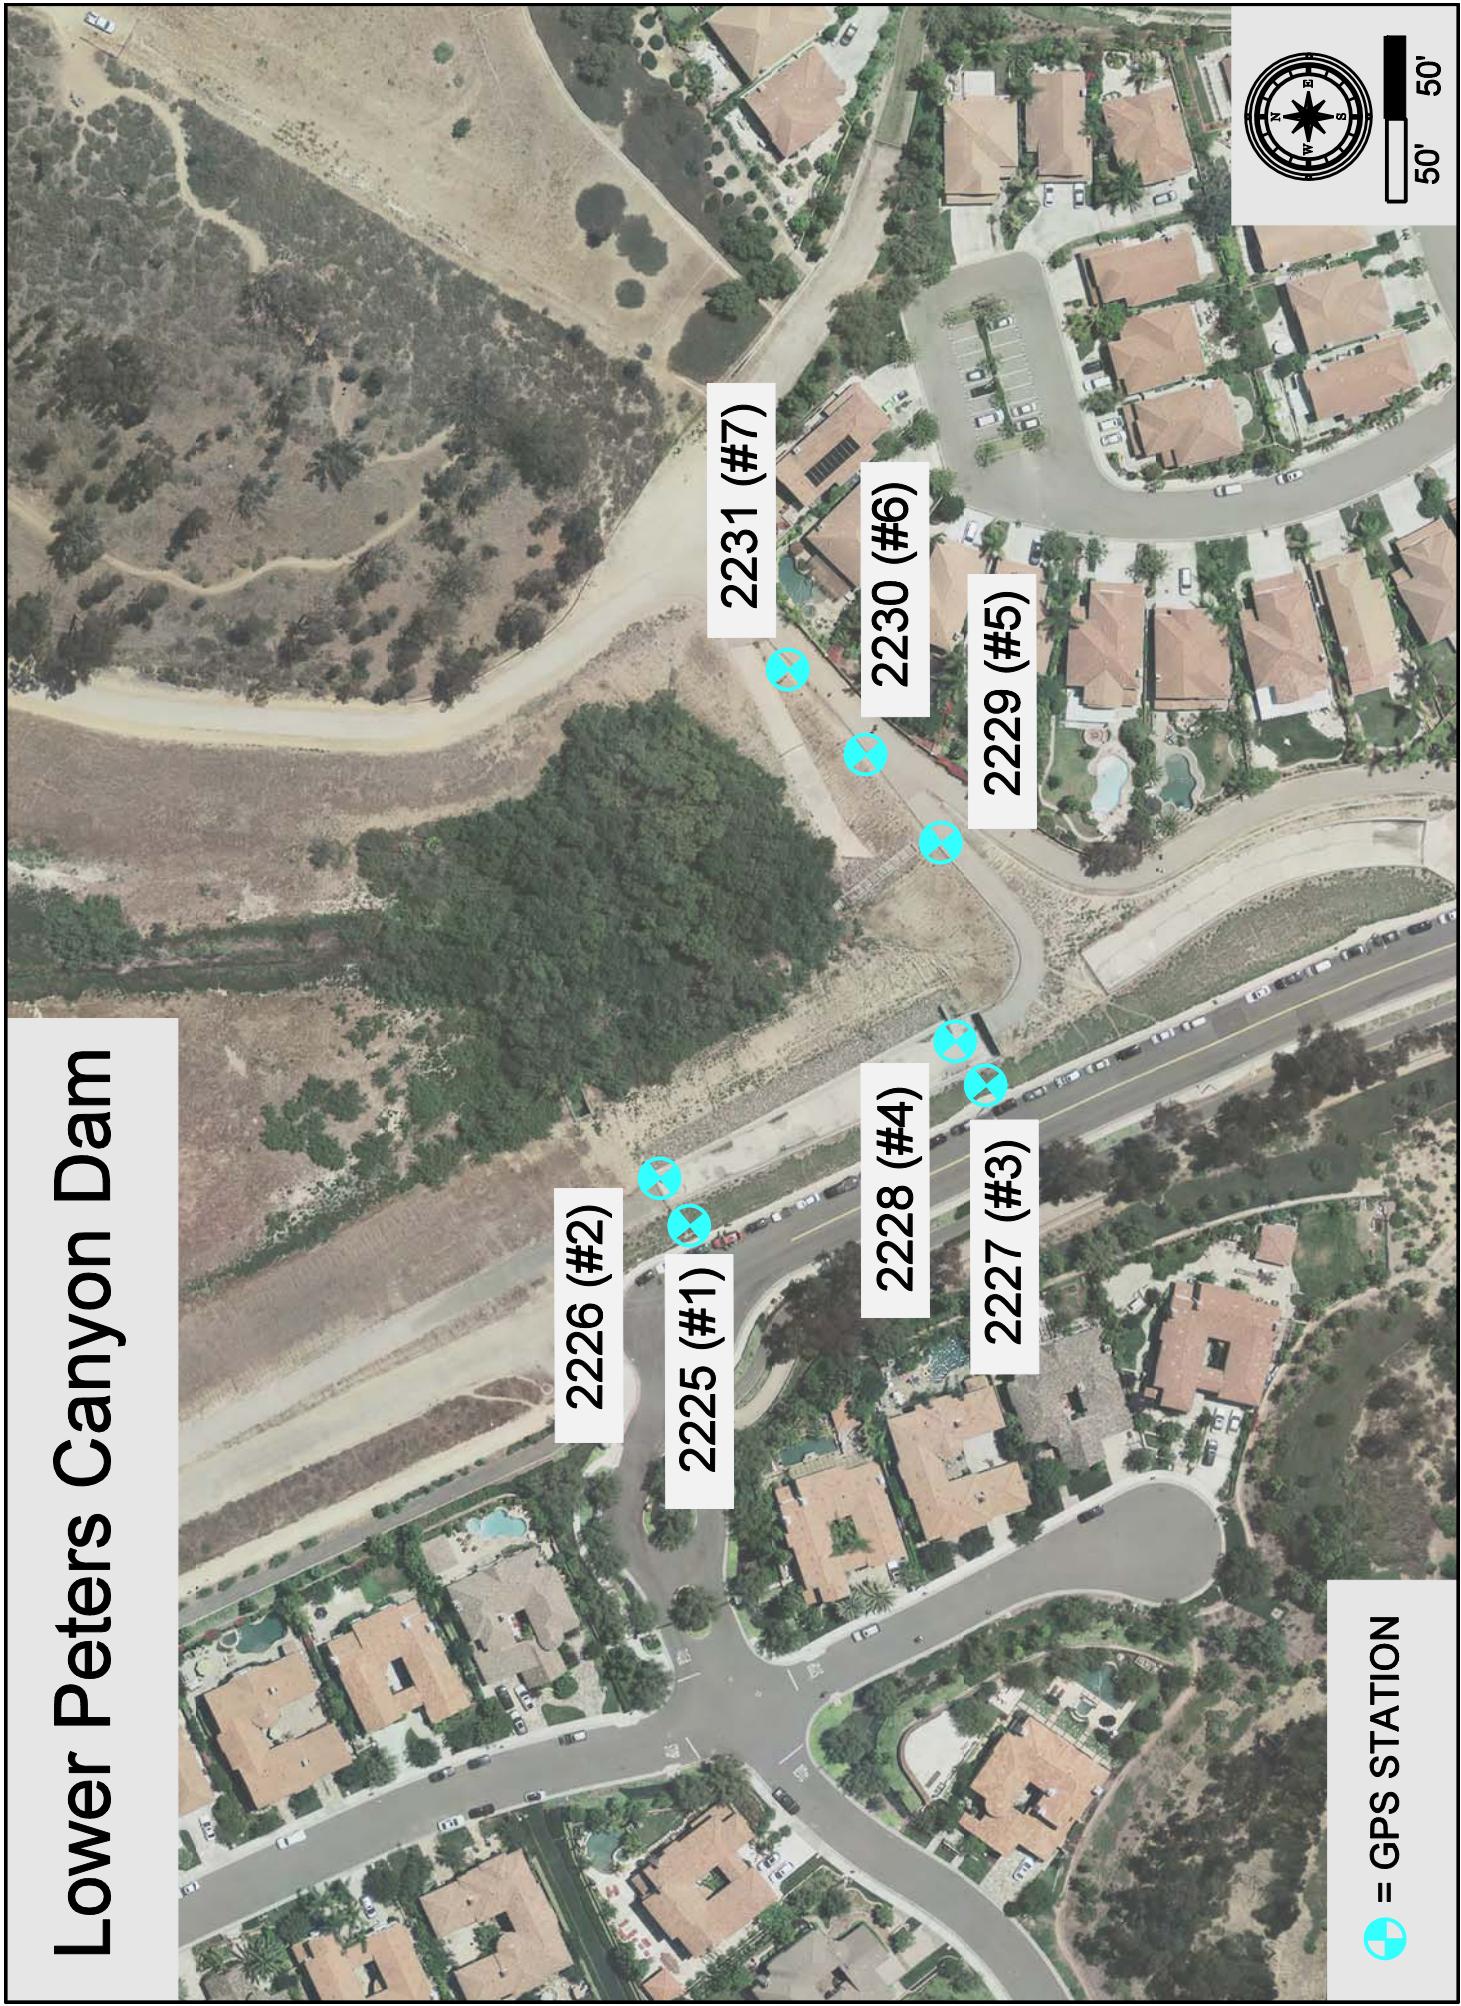
Lower Peters Canyon Dam (F06D02) Monitoring Survey

Lower Peters Canyon Dam

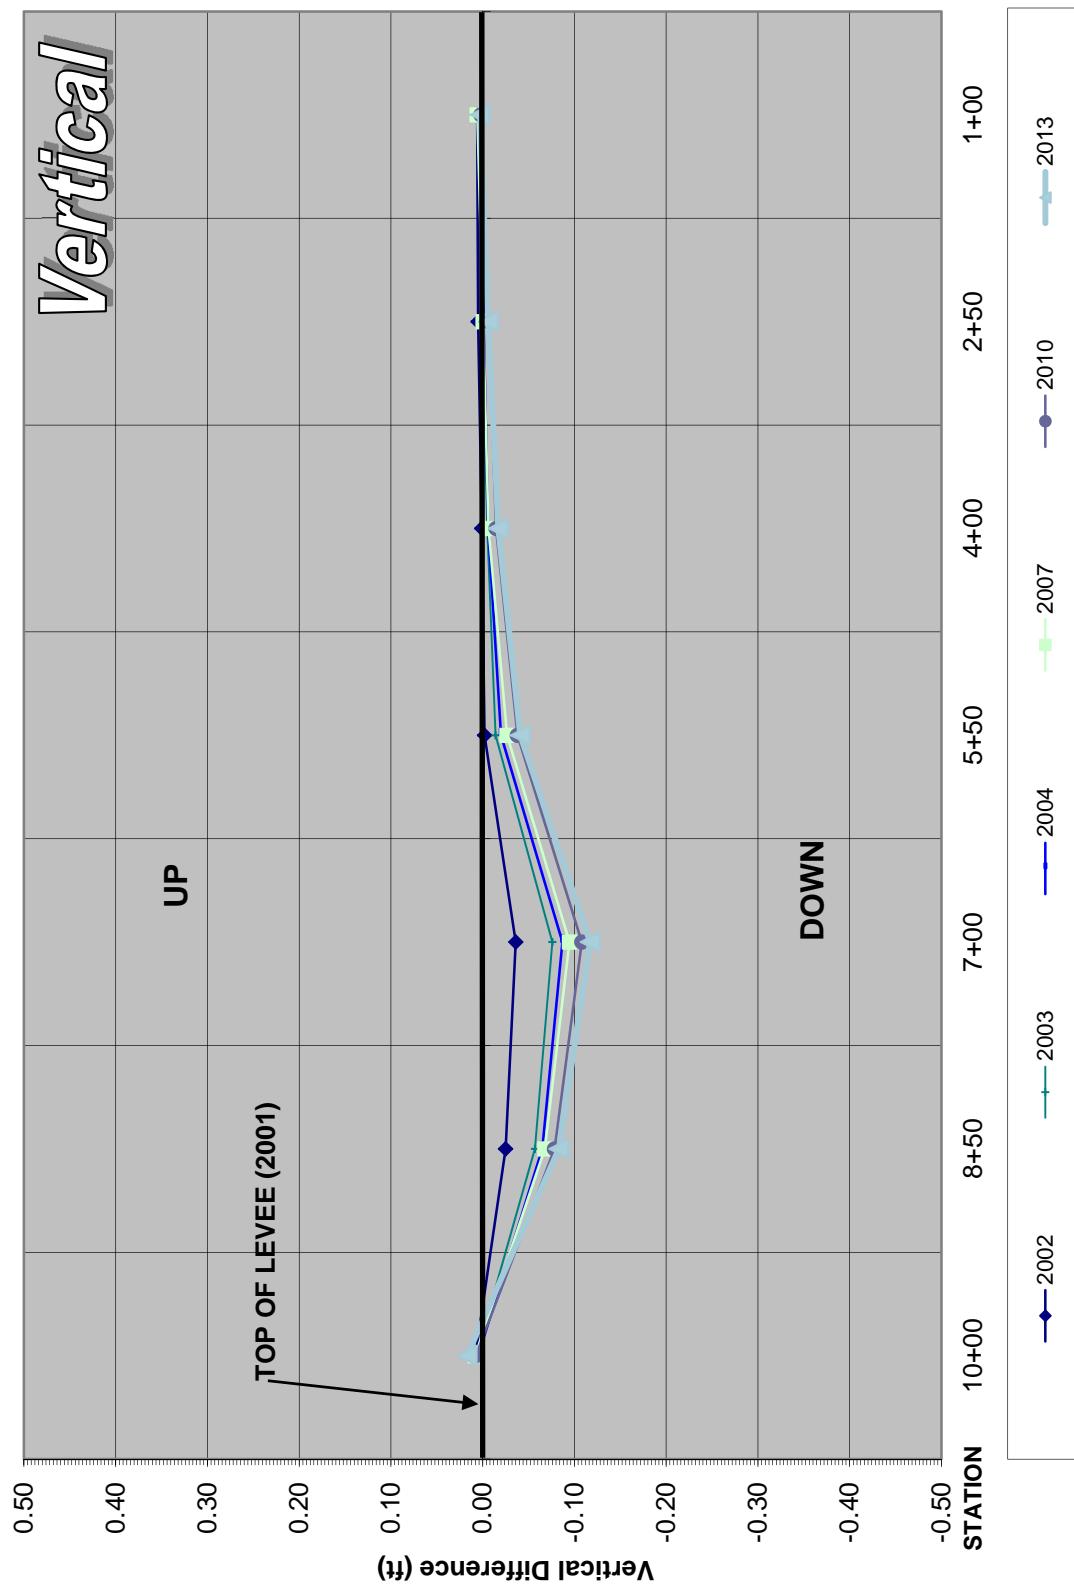
**Orchard Estates Retarding Basin
Vertical Movement (Difference from 2001 Elevations) - Profile View - Looking Upstream**

- 2001** Initial survey performed. Comparisons will begin 2002.
- 2002** No Significant Movement Detected on dam monitoring points. 2002 height of benchmark "Orchard" located on spillway headwall differs by -0.10' than 2001 height.
- 2003** Stations 7+00 and 8+50 show gradual settling.
- 2004** No Significant Movement Detected.
- 2007** No Significant Movement Detected.
- 2010** No Significant Movement Detected.
- 2013** Station 7+00 shows slight horizontal movement downstream. Stations 7+00 and 8+00 show continual vertical settling.

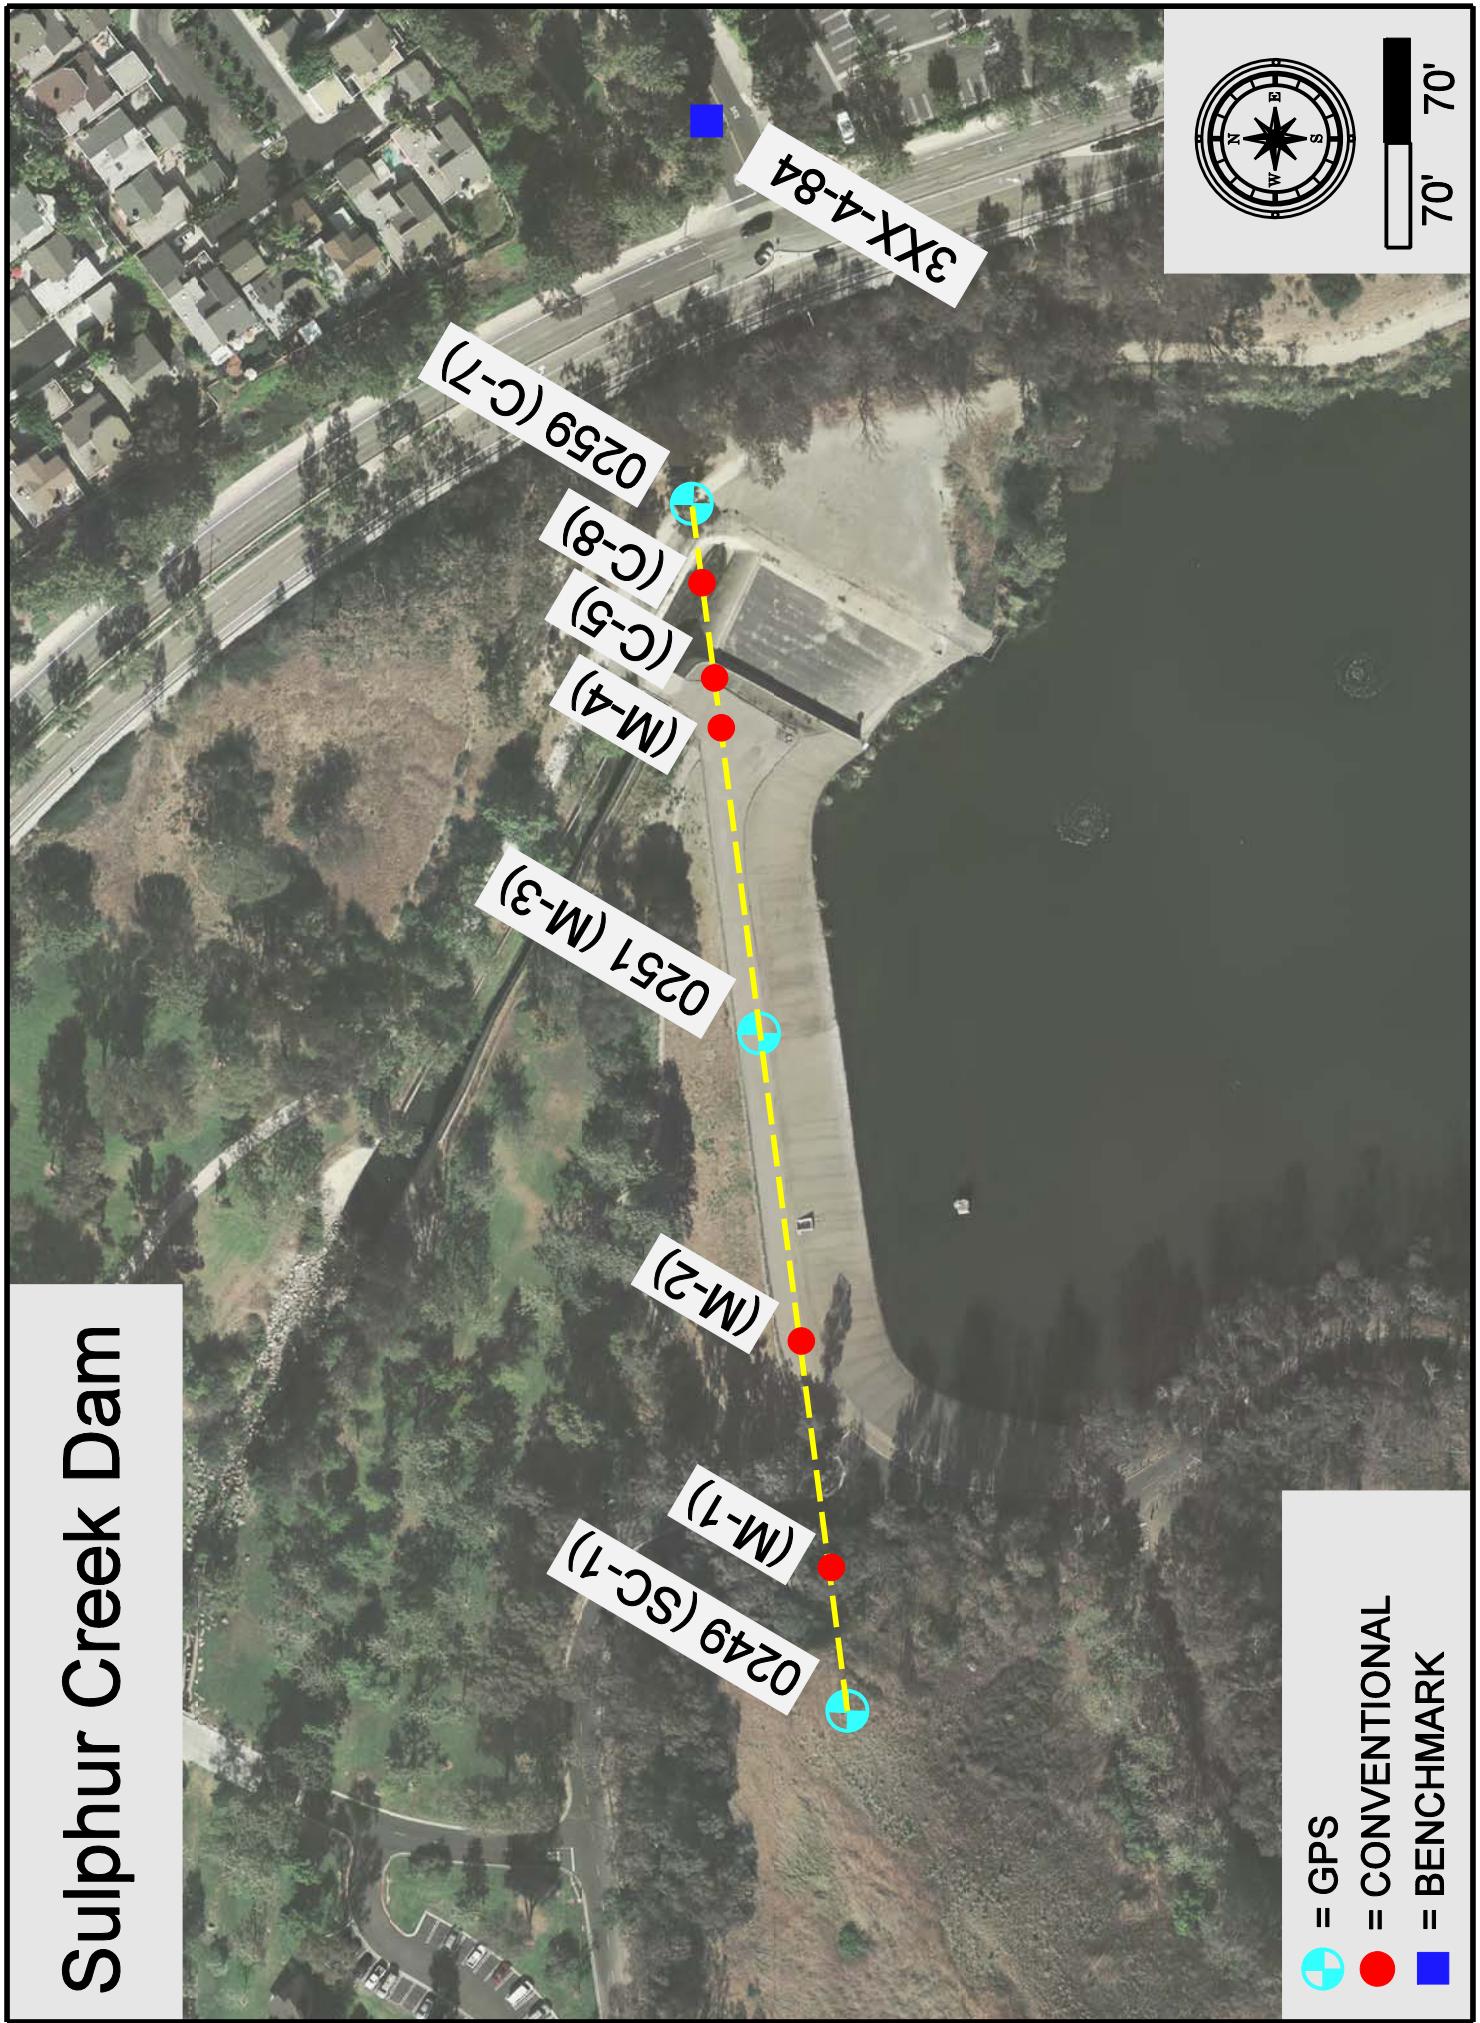
Sulphur Creek Dam (J03D01) Monitoring Survey

○ = GPS
● = CONVENTIONAL
■ = BENCHMARK

Control points "SC-1" and "SC-2" are held for **Out From Line** calculations until 1993. In 1993, "SC-2" was found disturbed and replaced by "C-7" for line.
Negative numbers represent stations right of line (downstream), positive numbers represent stations left of line (upstream).

| 1981-1990 | Downstream horizontal movement measured on all stations located on top of dam. Vertical uplift is found on all stations. |
| 2002 | Same horizontal trend continues. Vertical appears stable. C-6 was destroyed due to spillway construction and has been replaced by C-8. |

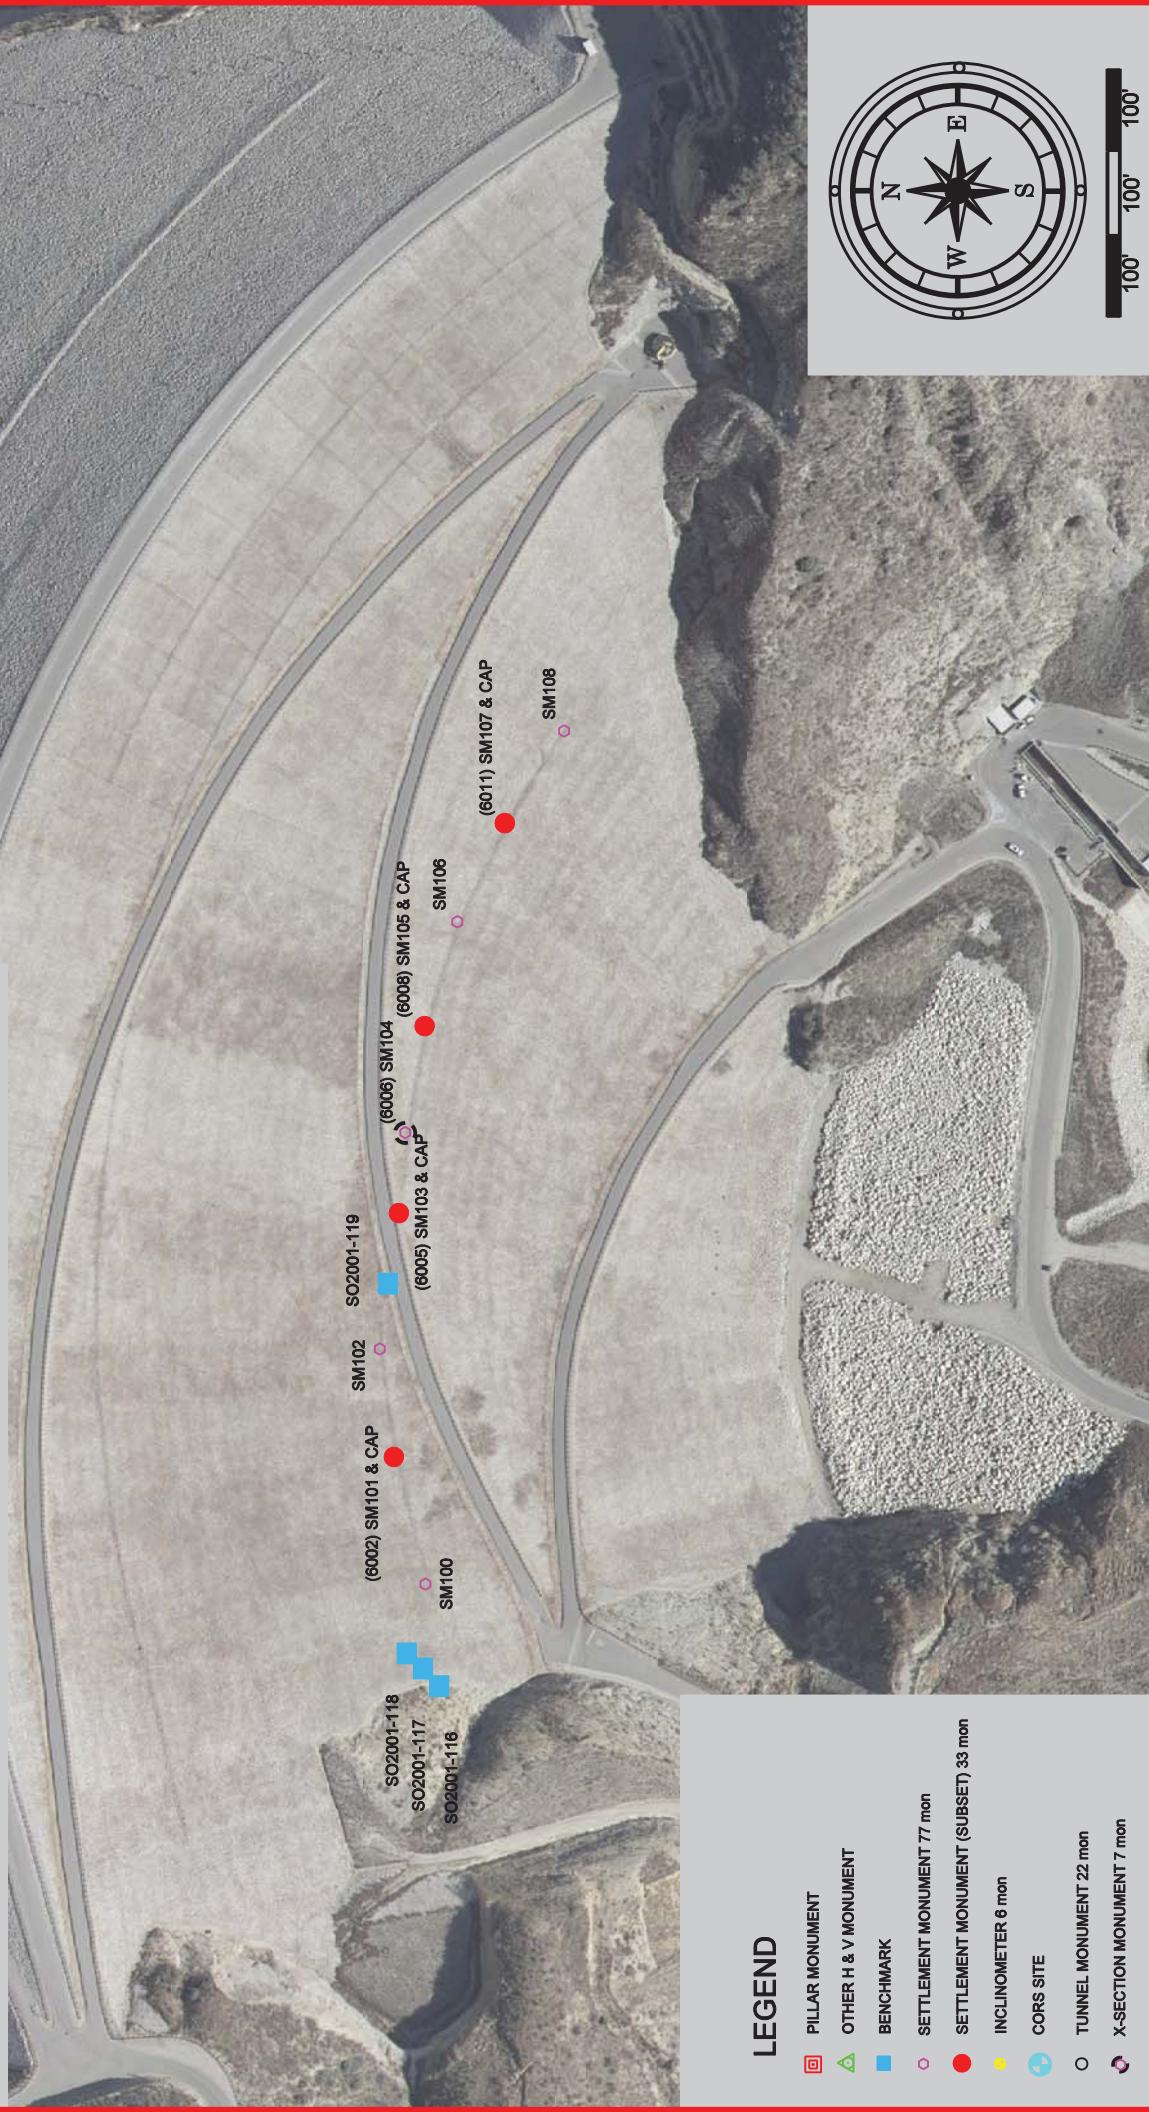
Seven Oaks Dam Monitoring Survey Downstream 2310' Level - Monitoring Points

Seven Oaks Dam - Downstream 2310' Level (Horizontal) Horizontal Movement since January 2001 Initial Survey

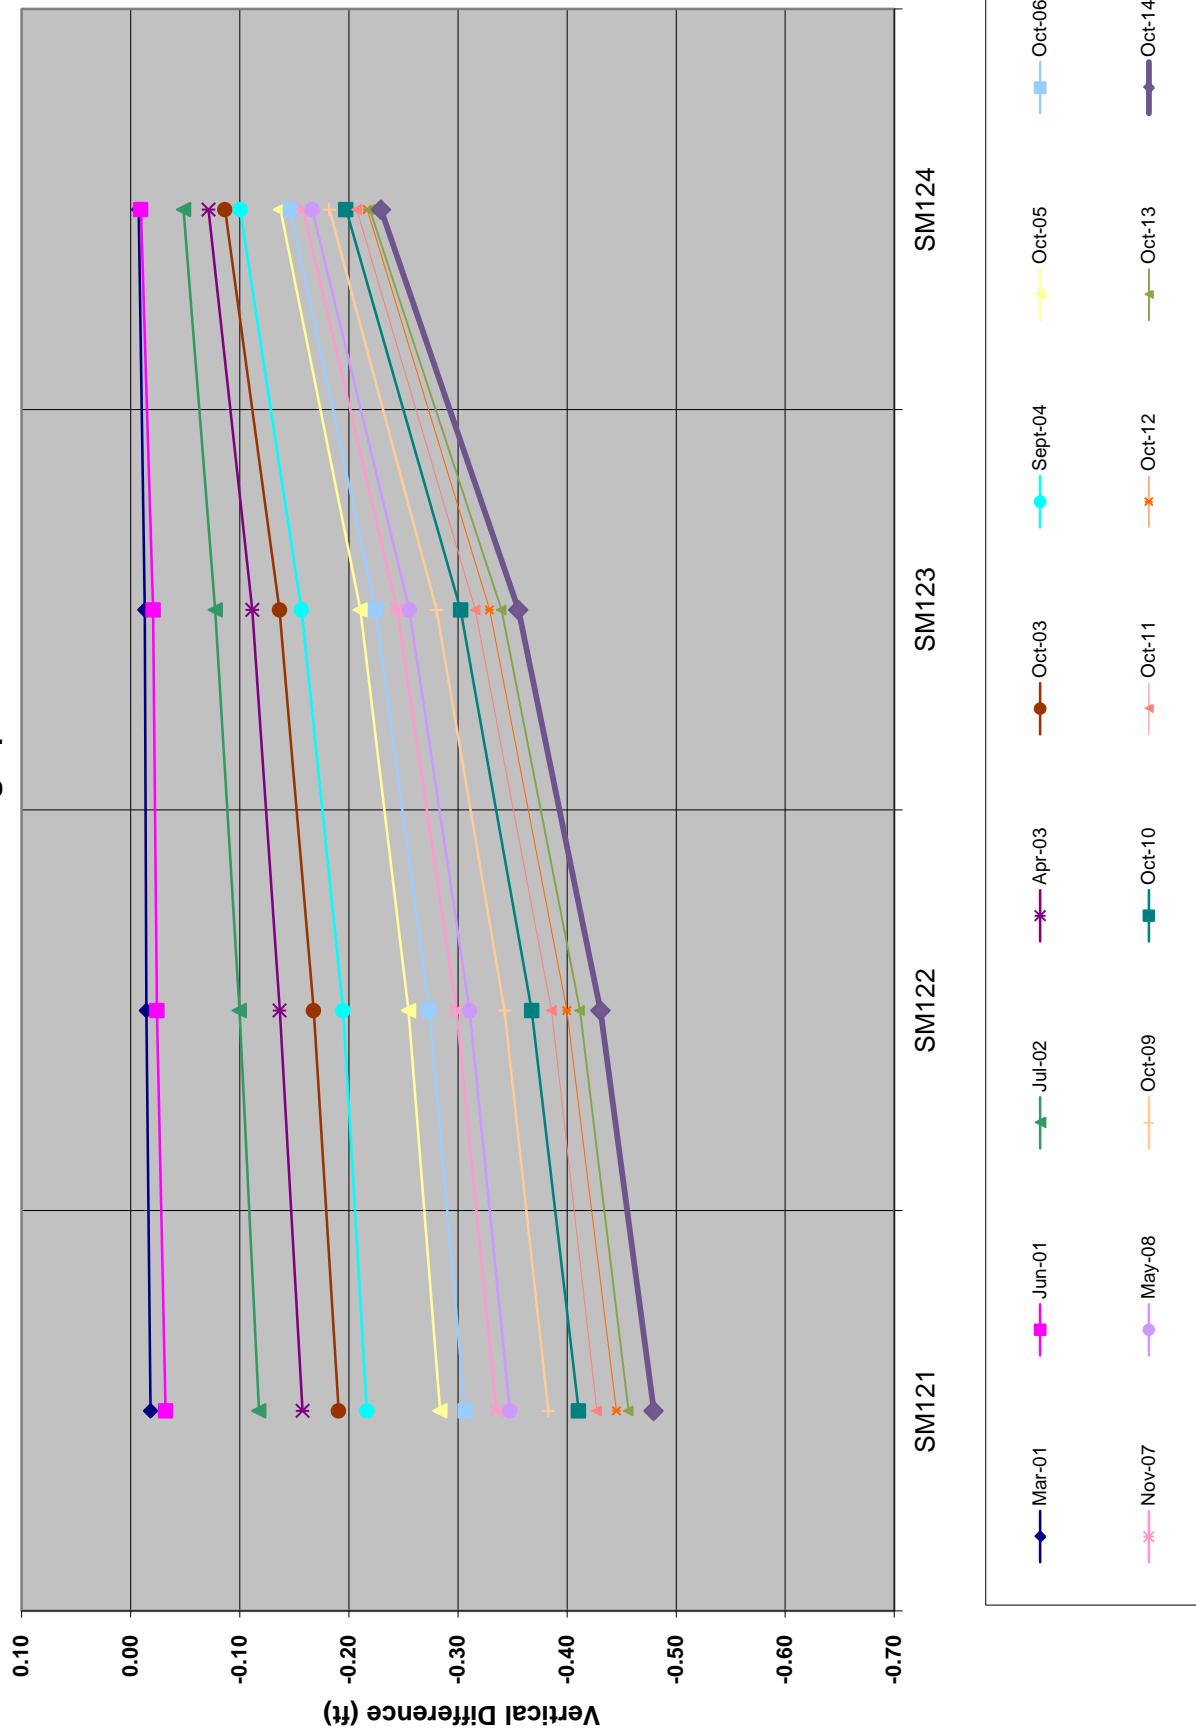
**Seven Oaks Dam - Downstream 2560' Level
Vertical Movement since January 2001 Survey
Profile View - Looking Upstream**

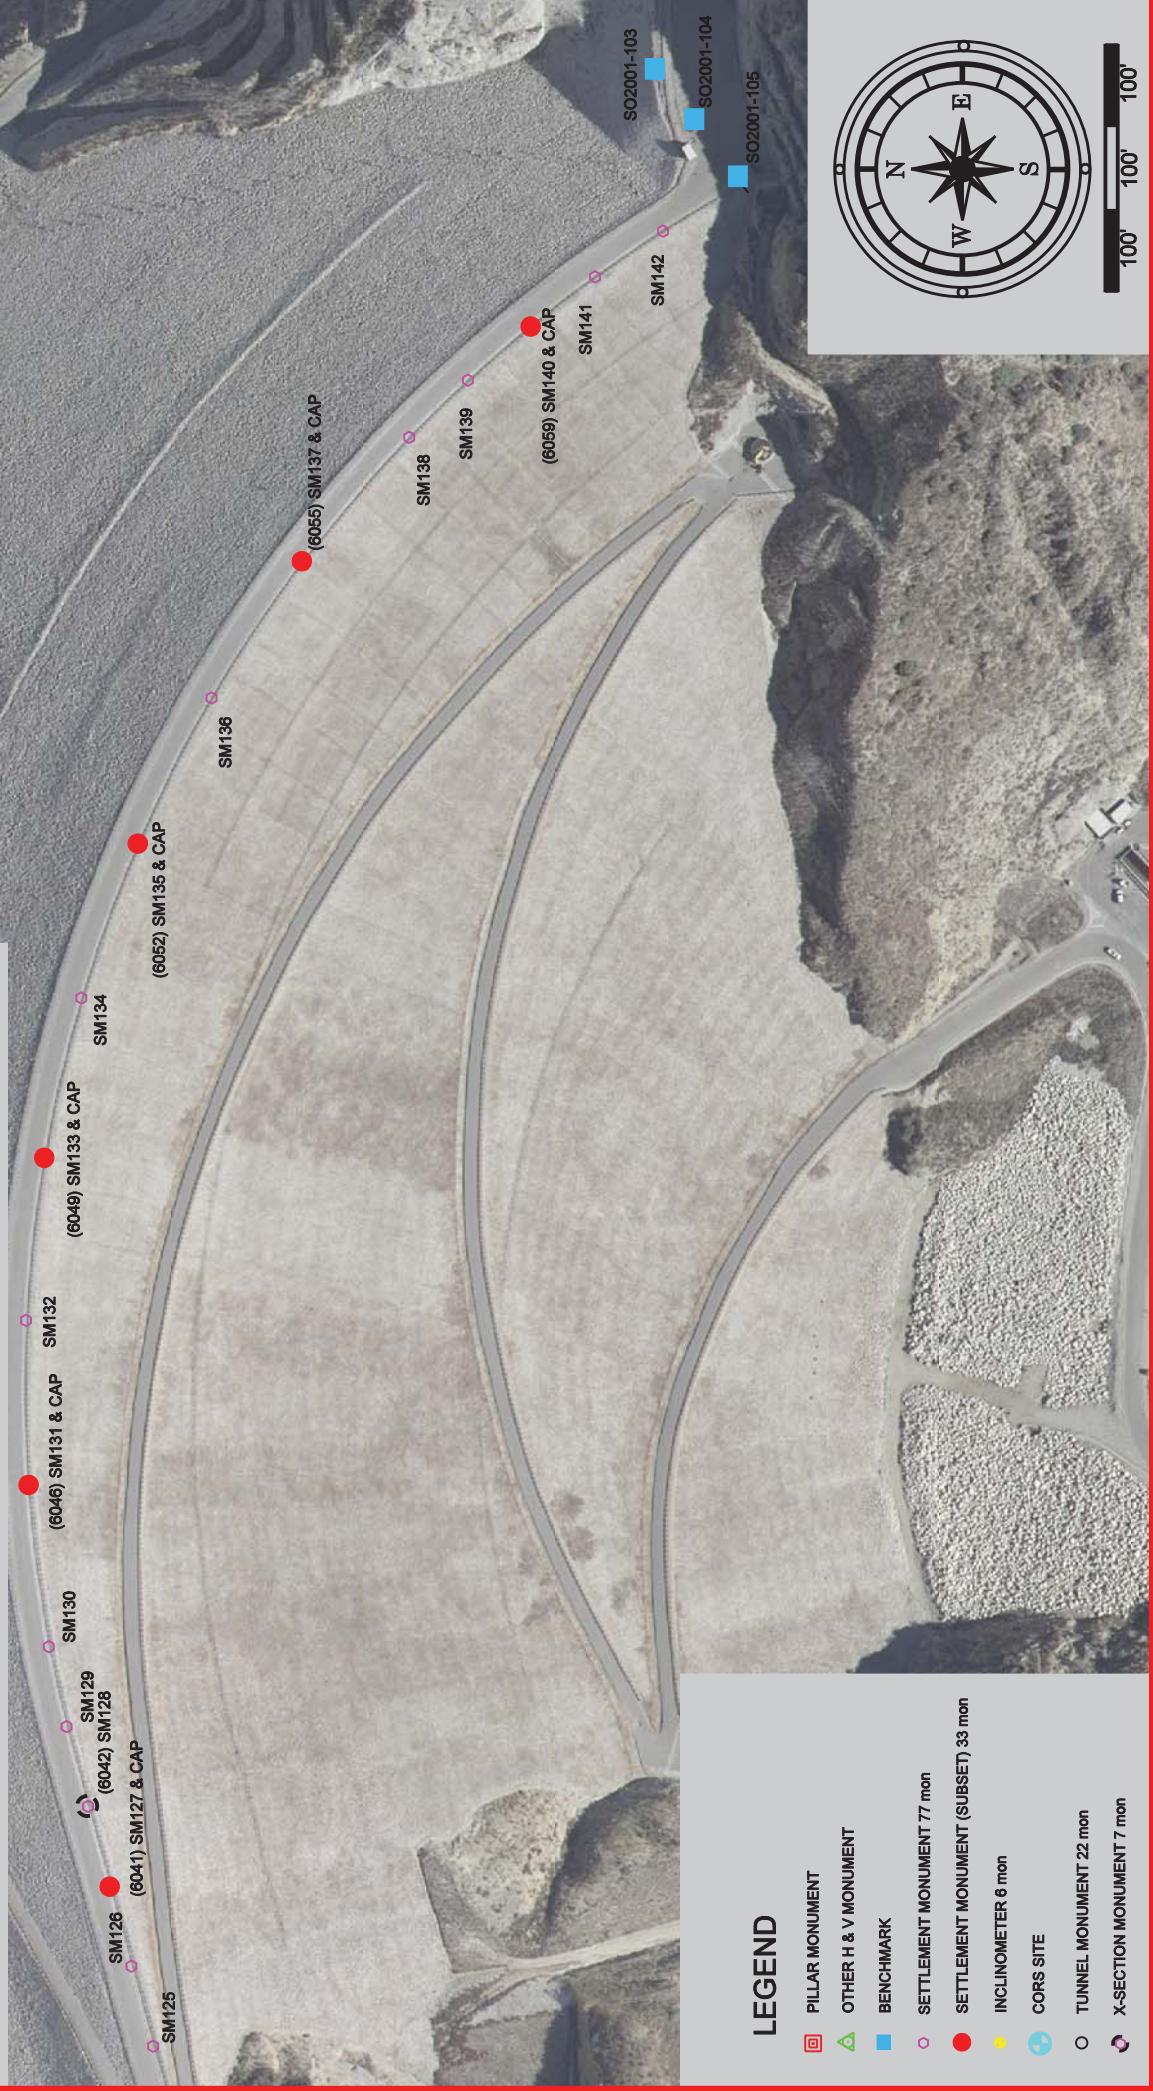
Seven Oaks Dam Monitoring Survey Downstream Top of Dam - Monitoring Points

Seven Oaks Dam - Downstream Top of Dam (Horizontal) Horizontal Movement since January 2001 Survey

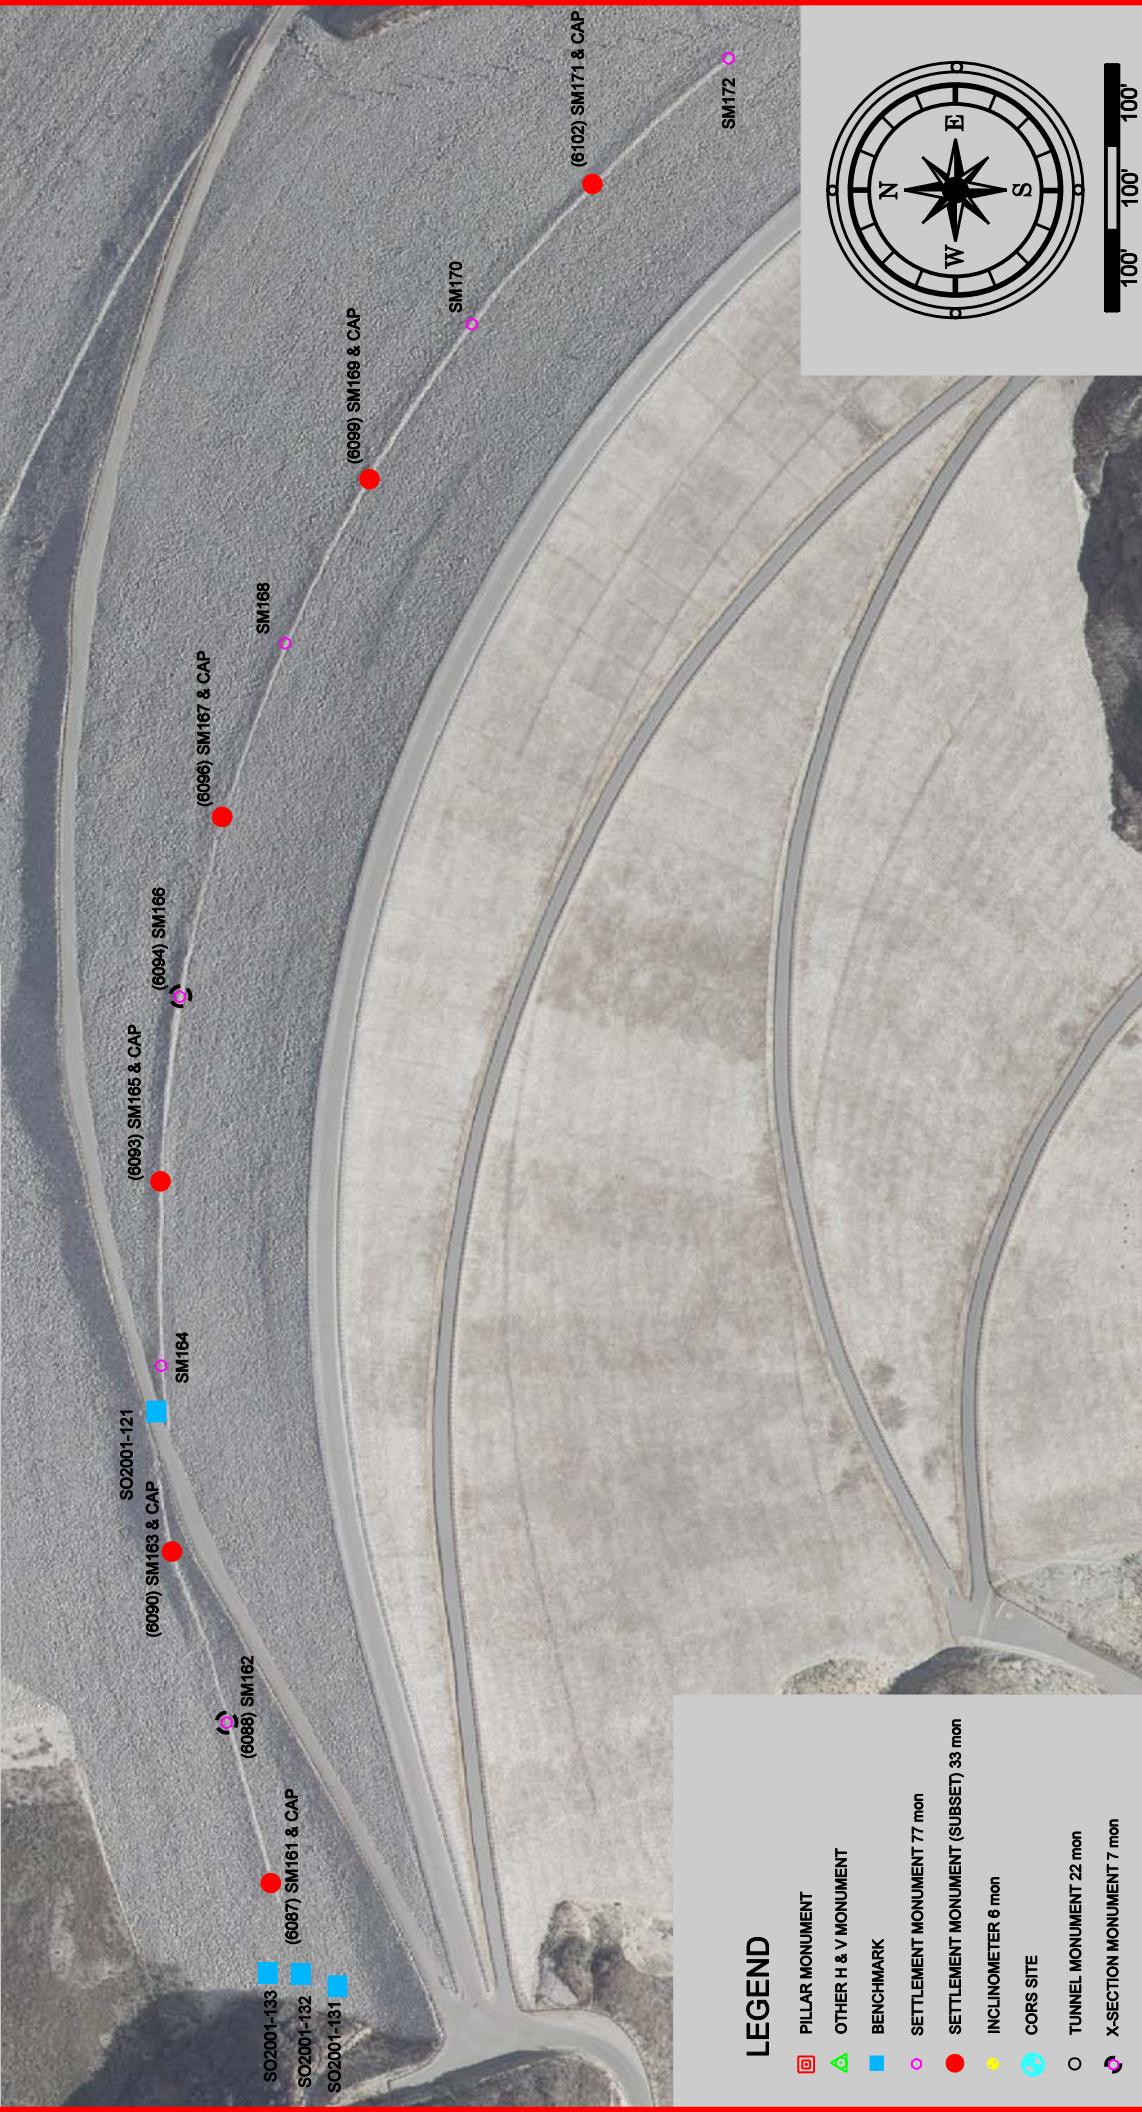
Seven Oaks Dam Monitoring Survey Upstream 2530' Level - Monitoring Points

Seven Oaks Dam - Upstream 2530' level (Horizontal) Horizontal Movement since January 2001 Survey

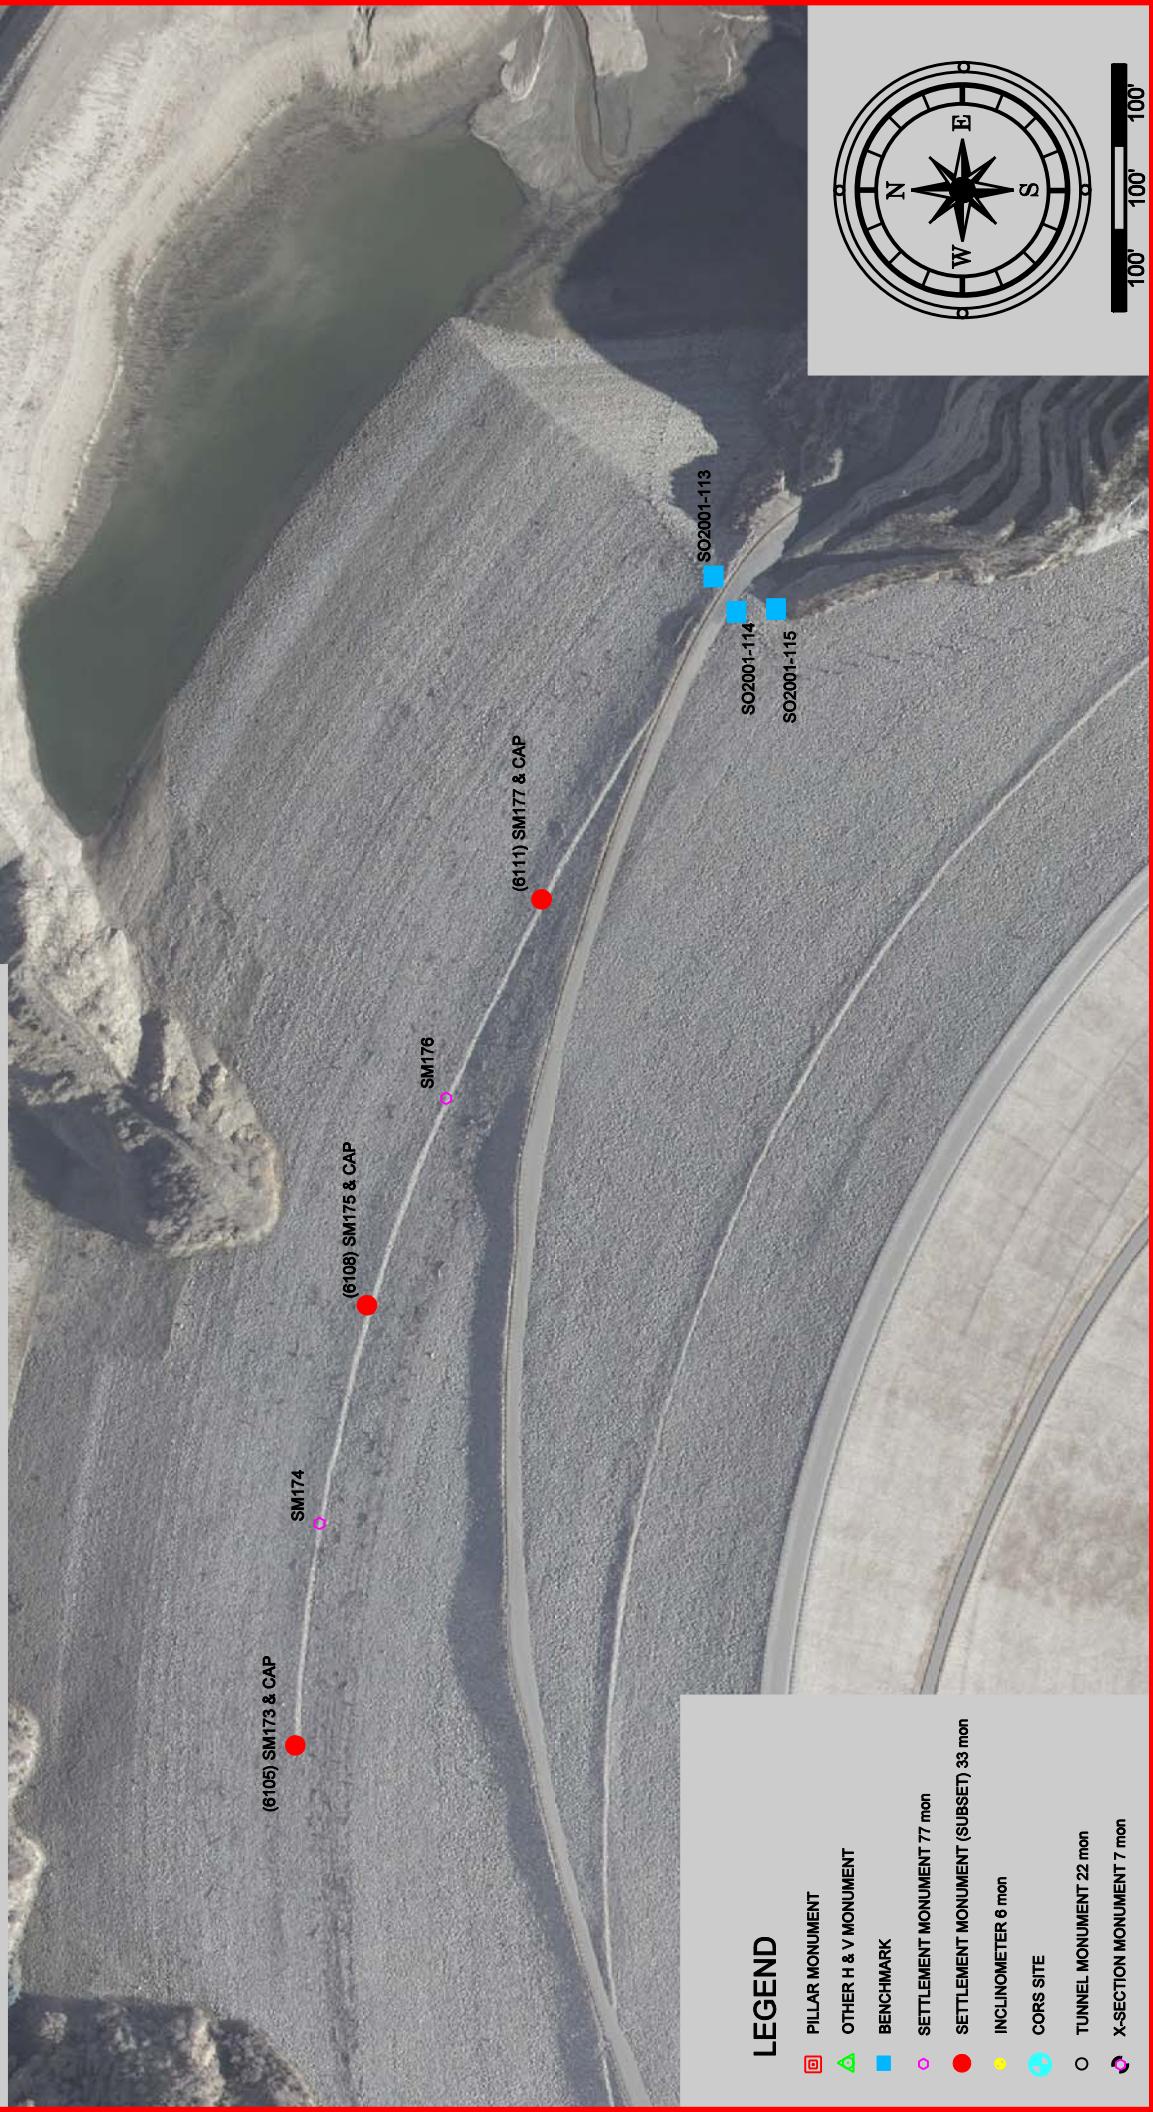
Seven Oaks Dam Monitoring Survey Upstream 2360' Level - Monitoring Points

Seven Oaks Dam - Upstream 2360' level (Horizontal) Horizontal Movement since January 2001 Survey
