Subsidence and Deformation Monitoring Studies 2014

OC Survey
Geodetic Unit

Dam Monitoring Survey Reports

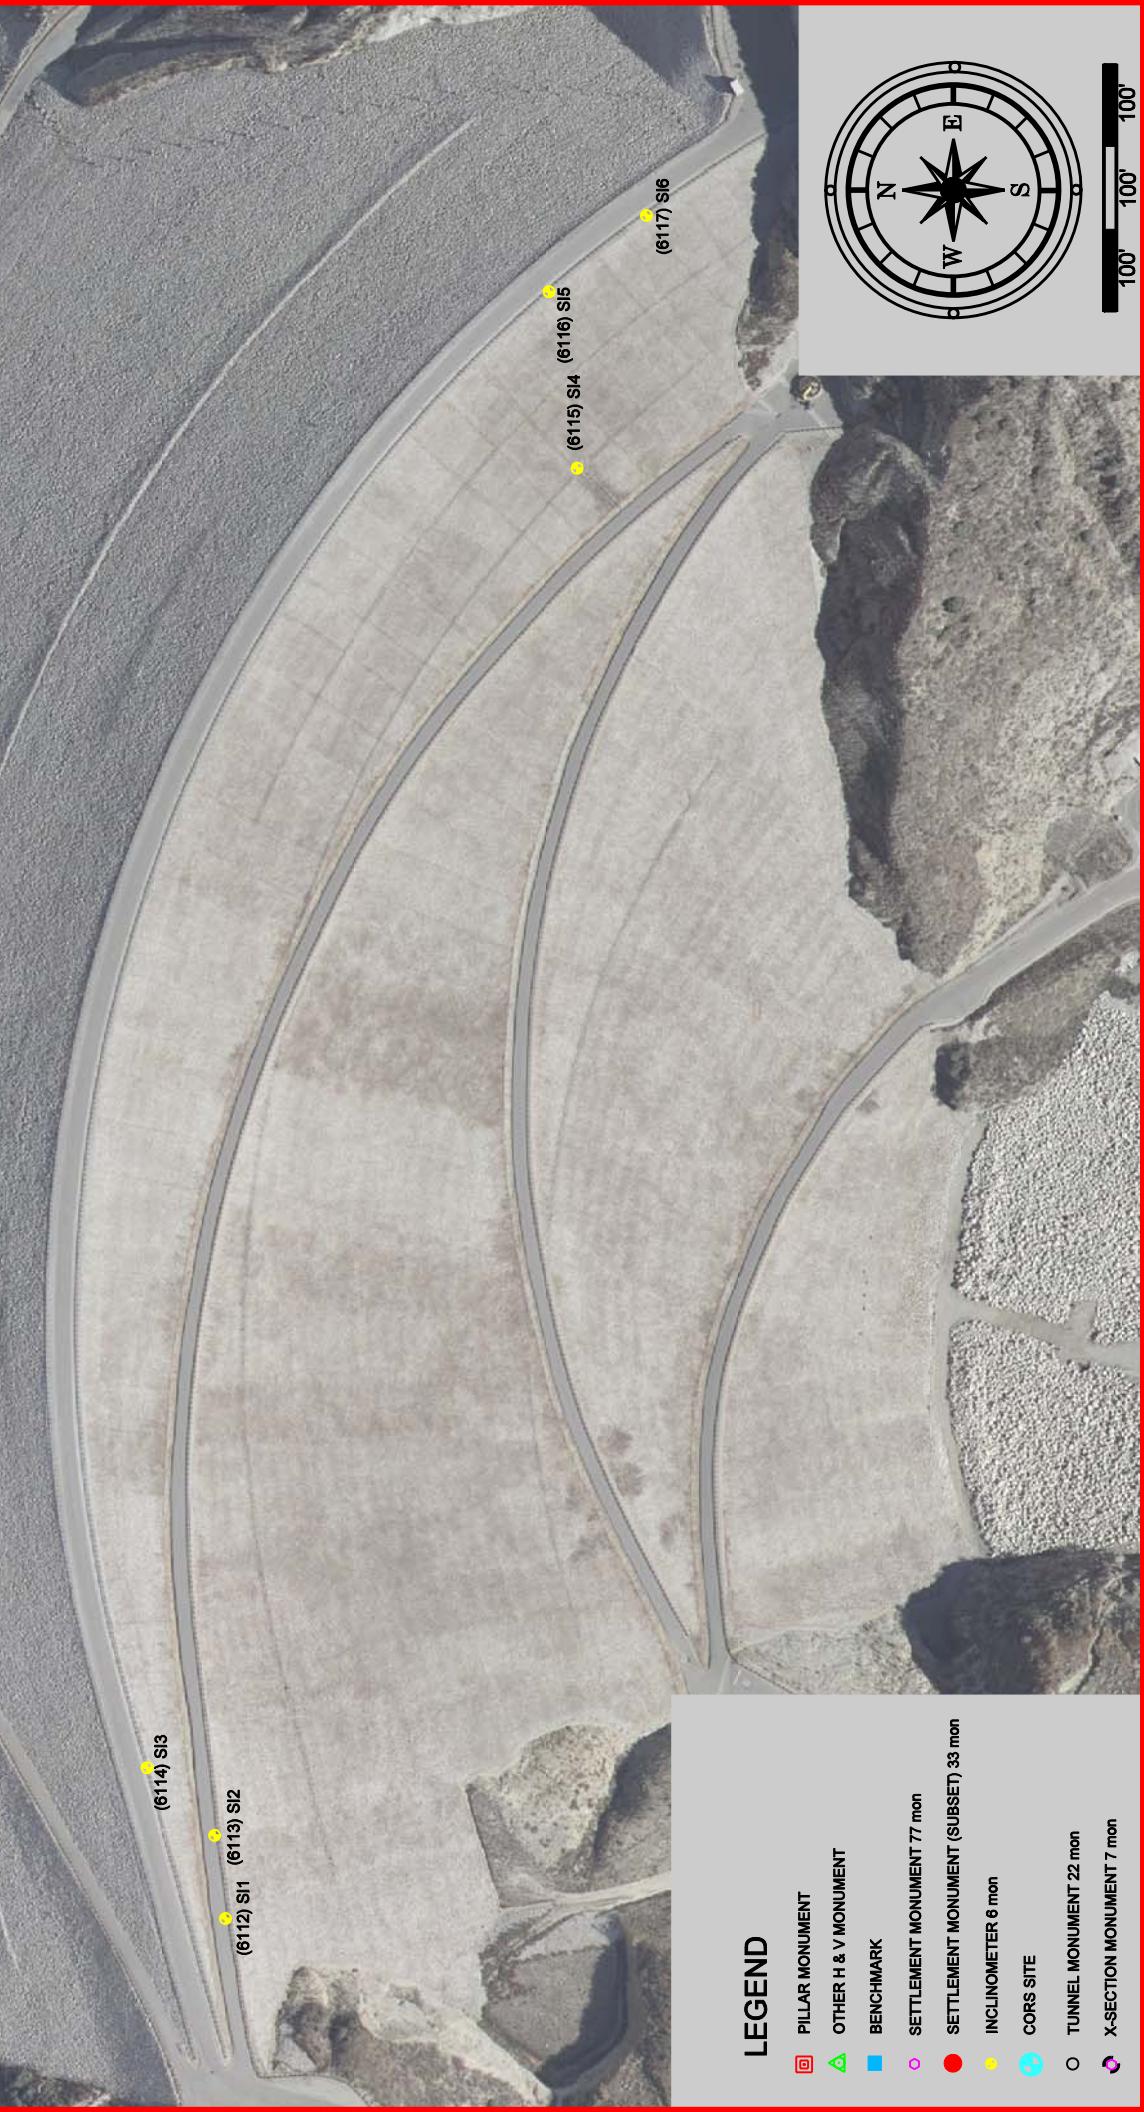
Seven Oaks Dam Monitoring Survey Inclinometer Locations - Monitoring Points

Seven Oaks Dam - Inclinometers (Horizontal)

Horizontal Movement since January 2001 Survey

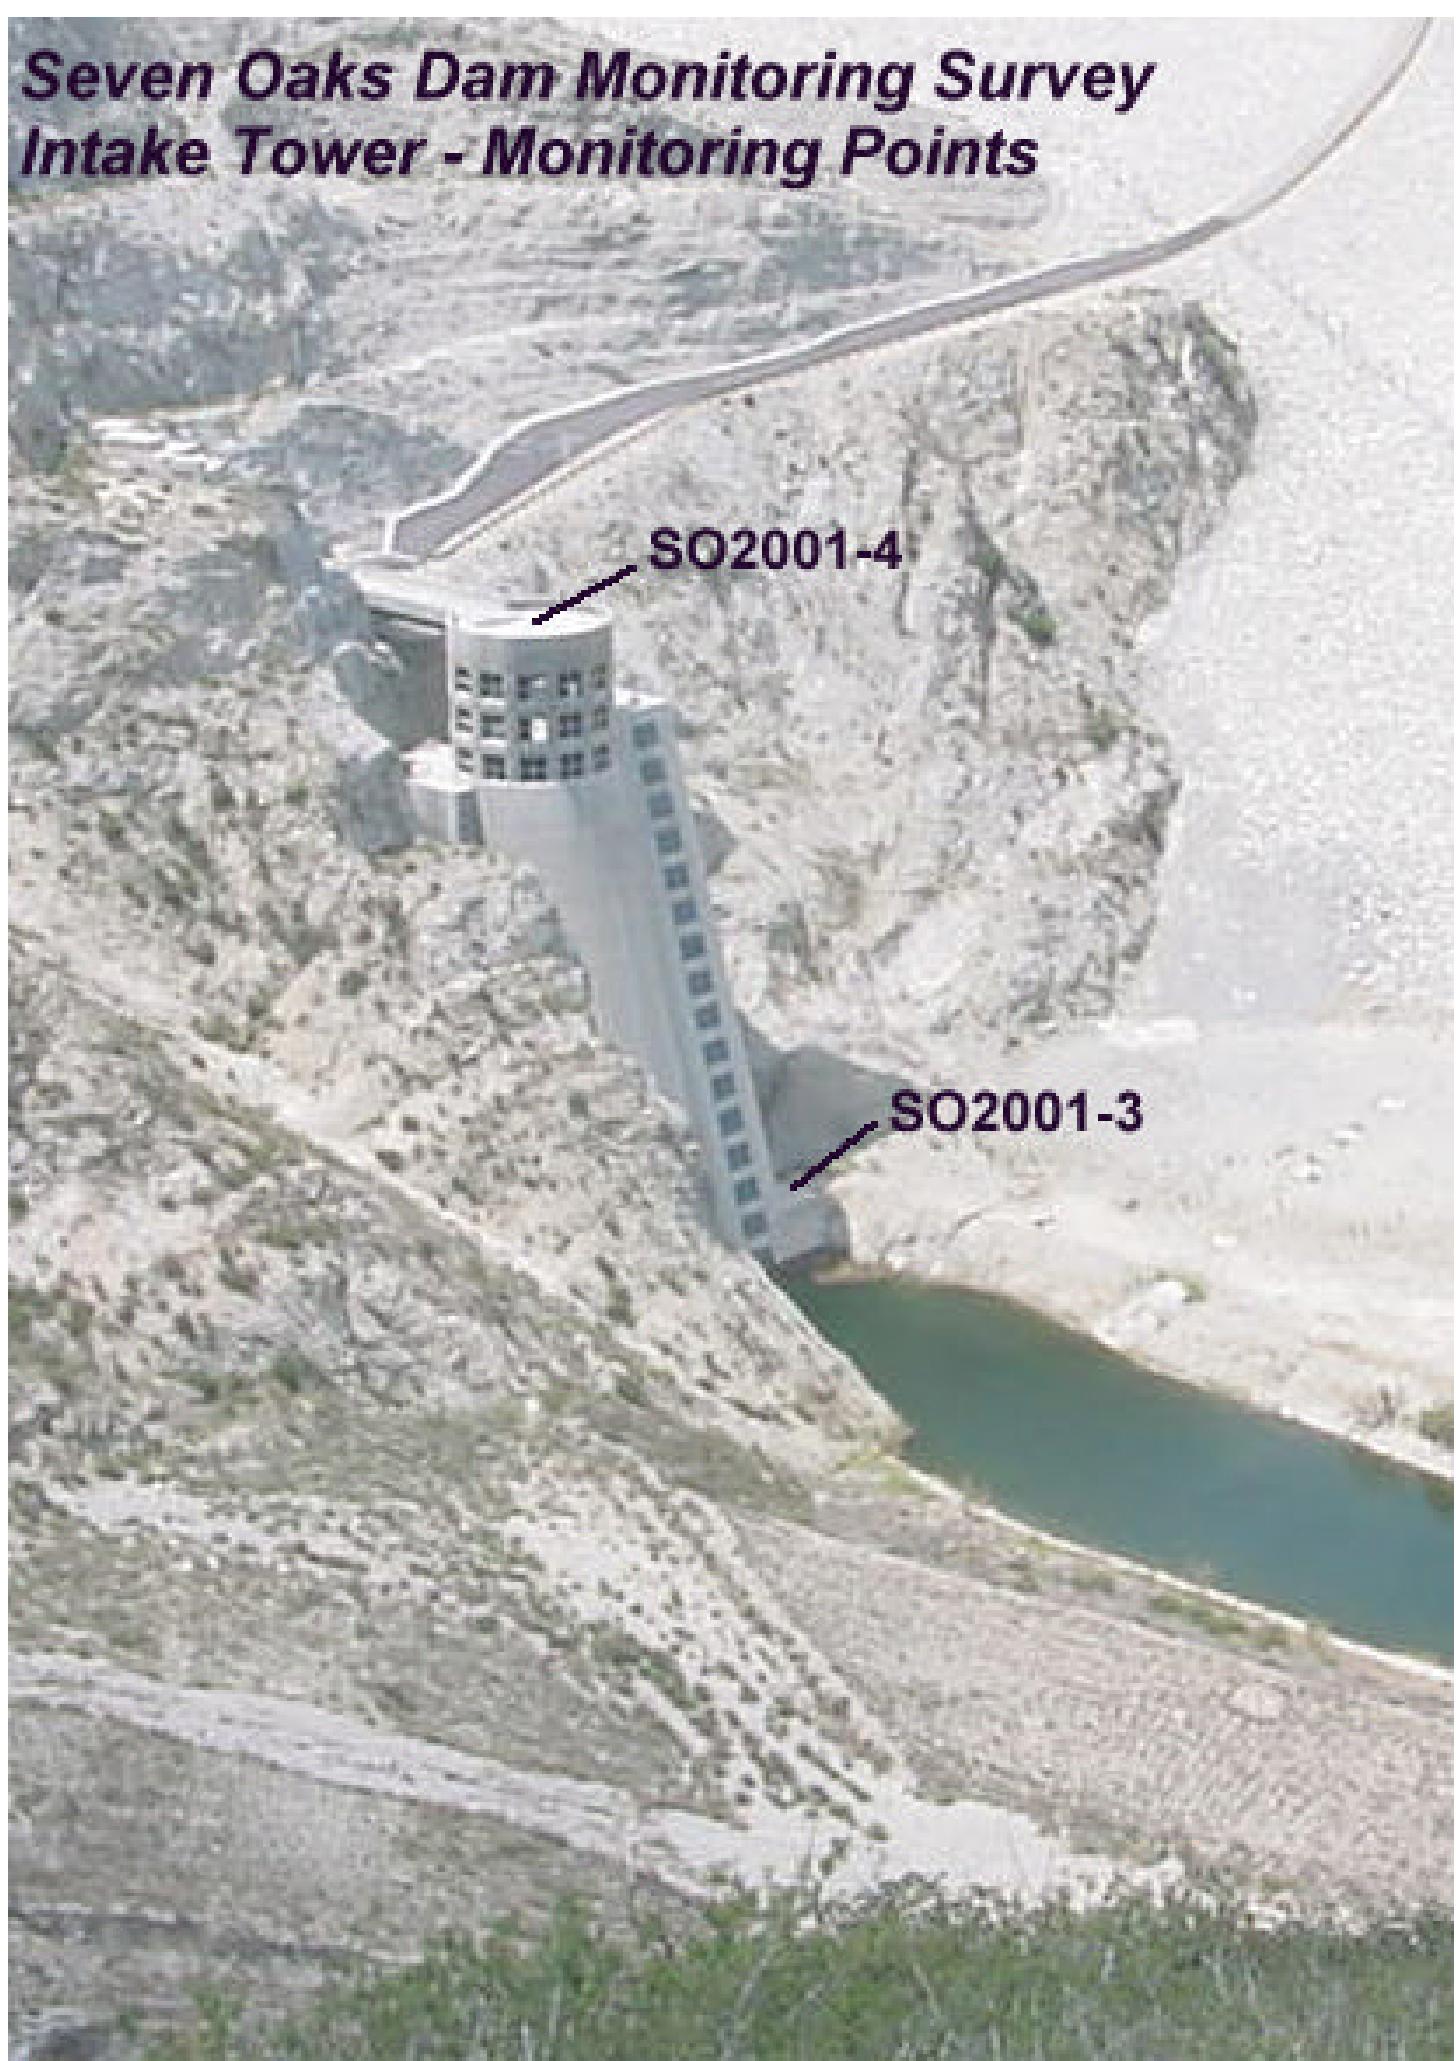
Intake Tower - Monitoring Points

Seven Oaks Dam - Intake Tower Structure (Horizontal) Horizontal Movement since January 2001 Initial Survey

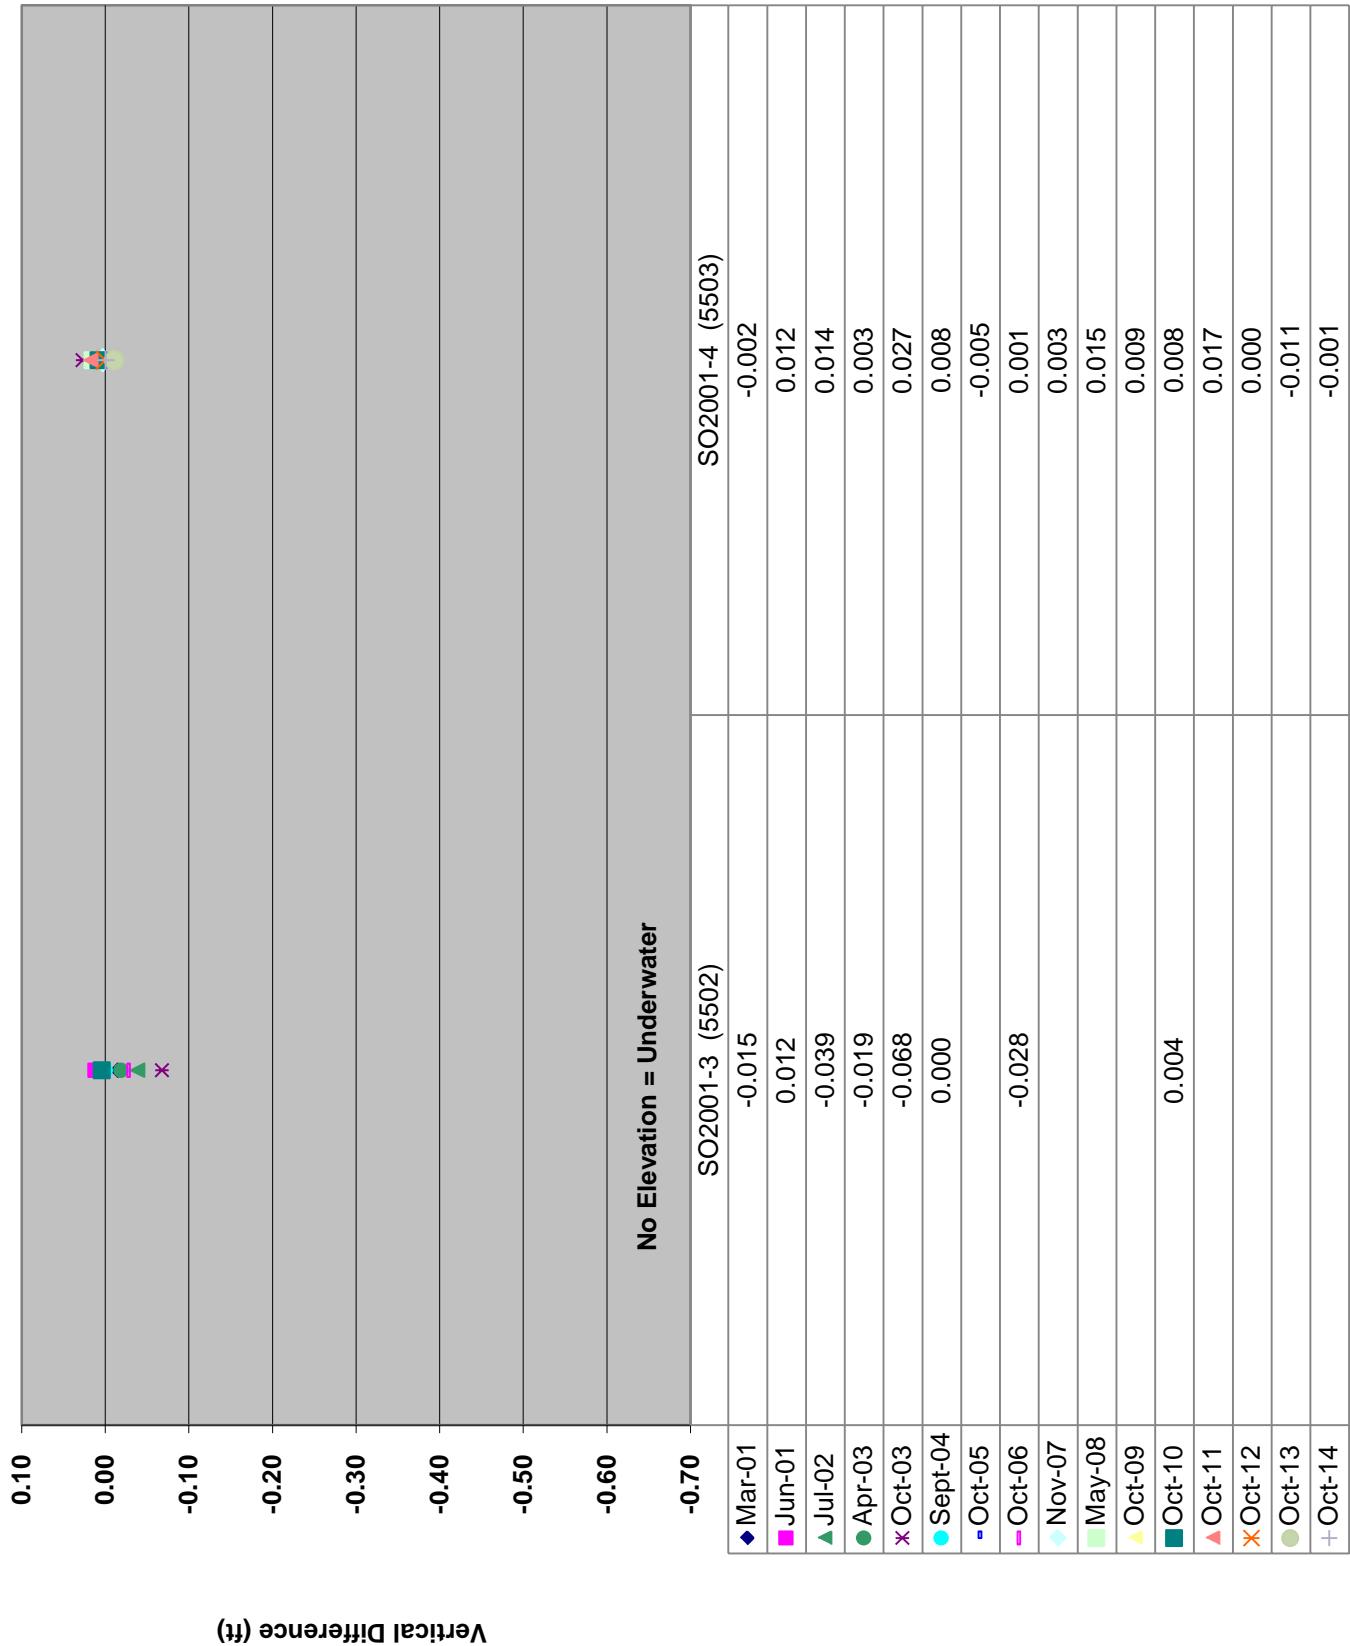
Seven Oaks Dam - Intake Structure
 Vertical Movement since January 2001 Survey
