## Trabuco Oaks Road

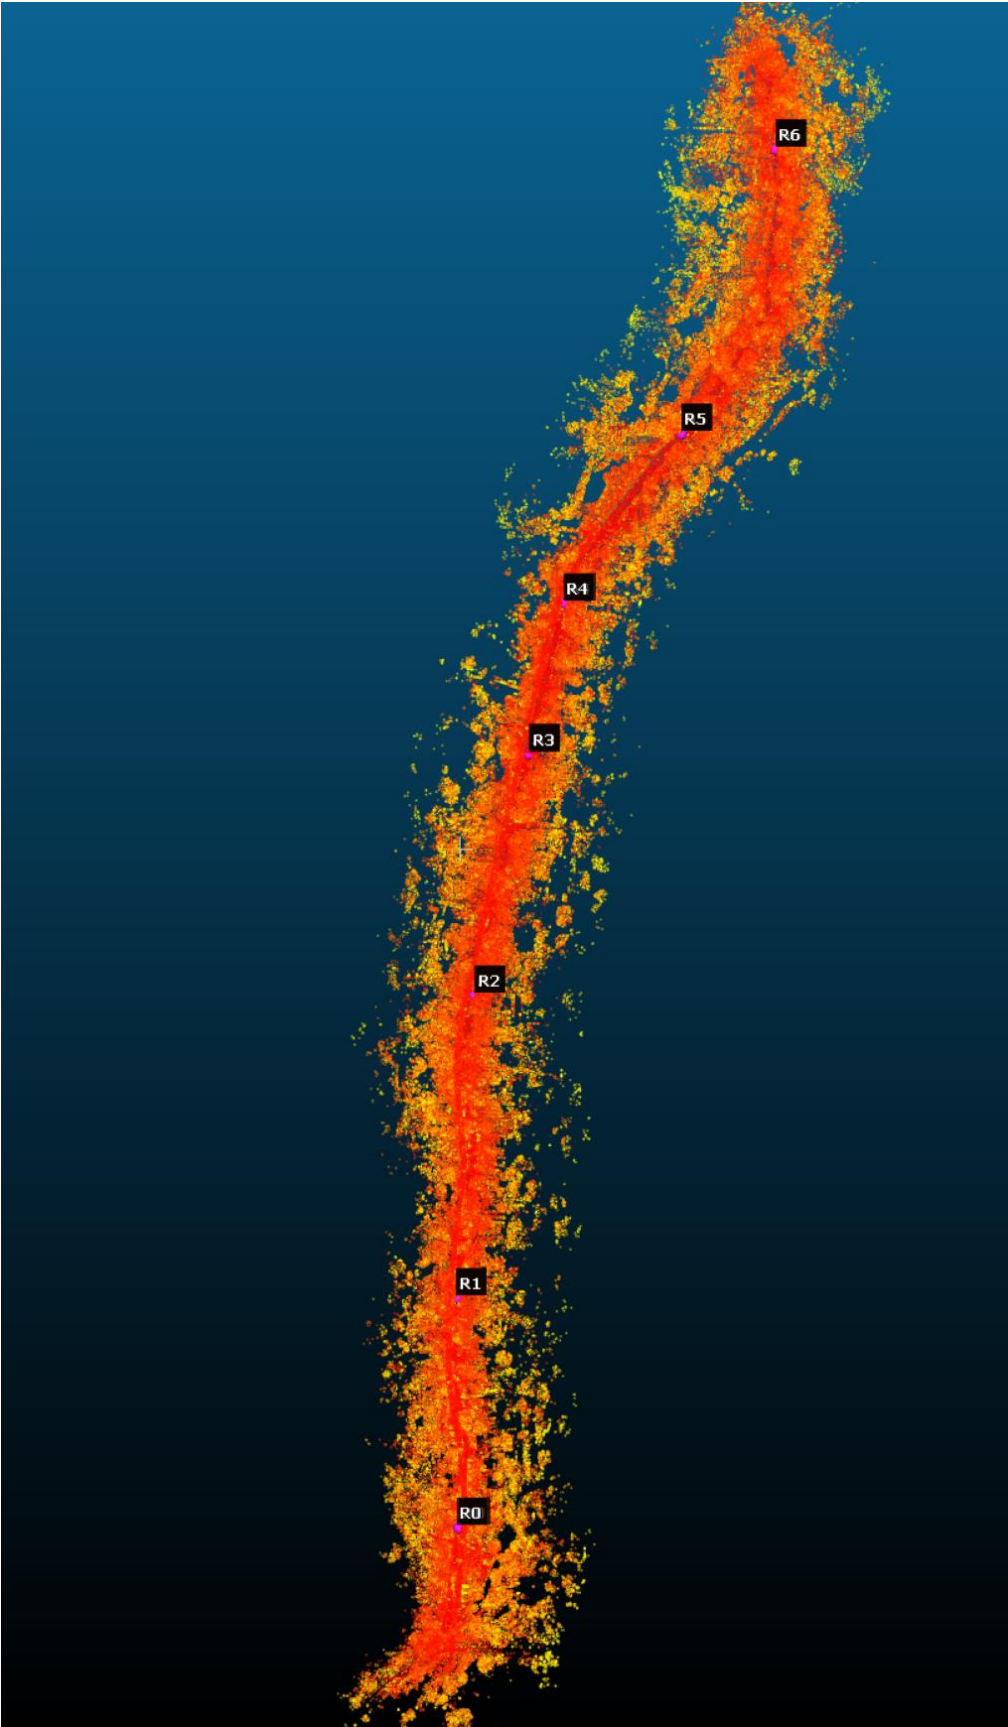
Final RMS: 6.88483

Scale: 3.27796 (already integrated in above matrix!)
