# Access Compliance Report
# Public Rights-of-Way
# (Curb Ramps)

**Main Street: BANTA_AVE** | **Cross Street: ENDRY_ST** | **Location: NW**

**ADA ID: RPAT210916085301** | **Ramp Type:Type 1 - Perpendicular Diagonal Initial Pass/Fail: Fail** | **Overall Compliance: No** | **Severity Score: 35**

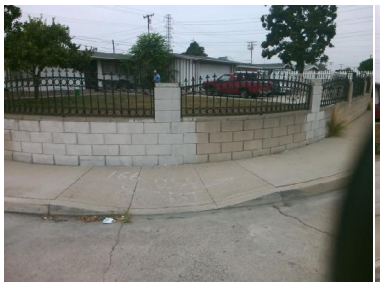
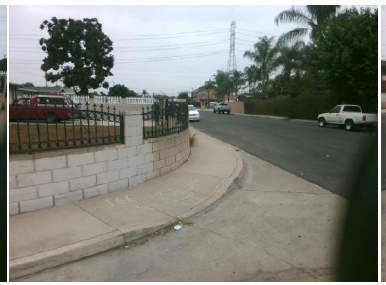
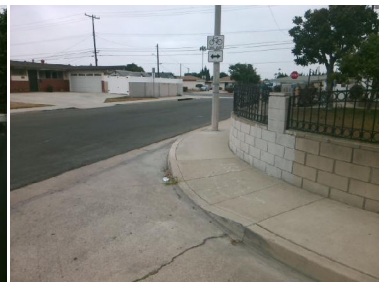
| Compliance | Description | Data | Compliance | Description | Data |
|---|---|---|---|---|---|
| **No** | Ramp Width (in) | **37** | | | **N/A** |
| **No** | Ramp Run Slope (%) | **12.2** | **N/A** | Flare Slope LT (%) | **N/A** |
| **No** | Ramp Cross Slope (%) | **4.4** | **N/A** | Flare Traversable LT | **N/A** |

**Remove & Replace Curb Ramp With Two New Directional Ramps or Equivalent.**
