Access Compliance Report
Public Rights-of-Way
(Curb Ramps)

Main Street: PALM_DR | **Cross Street: CEDARLAWN_DR** | **Location: NW**

ADA ID: RPAT210917102223 | **Ramp Type:Type 1 - Perpendicular Diagonal Initial Pass/Fail: Pass** | **Overall Compliance: No** | **Severity Score: 4**

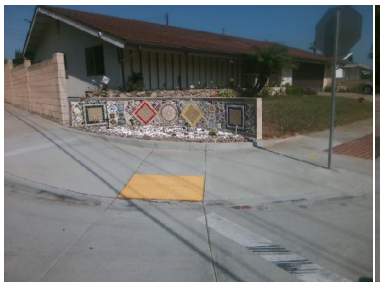
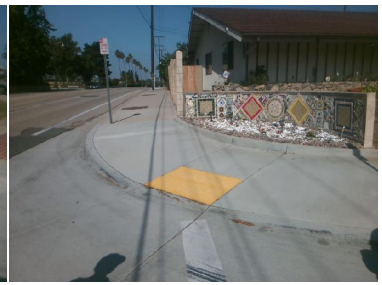
Compliance	Description	Data	Compliance	Description	Data
N/A	Ramp Length (in)	**60**	**N/A**	Flare Type LT	
Yes	Ramp Width (in)	**48**			**Sloped**
Yes	Ramp Run Slope (%)	**6.6**	**Yes**	Flare Slope LT (%)	**9.1**
Yes	Ramp Cross Slope (%)	**1.2**	**N/A**	Flare Traversable LT	**Yes**
N/A	Landing Present	**Yes**	**N/A**	Flare Type RT	
N/A	Landing Length (in)	**40**			**Sloped**
Yes	Landing Width (in)	**48**	**N/A**	Flare Slope RT (%)	**4.1**
Yes	Landing Run Slope (%)	**0.7**	**N/A**	Flare Traversable RT	**No**
Yes	Landing Cross Slope (%)	**1.6**	**Yes**	DWS Provided	**Yes**
N/A	Landing Movement Obstructed?	**Yes**	**Yes**	DWS Contrast	**Yes**
	Landing Movement Type	**Curb**	**Yes**	DWS Length (in)	**36**
N/A	Landing Shared	**No**	**Yes**	DWS Full Width	**Yes**
N/A	Clear Space	**Yes**	**Yes**	DWS Offset Left (in)	**0**
N/A	Clear Space To Crosswalk (in)	**48**	**Yes**	DWS Offset Right (in)	**N/A**
N/A	Marked Crosswalk 1	**No**	**N/A**	Marked Crosswalk 2	**No**

Crossing 1 Direction	**S**		Crossing 2 Direction	**E**
	Marked Crosswalk 1 Width (in)	**N/A**		Marked Crosswalk 2 Width (in)	**N/A**
N/A	Ramp Inside Crosswalk 1	**N/A**	**Yes**	Ramp Inside Crosswalk 2	**N/A**
	Crossing 1 Slope (%)	**4.3**		Crossing 2 Slope (%)	**2**
	Crossing 1 Cross Slope (%)	**2.4**		Crossing 2 Cross Slope (%)	**1.1**
Yes	Gutter Ponding	**No**	**No**	Curb Slope	**10.1**
Yes	Gutter Lip Height (in)	**0**		Road Run Slope (%)	**2.5**
Yes	Gutter Run Slope (%)	**2.8**		Road Cross Slope (%)	**3**
No	Gutter Cross Slope (%)	**2.1**			
Yes	Overall Surface Condition:	**Acceptable**	**Yes**	Perp Joint Present	**Yes**
	Cross Gutter Present?	**Yes**		Spandrel Present?	**Yes**
	Replace Cross Gutter?	**No**		Replace Spandrel?	**No**
