Access Compliance Report
Public Rights-of-Way
(Curb Ramps)

Main Street: BIXBY_AVE | **Cross Street: N_SKYWOOD_ST** | **Location: NW**

ADA ID: RPAT210924125320 | **Ramp Type:Type 1 - Perpendicular** | **Initial Pass/Fail: Fail** | **Overall Compliance: No** | **Severity Score: 34**

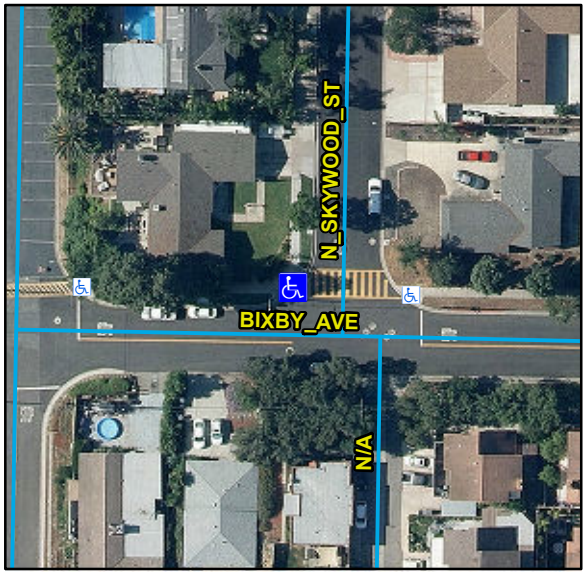
R304.2.2, R204.3, R304.5.1, R304.5.3, STD 1115

Compliance	Description	Data	Compliance	Description	Data
N/A	Ramp Length (in)	**93**	**N/A**	Flare Type LT	
No	Ramp Width (in)	**47**			**N/A**
Yes	Ramp Run Slope (%)	**7.9**	**N/A**	Flare Slope LT (%)	**N/A**
No	Ramp Cross Slope (%)	**10.8**	**N/A**	Flare Traversable LT	**N/A**
N/A	Landing Present	**N/A**	**N/A**	Flare Type RT	
N/A	Landing Length (in)	**N/A**			**N/A**
N/A	Landing Width (in)	**N/A**	**N/A**	Flare Slope RT (%)	**N/A**
N/A	Landing Run Slope (%)	**N/A**	**N/A**	Flare Traversable RT	**N/A**
N/A	Landing Cross Slope (%)	**N/A**	**N/A**	DWS Provided	**N/A**
N/A	Landing Movement Obstructed?	**N/A**	**N/A**	DWS Contrast	**N/A**
	Landing Movement Type	**N/A**	**N/A**	DWS Length (in)	**N/A**
N/A	Landing Shared	**N/A**	**N/A**	DWS Full Width	**N/A**
N/A	Clear Space	**N/A**	**N/A**	DWS Offset Left (in)	**N/A**
N/A	Clear Space To Crosswalk (in)	**N/A**	**N/A**	DWS Offset Right (in)	**N/A**
N/A	Marked Crosswalk 1	**Yes**	**N/A**	Marked Crosswalk 2	**N/A**

Remove & Replace Entire Ramp.
