Access Compliance Report
Public Rights-of-Way
(Curb Ramps)

Main Street: S_OLYMPIA_WAY | **Cross Street: E_DIXON_AVE** | **Location: NE**

ADA ID: RPAT211005085459 | **Ramp Type:Type 1 - Perpendicular Diagonal** | **Initial Pass/Fail: Pass** | **Overall Compliance: No** | **Severity Score: 20**

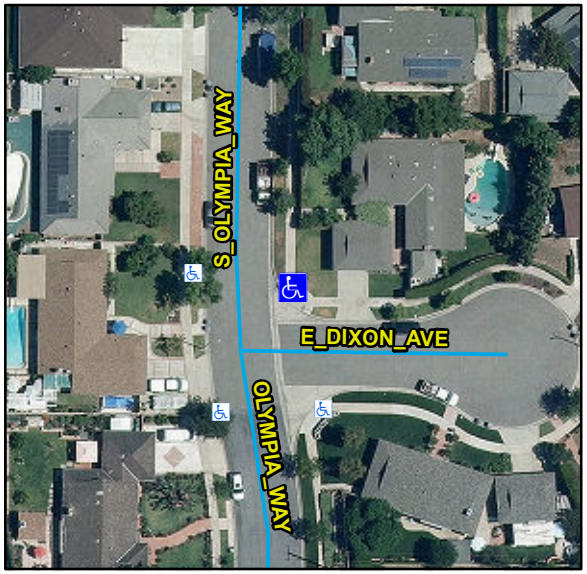
R304.2.2, R304.2.1, R304.2.2-Perp, R304.3.2-Para, R304.5.3, R305, STD 1115

Remove & Replace Curb Ramp With Two New Directional Ramps or Equivalent.
