Access Compliance Report
Public Rights-of-Way
(Curb Ramps)

Main Street: MALENA_DR | **Cross Street: E_LARKSTONE_DR** | **Location: SW**

ADA ID: RPAT211022132556 | **Ramp Type:Type 1 - Perpendicular Diagonal** | **Initial Pass/Fail: Fail** | **Overall Compliance: No** | **Severity Score: 19**

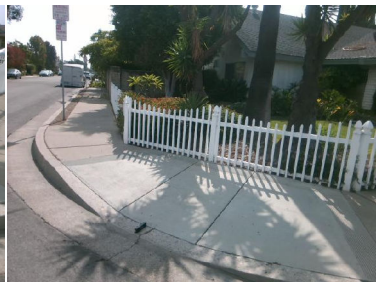
R304.2.2, R304.5.1, STD 1115

Remove & Replace Curb Ramp With Two New Directional Ramps or Equivalent.
