Access Compliance Report
Public Rights-of-Way
(Curb Ramps)

Main Street: ERVIN_LN | **Cross Street: WINTHROPE_ST** | **Location: SE**

ADA ID: RPAT211026130302 | **Ramp Type: Type 4 - Parallel** | **Initial Pass/Fail: Fail** | **Overall Compliance: No** | **Severity Score: 2**

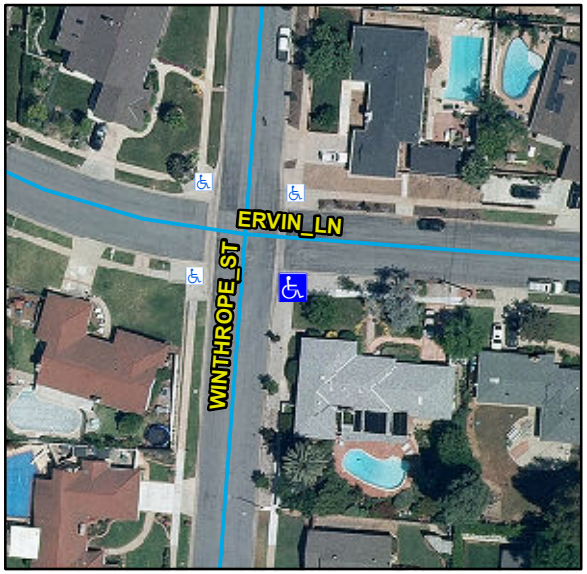
R204.3, R304.5.3, STD 1115

Remove & Replace Curb Ramp With Two New Directional Ramps or Equivalent.

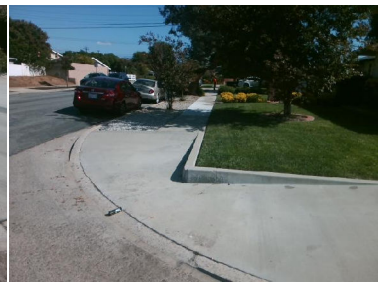
Compliance	Description	Data	Compliance	Description	Data
N/A	Ramp Length LT (in)	**134**	**N/A**	Ramp Length RT (in)	**155**
Yes	Ramp Width LT (in)	**87**	**Yes**	Ramp Width RT (in)	**104**
Yes	Ramp Run Slope LT (%)	**8.2**	**Yes**	Ramp Run Slope RT (%)	**5**
No	Ramp Cross Slope LT (%)	**2.3**	**No**	Ramp Cross Slope RT (%)	**2.4**
N/A	Landing Present	**N/A**	**N/A**	DWS Provided	**N/A**
N/A	Landing Length (in)	**N/A**	**N/A**	DWS Contrast	**N/A**
N/A	Landing Width (in)	**N/A**	**N/A**	DWS Length (in)	**N/A**
N/A	Landing Run Slope (%)	**N/A**	**N/A**	DWS Full Width	**N/A**
N/A	Landing Cross Slope (%)	**N/A**		DWS Offset Type	**N/A**
N/A	Landing Movement Obstructed?	**N/A**	**N/A**	DWS Offset Left (in)	**N/A**
	Landing Movement Type	**N/A**	**N/A**	DWS Offset Right (in)	**N/A**
N/A	Landing Shared	**N/A**			
N/A	Clear Space	**Yes**			
N/A	Clear Space To Crosswalk (in)	**N/A**			
N/A	Marked Crosswalk 1	**No**	**N/A**	Marked Crosswalk 2	**No**
