Access Compliance Report
Public Rights-of-Way
(Curb Ramps)

Main Street: TRUMPET_VINE_ST **Cross Street:** DELPHINIUM_ST **Location:** SW

ADA ID: RPAT211102102757 **Ramp Type:** Type 4 - Parallel **Initial Pass/Fail:** Fail **Overall Compliance:** No **Severity Score:** 15

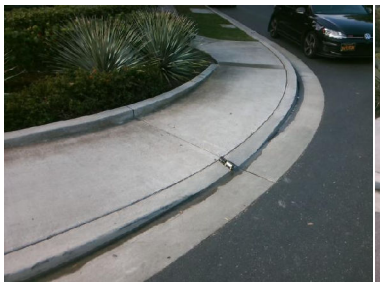
Compliance	Description	Data	Compliance	Description	Data
N/A	Ramp Length LT (in)	112	N/A	Ramp Length RT (in)	105
Yes	Ramp Width LT (in)	53	Yes	Ramp Width RT (in)	53
No	Ramp Run Slope LT (%)	9.6	Yes	Ramp Run Slope RT (%)	0.1
Yes	Ramp Cross Slope LT (%)	0.3	Yes	Ramp Cross Slope RT (%)	0.2
N/A	Landing Present	N/A	N/A	DWS Provided	N/A
N/A	Landing Length (in)	N/A	N/A	DWS Contrast	N/A
N/A	Landing Width (in)	N/A	N/A	DWS Length (in)	N/A
N/A	Landing Run Slope (%)	N/A	N/A	DWS Full Width	N/A
N/A	Landing Cross Slope (%)	N/A		DWS Offset Type	N/A
N/A	Landing Movement Obstructed?	N/A	N/A	DWS Offset Left (in)	N/A
	Landing Movement Type	N/A	N/A	DWS Offset Right (in)	N/A
N/A	Landing Shared	N/A			
N/A	Clear Space	Yes			
N/A	Clear Space To Crosswalk (in)	N/A			
N/A	Marked Crosswalk 1	No	N/A	Marked Crosswalk 2	No
	Crossing 1 Direction	E		Crossing 2 Direction	N
	Marked Crosswalk 1 Width (in)	N/A		Marked Crosswalk 2 Width (in)	N/A

Remove & Replace Curb Ramp With Two New Directional Ramps or Equivalent.
