Access Compliance Report
Public Rights-of-Way
(Curb Ramps)

Main Street: STRAWFLOWER_ST | **Cross Street:** GILLY_FLOWER_ST | **Location:** SE

ADA ID: RPAT211102135237 | **Ramp Type:** Type 1 - Perpendicular | **Initial Pass/Fail:** Fail | **Overall Compliance:** No | **Severity Score:** 32

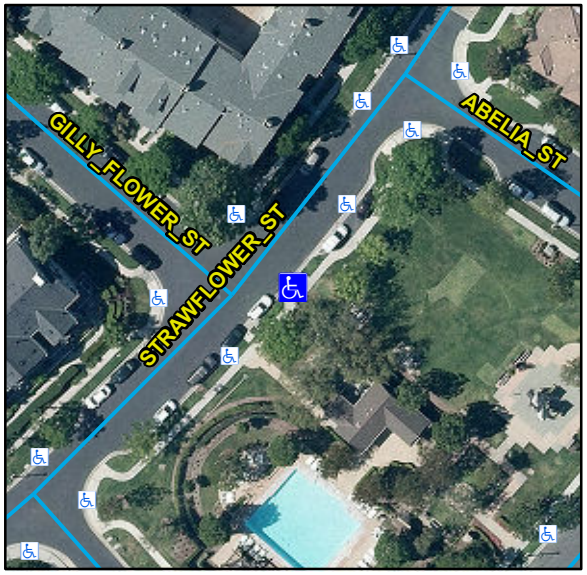
R304.2.2, R204.3, STD 1115

Compliance	Description	Data	Compliance	Description	Data
N/A	Ramp Length (in)	66	N/A	Flare Type LT	
Yes	Ramp Width (in)	50			N/A
No	Ramp Run Slope (%)	12.5	N/A	Flare Slope LT (%)	N/A
Yes	Ramp Cross Slope (%)	1.3	N/A	Flare Traversable LT	N/A
N/A	Landing Present	N/A	N/A	Flare Type RT	
N/A	Landing Length (in)	N/A			N/A
N/A	Landing Width (in)	N/A	N/A	Flare Slope RT (%)	N/A
N/A	Landing Run Slope (%)	N/A	N/A	Flare Traversable RT	N/A
N/A	Landing Cross Slope (%)	N/A	N/A	DWS Provided	N/A
N/A	Landing Movement Obstructed?	N/A	N/A	DWS Contrast	N/A
	Landing Movement Type	N/A	N/A	DWS Length (in)	N/A
N/A	Landing Shared	N/A	N/A	DWS Full Width	N/A
N/A	Clear Space	N/A	N/A	DWS Offset Left (in)	N/A
N/A	Clear Space To Crosswalk (in)	N/A	N/A	DWS Offset Right (in)	N/A
N/A	Marked Crosswalk 1	No	N/A	Marked Crosswalk 2	N/A
	Crossing 1 Direction	N		Crossing 2 Direction	N/A
	Marked Crosswalk 1 Width (in)	N/A		Marked Crosswalk 2 Width (in)	N/A

Remove & Replace Entire Ramp.
