Access Compliance Report
Public Rights-of-Way
(Curb Ramps)

Main Street: CHAPMAN_AVE | **Cross Street:** BEACH_BLVD | **Location:** SE

ADA ID: RPAT211130123621 | **Ramp Type:** Type 4 - Parallel | **Initial Pass/Fail:** Fail | **Overall Compliance:** No | **Severity Score:** 45

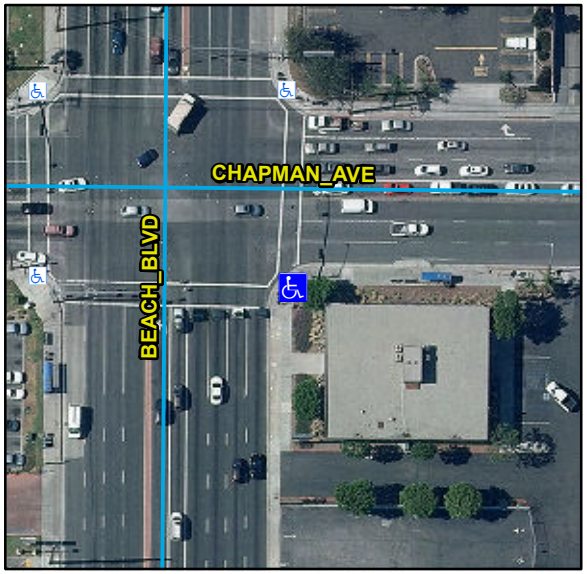
R304.3.2, R304.5.3, STD 1115

Compliance	Description	Data	Compliance	Description	Data
N/A	Ramp Length LT (in)	52	N/A	Ramp Length RT (in)	68
Yes	Ramp Width LT (in)	85	Yes	Ramp Width RT (in)	72
No	Ramp Run Slope LT (%)	11.3	No	Ramp Run Slope RT (%)	9.5
No	Ramp Cross Slope LT (%)	8.8	No	Ramp Cross Slope RT (%)	10.1
N/A	Landing Present	N/A	N/A	DWS Provided	N/A
N/A	Landing Length (in)	N/A	N/A	DWS Contrast	N/A
N/A	Landing Width (in)	N/A	N/A	DWS Length (in)	N/A
N/A	Landing Run Slope (%)	N/A	N/A	DWS Full Width	N/A
N/A	Landing Cross Slope (%)	N/A		DWS Offset Type	N/A
N/A	Landing Movement Obstructed?	N/A	N/A	DWS Offset Left (in)	N/A
	Landing Movement Type	N/A	N/A	DWS Offset Right (in)	N/A
N/A	Landing Shared	N/A			
N/A	Clear Space	Yes			
N/A	Clear Space To Crosswalk (in)	48			
N/A	Marked Crosswalk 1	Yes	N/A	Marked Crosswalk 2	Yes
	Crossing 1 Direction	N		Crossing 2 Direction	W
	Marked Crosswalk 1 Width (in)	120		Marked Crosswalk 2 Width (in)	120

Remove & Replace Curb Ramp With Two New Directional Ramps or Equivalent.
