Access Compliance Report
Public Rights-of-Way
(Curb Ramps)

Main Street: IRVINE_AVE | **Cross Street: MESA_DR** | **Location: SW**

ADA ID: RPAT220128133627 | **Ramp Type:Type 1 - Perpendicular Diagonal Initial Pass/Fail: Fail** | **Overall Compliance: No** | **Severity Score: 2**

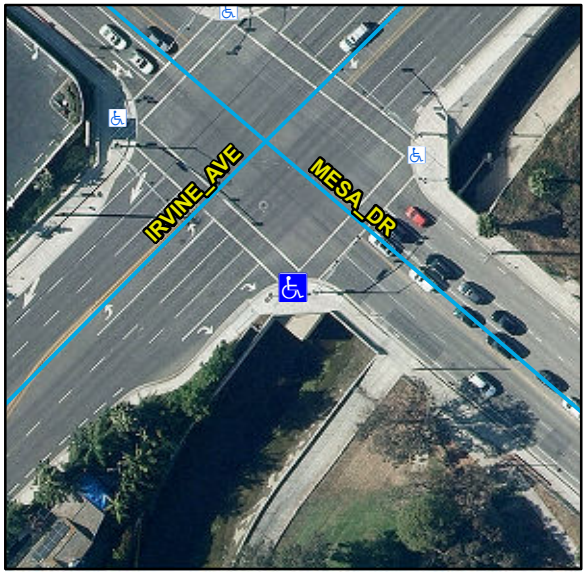
R304.5.3, STD 1115

Remove & Replace Curb Ramp With Two New Directional Ramps or Equivalent.
