Access Compliance Report
Public Rights-of-Way
(Curb Ramps)

Main Street: BIENVILLE_AVE | **Cross Street: PERDIDO_ST** | **Location: SE**

ADA ID: RPRK210924131237 | **Ramp Type:Type 1 - Perpendicular Diagonal Initial Pass/Fail: Fail** | **Overall Compliance: No** | **Severity Score: 30**

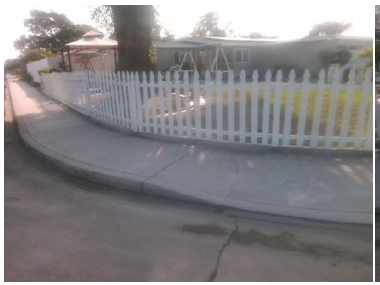
Compliance	Description	Data	Compliance	Description	Data
N/A	Ramp Length (in)	**50**	**N/A**	Flare Type LT	
Yes	Ramp Width (in)	**48**			**N/A**
No	Ramp Run Slope (%)	**12.8**	**N/A**	Flare Slope LT (%)	**N/A**
Yes	Ramp Cross Slope (%)	**0.6**	**N/A**	Flare Traversable LT	**N/A**
N/A	Landing Present	**N/A**	**N/A**	Flare Type RT	
N/A	Landing Length (in)	**N/A**			**N/A**
N/A	Landing Width (in)	**N/A**	**N/A**	Flare Slope RT (%)	**N/A**
N/A	Landing Run Slope (%)	**N/A**	**N/A**	Flare Traversable RT	**N/A**
N/A	Landing Cross Slope (%)	**N/A**	**N/A**	DWS Provided	**N/A**
N/A	Landing Movement Obstructed?	**N/A**	**N/A**	DWS Contrast	**N/A**
	Landing Movement Type	**N/A**	**N/A**	DWS Length (in)	**N/A**
N/A	Landing Shared	**N/A**	**N/A**	DWS Full Width	**N/A**
N/A	Clear Space	**Yes**	**N/A**	DWS Offset Left (in)	**N/A**
N/A	Clear Space To Crosswalk (in)	**N/A**	**N/A**	DWS Offset Right (in)	**N/A**
N/A	Marked Crosswalk 1	**No**	**N/A**	Marked Crosswalk 2	**No**

Remove & Replace Curb Ramp With Two New Directional Ramps or Equivalent.
