# Access Compliance Report
# Public Rights-of-Way
# (Curb Ramps)

**Main Street: BIMINI_DR** | **Cross Street: LA_LIMONAR_DR** | **Location: SE**

**ADA ID: RPRK211013133552** | **Ramp Type:Type 1 - Perpendicular Diagonal Initial Pass/Fail: Pass** | **Overall Compliance: No** | **Severity Score: 20**

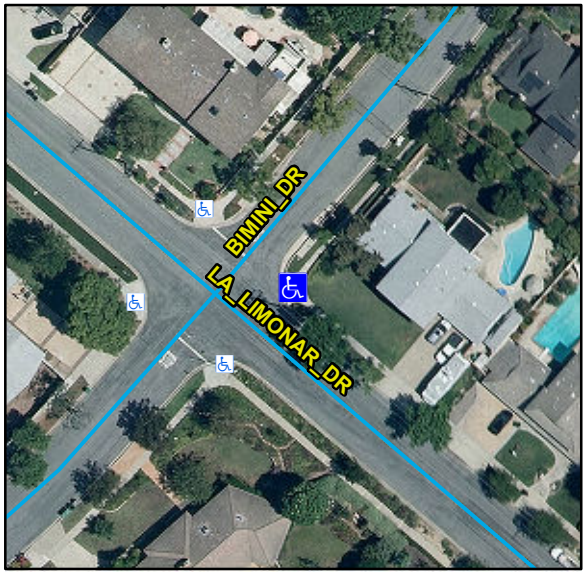
**R204.3, R304.2.1, R304.2.2-Perp, R304.3.2-Para, R304.5.3, R305, STD 1115**

**Remove & Replace Curb Ramp With Two New Directional Ramps or Equivalent.**
