Access Compliance Report
Public Rights-of-Way
(Curb Ramps)

Main Street: N/A | **Cross Street: OSO_PKWY** | **Location: NE**

ADA ID: RPRK211021115804 | **Ramp Type:Type 1 - Perpendicular** | **Initial Pass/Fail: Pass** | **Overall Compliance: No** | **Severity Score: 8**

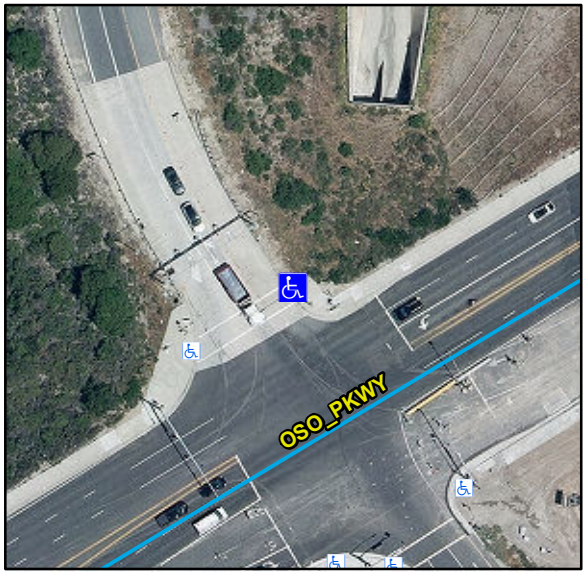
R304.2.1, R304.5.3, STD 1115

Remove & Replace Landing.
