Access Compliance Report
Public Rights-of-Way
(Curb Ramps)

Main Street: IRON_HORSE_TRAIL | **Cross Street:** HALF_MOON_TRAIL | **Location:** E

ADA ID: RPRK211021132139 | **Ramp Type:** Type 4 - Parallel | **Initial Pass/Fail:** Fail | **Overall Compliance:** No | **Severity Score:** 15

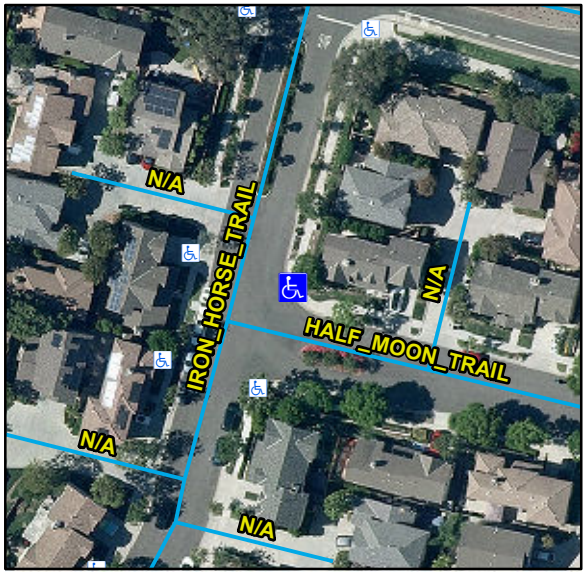
Compliance	Description	Data	Compliance	Description	Data
N/A	Ramp Length LT (in)	114	N/A	Ramp Length RT (in)	116
Yes	Ramp Width LT (in)	48	Yes	Ramp Width RT (in)	49
No	Ramp Run Slope LT (%)	10.3	Yes	Ramp Run Slope RT (%)	7.9
Yes	Ramp Cross Slope LT (%)	0.3	Yes	Ramp Cross Slope RT (%)	1.1
N/A	Landing Present	N/A	N/A	DWS Provided	N/A
N/A	Landing Length (in)	N/A	N/A	DWS Contrast	N/A
N/A	Landing Width (in)	N/A	N/A	DWS Length (in)	N/A
N/A	Landing Run Slope (%)	N/A	N/A	DWS Full Width	N/A
N/A	Landing Cross Slope (%)	N/A		DWS Offset Type	N/A
N/A	Landing Movement Obstructed?	N/A	N/A	DWS Offset Left (in)	N/A
	Landing Movement Type	N/A	N/A	DWS Offset Right (in)	N/A
N/A	Landing Shared	N/A			
N/A	Clear Space	Yes			
N/A	Clear Space To Crosswalk (in)	N/A			
N/A	Marked Crosswalk 1	No	N/A	Marked Crosswalk 2	No
	Crossing 1 Direction	NW		Crossing 2 Direction	SW
	Marked Crosswalk 1 Width (in)	N/A		Marked Crosswalk 2 Width (in)	N/A

Remove & Replace Curb Ramp With Two New Directional Ramps or Equivalent.

R204.3, R304.3.2, STD 1115
