Access Compliance Report
Public Rights-of-Way
(Curb Ramps)

Main Street: MAYBECK_LN | **Cross Street: DANBURY** | **Location: SW**

ADA ID: RPRK211025113137 | **Ramp Type: Type 4 - Parallel** | **Initial Pass/Fail: Fail** | **Overall Compliance: No** | **Severity Score: 16**

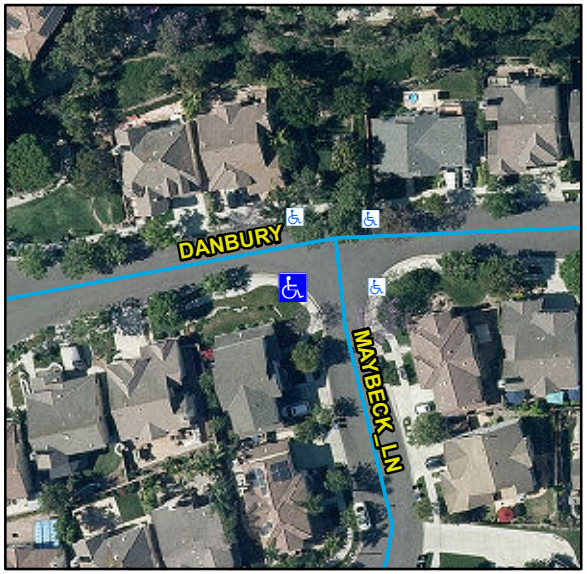
Compliance	Description	Data	Compliance	Description	Data
N/A	Ramp Length LT (in)	**116**	**N/A**	Ramp Length RT (in)	**119**
Yes	Ramp Width LT (in)	**52**	**Yes**	Ramp Width RT (in)	**52**
No	Ramp Run Slope LT (%)	**9.4**	**Yes**	Ramp Run Slope RT (%)	**1.5**
No	Ramp Cross Slope LT (%)	**2.6**	**Yes**	Ramp Cross Slope RT (%)	**1.5**
N/A	Landing Present	**N/A**	**N/A**	DWS Provided	**N/A**
N/A	Landing Length (in)	**N/A**	**N/A**	DWS Contrast	**N/A**
N/A	Landing Width (in)	**N/A**	**N/A**	DWS Length (in)	**N/A**
N/A	Landing Run Slope (%)	**N/A**	**N/A**	DWS Full Width	**N/A**
N/A	Landing Cross Slope (%)	**N/A**		DWS Offset Type	**N/A**
N/A	Landing Movement Obstructed?	**N/A**	**N/A**	DWS Offset Left (in)	**N/A**
	Landing Movement Type	**N/A**	**N/A**	DWS Offset Right (in)	**N/A**
N/A	Landing Shared	**N/A**			
N/A	Clear Space	**Yes**			
N/A	Clear Space To Crosswalk (in)	**N/A**			
N/A	Marked Crosswalk 1	**No**	**N/A**	Marked Crosswalk 2	**No**

Remove & Replace Curb Ramp With Two New Directional Ramps or Equivalent.
