Access Compliance Report
Public Rights-of-Way
(Curb Ramps)

Main Street: UNIVERSITY_AVE | **Cross Street:** CREIGHTON_DR | **Location:** S

ADA ID: RPRK211026140937 | **Ramp Type:** Type 1 - Perpendicular | **Initial Pass/Fail:** Pass | **Overall Compliance:** No | **Severity Score:** 16

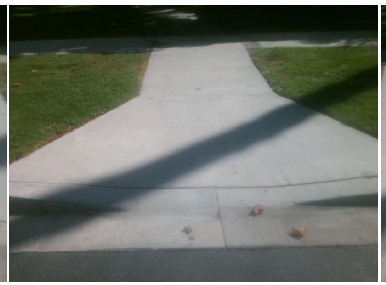
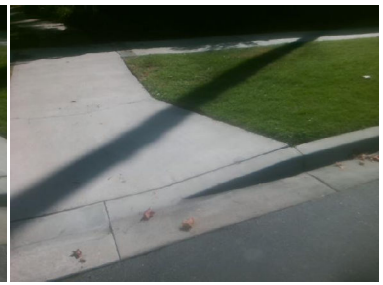
N/A	Ramp Inside Crosswalk 1	N/A	Yes	Ramp Inside Crosswalk 2	N/A
	Crossing 1 Slope (%)	6.8		Crossing 2 Slope (%)	N/A
	Crossing 1 Cross Slope (%)	0.6		Crossing 2 Cross Slope (%)	N/A
Yes	Gutter Ponding	No	Yes	Curb Slope	5
Yes	Gutter Lip Height (in)	0		Road Run Slope (%)	N/A
No	Gutter Run Slope (%)	8.5		Road Cross Slope (%)	N/A
Yes	Gutter Cross Slope (%)	0.7			
Yes	Overall Surface Condition:	Acceptable	Yes	Perp Joint Present	Yes
	Cross Gutter Present?	No		Spandrel Present?	No
	Replace Cross Gutter?	N/A		Replace Spandrel?	N/A

Install Detectable Warning System. Remove & Replace Gutter.
