# Access Compliance Report
# Public Rights-of-Way
# (Curb Ramps)

**Main Street: TRIAD_LN** | **Cross Street: ETON_PL** | **Location: NE**

**ADA ID: RPRK211028120727** | **Ramp Type: Type 4 - Parallel** | **Initial Pass/Fail: Fail** | **Overall Compliance: No** | **Severity Score: 2**

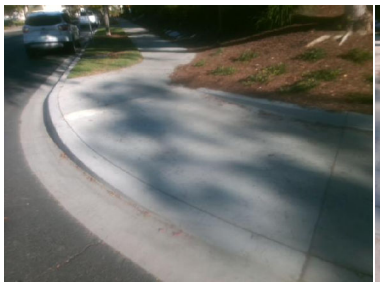
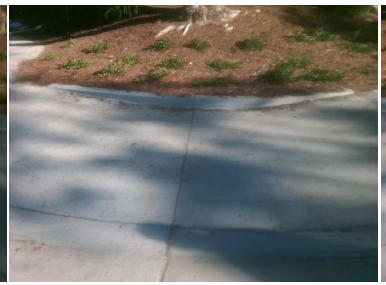
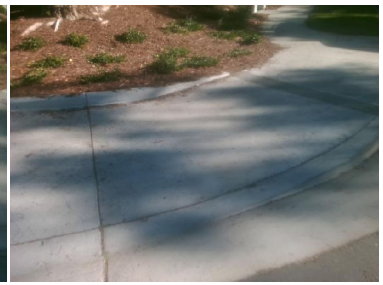
| Compliance | Description | Data | Compliance | Description | Data |
|---|---|---|---|---|---|
| **Yes** | Ramp Cross Slope LT (%) | **1.2** | **No** | Ramp Cross Slope RT (%) | **3.5** |
| **N/A** | Gutter Ponding | **N/A** | **No** | Curb Slope | **10.3** |

**Remove & Replace Curb Ramp With Two New Directional Ramps or Equivalent.**
