Access Compliance Report
Public Rights-of-Way
(Curb Ramps)

Main Street: ETON_PL | **Cross Street: TRIAD_LN** | **Location: SE**

ADA ID: RPRK211028121242 | **Ramp Type: Type 4 - Parallel** | **Initial Pass/Fail: Fail** | **Overall Compliance: No** | **Severity Score: 2**

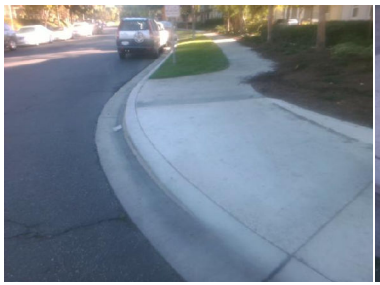
Compliance	Description	Data	Compliance	Description	Data
N/A	Ramp Length LT (in)	**137**	**N/A**	Ramp Length RT (in)	**128**
Yes	Ramp Width LT (in)	**90**	**Yes**	Ramp Width RT (in)	**89**
Yes	Ramp Run Slope LT (%)	**5.2**	**Yes**	Ramp Run Slope RT (%)	**1.6**
Yes	Ramp Cross Slope LT (%)	**1.1**	**No**	Ramp Cross Slope RT (%)	**2.6**
N/A	Landing Present	**N/A**	**N/A**	DWS Provided	**N/A**
N/A	Landing Length (in)	**N/A**	**N/A**	DWS Contrast	**N/A**
N/A	Landing Width (in)	**N/A**	**N/A**	DWS Length (in)	**N/A**
N/A	Landing Run Slope (%)	**N/A**	**N/A**	DWS Full Width	**N/A**
N/A	Landing Cross Slope (%)	**N/A**		DWS Offset Type	**N/A**
N/A	Landing Movement Obstructed?	**N/A**	**N/A**	DWS Offset Left (in)	**N/A**
	Landing Movement Type	**N/A**	**N/A**	DWS Offset Right (in)	**N/A**
N/A	Landing Shared	**N/A**			
N/A	Clear Space	**Yes**			
N/A	Clear Space To Crosswalk (in)	**N/A**			
N/A	Marked Crosswalk 1	**No**	**N/A**	Marked Crosswalk 2	**No**

Remove & Replace Curb Ramp With Two New Directional Ramps or Equivalent.
